CAPITOLA CITY COUNCIL SPECIAL MEETING

SUBJECT: Consider a Budget Amendment To Fund Emergency Tree Removal at City Hall,
420 Capitola Avenue

A Limited Risk Assessment of 13 Trees City Hall and Beach & Village Parking Lots

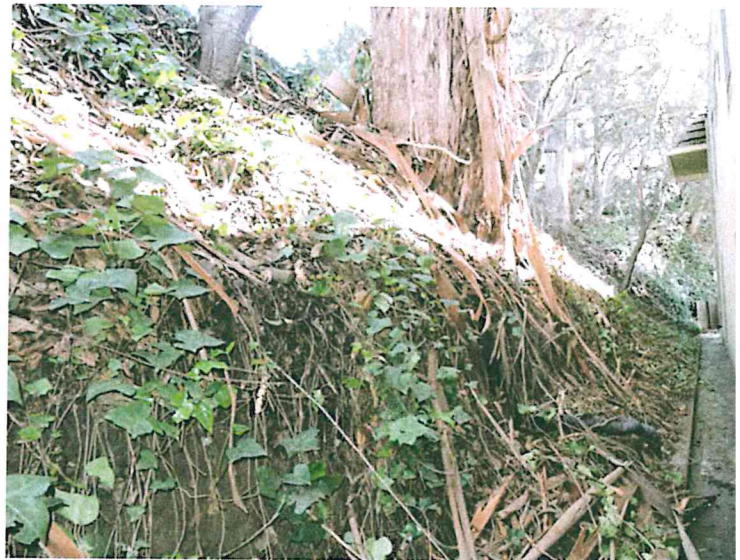
Tree #112 grows to the north of the upper parking lot over a high voltage utility line and parking spaces #961 and 968 in the lower parking lot. The growing site slopes dramatically and is covered with ivy and poison oak growth.

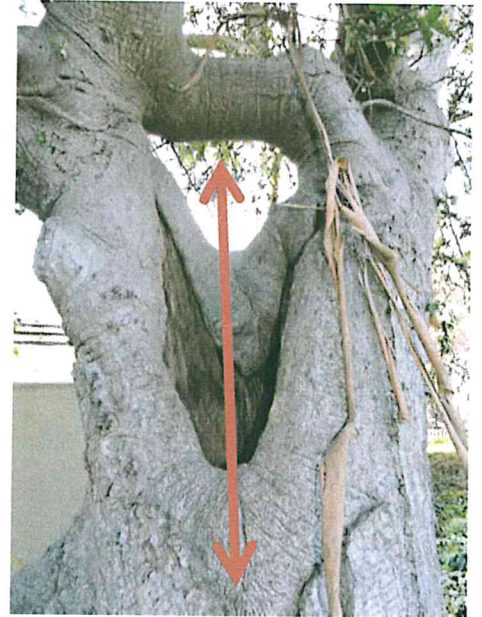
Assigned Number: 102

- Poor trunk/stem attachments with **included bark**
- Heavily weighted, over-extended lateral branches spread to the west over City Hall
- Stress fractures are visible at several positions on the supporting trunks
- Fair Health with Poor Structure

- Probability of Failure, Moderately High = 3
- Target Area, High = 4
- Size of the Defective Part, Branches or Stems between 4 and 20 diameter inches = 2

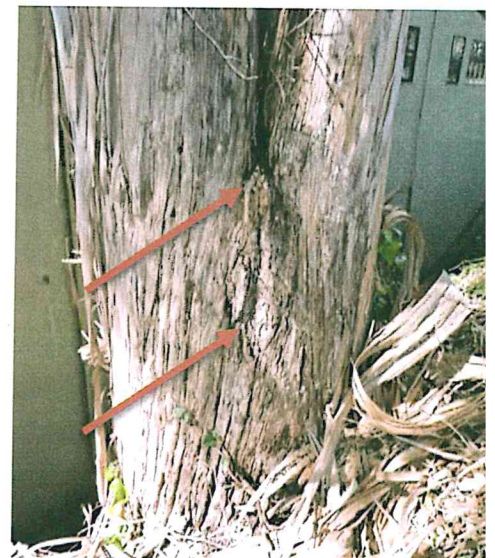
Tree #103, continued

- Stout trunk stands at the bottom of a steep slope just above an un-reinforced 4-foot vertical cut
- Exposed surface roots
- Divides into two poorly attached secondary trunks with included bark at the height of 6-feet above grade, see red arrows at right photo
- The upper canopy is over-weighted, extending to the North and East over the City Hall building
- HIGH FAILURE POTENTIAL

- Fair Health with Poor Structure

- Probability of Failure, High = 4
- Target Area, High = 4
- Size of the Defective Part, Branches or Stems greater than 20 diameter inches = 3

The bulge on the trunk of Tree #103 can be an indication of forces from inside the tree pushing against the bark and the attachment point. Bulges can also indicate an area of internal decay (Mattheck 1997).

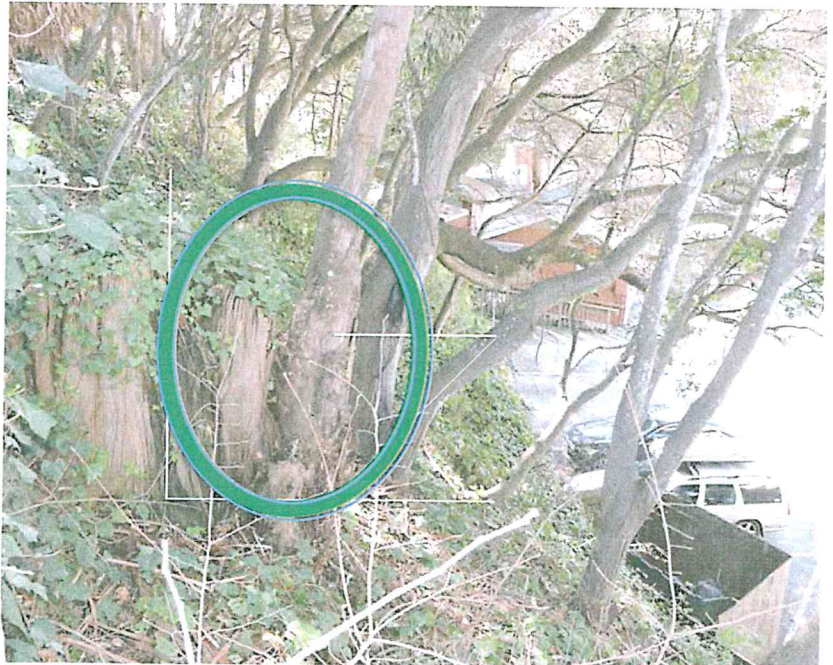
Assigned Number: 110**Species:** Tasmanian blue gum eucalyptus (*Eucalyptus globulus*)**Diameter:** Four trunks ranging from 43 to 18.5 diameter inches at 54 inches above grade**Approximate Height:**

- Visual assessment was limited by dense ivy and poison oak growth in the lower trunk sections
- Grows adjacent to frequently used, unimproved foot path and Santa Cruz County Regional Transportation Commission's (SCCRTC) rail line
- Codominant stems with included bark
- Suppressed growth to the South
- Over-extended/weighted canopies to the North, West and East
- HIGH FAILURE POTENTIAL
- Fair Health with Poor Structure

- Probability of Failure, High = 4
- Target Area, High = 4
- Size of the Defective Part, Branches or Stems greater than 20 diameter inches = 3

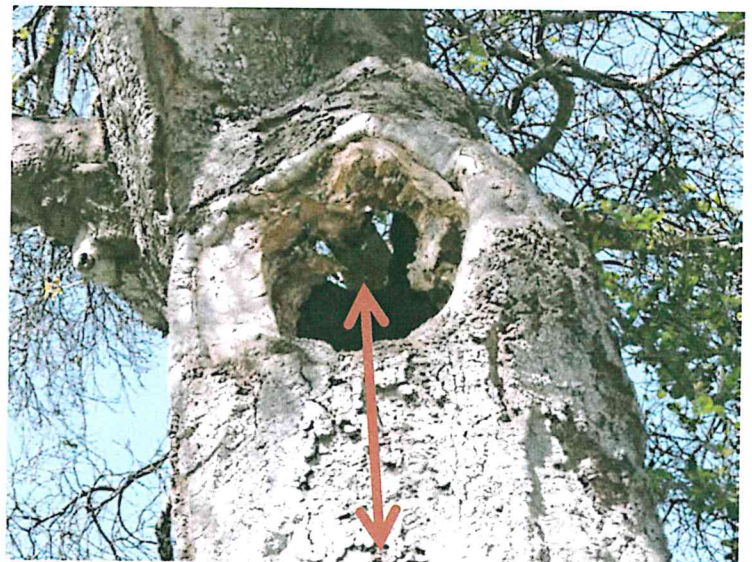
Assigned Number: 112, continued

- Leans to the North toward un-insulated electrical utility lines and Lower Beach & Village parking spaces #961 through 968
- Two large diameter pruning wounds are poorly **compartmentalized** with extensive **decay** columns
- Decay columns have merged to create a hollow trunk that extends down to the **buttress** area and up toward major scaffold branch attachment points
- HIGH FAILURE POTENTIAL

- Fair Health with Poor Structure

- Probability of Failure, High = 4
- Target Area, High = 4
- Size of the Defective Part, Branches or Stems greater than 20 diameter inches =3

Unfortunately, the most significant coast live oak trees evaluated, Trees #101 and 112 have large decay “chimneys” that began with large pruning wounds or branch failures that did not compartmentalize. These decay columns weaken support capabilities and are prone to failure. There are no professional treatments available to remedy the advancement of decay and further weakening.
