ADDENDUM NO. 1

TO: All Plan holders and Prospective Bidders
FROM: City of Capitola Public Works
DATE: March 27, 2020
RE: **ADDENDUM NO. 1**
BROMMER STREET COMPLETE STREET IMPROVEMENT PROJECT

GEOTECHNICAL INVESTIGATION DESIGN PHASE

FOR
BROMMER COMPLETE STREET IMPROVEMENT
CAPITOLA, CALIFORNIA

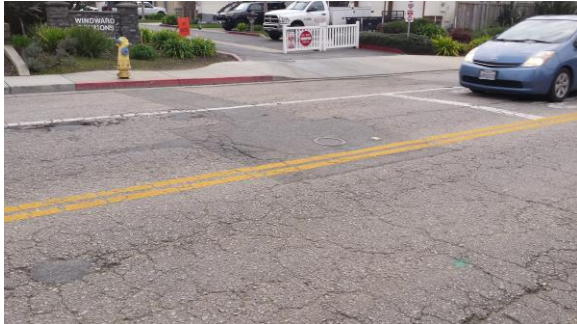
East of the 38th Avenue intersection the pavement has severe distress and is in poor to failed condition. There is alligator cracking, potholes, utility repairs, longitudinal cracking, and block cracking.

Alligator cracking is generally caused by subgrade failure. The stress in the subgrade becomes too high and the soil begins to breakdown causing cracking in the overlying pavement. The subgrade failure can be due to lack of poor subgrade strength and/or inadequate pavement section. Because alligator cracking is a failure of the subgrade repair options should include pavement rehabilitation methods that improve the subgrade such as full depth replacement and full depth reclamation.

Potholes are caused by complete failure of the pavement section due to age, lack of maintenance, and/or an inadequate pavement section. Rehabilitation methods that repair the entire pavement section should be used such as full depth replacement and full depth reclamation.

The pavement east of 38th Avenue was not maintained which caused subgrade failure as indicated by the severe alligator cracking and potholes. The pavement section has degraded into the subgrade and reached the point where maintenance options will not be effective.

Area east of 38th Avenue intersection showing severe alligator cracking and potholes.

Three options for pavement rehabilitation have been provided. Based on the pavement condition the following rehabilitation options should be considered for each area:

- Option 1: Full Depth Replacement (Entire Corridor)
- Option 2: Full Depth Reclamation (Entire Corridor)
- Option 3: Maintenance Options (38th Avenue Intersection and West)

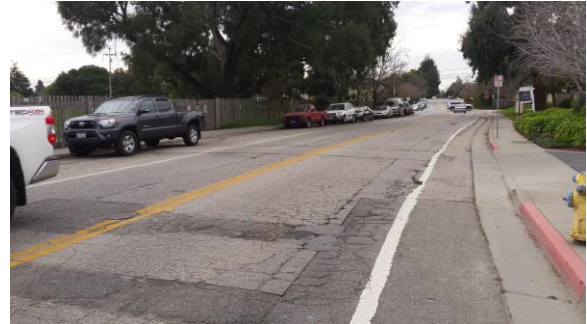
Area east of 38th Avenue intersection showing potholes, patches, and alligator cracking.

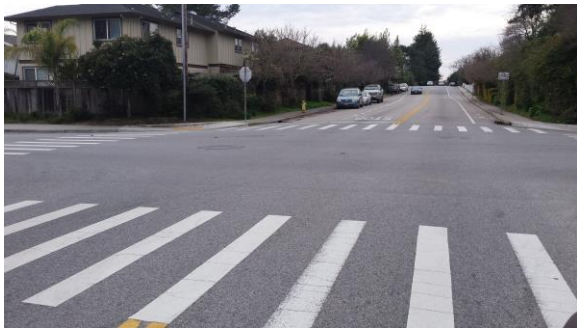
38th Avenue intersection in good condition.

A maintenance option may be chosen for the intersection of 38th Avenue and west to the city boundary. Maintenance options are not designed for a 20-year life cycle. Maintenance will significantly increase performance extending the life of the existing pavement in fair to good condition. Maintenance options will also improve the frictional properties of the pavement and the aesthetics. In general maintenance should be done every 3 to 5 years and can extend the life of the pavement to over 20 years if done at regular intervals.

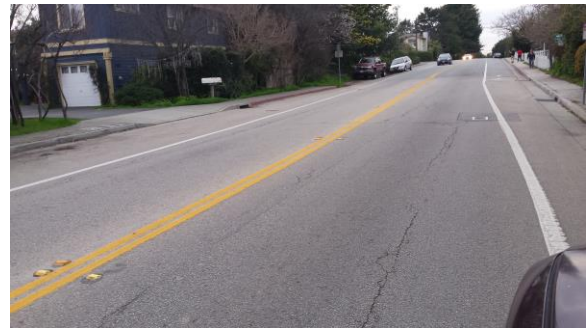
The pavement from the city boundary through the 38th avenue intersection has recently been rehabilitated. The intersection repair appears to have been completed more recently as part of rehabilitating a segment of 38th Avenue. The pavement surface in this area is in fair to good condition with some longitudinal cracking west of the intersection.

Longitudinal cracking is generally caused by poor placement of construction joints. Construction joints are the least dense area of the pavement and should be placed outside the wheelpath. Joints in the wheelpath commonly develop longitudinal cracking. Less frequently longitudinal cracking can be the result of joint reflection cracking from the underlying soil.

West of 38th Avenue intersection showing some longitudinal cracking.
