## RECONSTRUCT STORM DAMAGED BIKE PATH AND SHOULDER ON PARK AVE.

### FEDERAL NO. ER-32L0(346)

## **TECHNICAL MEMORANDUM**

RE: Design Alternatives Memorandum - Revised  
Park Avenue Slope Repair  
City of Capitola, California  
CE&G Document 180920.001

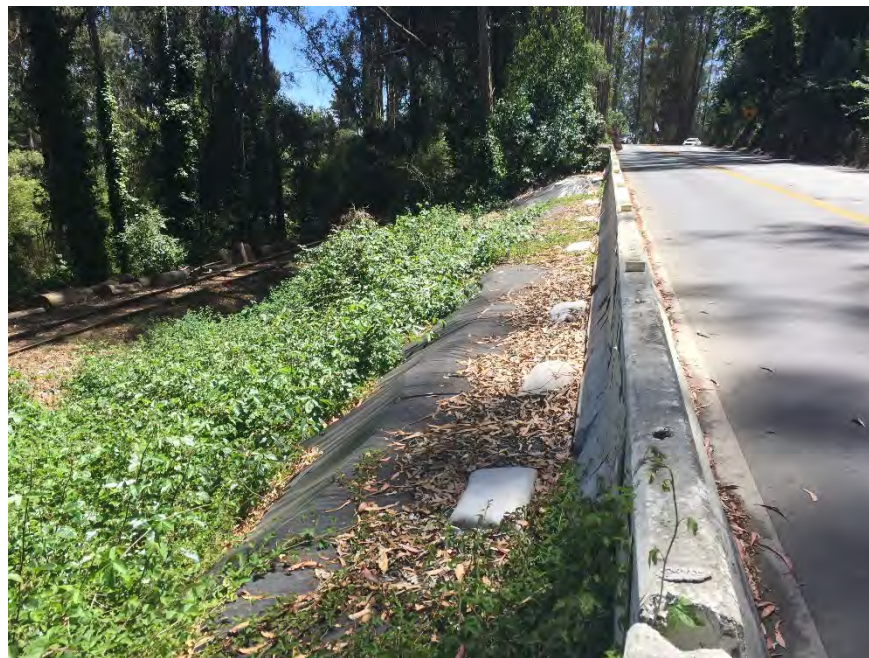
The damaged slope is currently covered with visquine and sandbags to protect the uplifted and loose surficial soils from surface runoff and reduce potential for additional damage. Temporary concrete “K-rail” barricades are placed along the edge of roadway pavement within the limits of the damaged slope. Photo 1 below shows the current condition of the slope along Park Avenue.

**Photo 1. Slope Damage Along Park Avenue, taken July 7, 2018**

The eastern slope along Park Avenue was damaged due to the toppling of trees, leading to uplift of the tree root balls causing movement along the slope. Based on site reconnaissance and our subsurface investigation, the damage appears to be shallow and only extend within the upper portions of the slope. Soils within the limits of the damaged slope are likely to be

loose and susceptible to erosion. Damaged areas include segments of bike lane where the roadway pavement lost support and failed, leaving the bike lane inoperable.

Permanent engineered slope repair is to consist of a reinforced-earth repair slope with a keyway at the toe of the bank slope. The embankment keyway footing should extend a minimum of 3 feet into competent native materials.

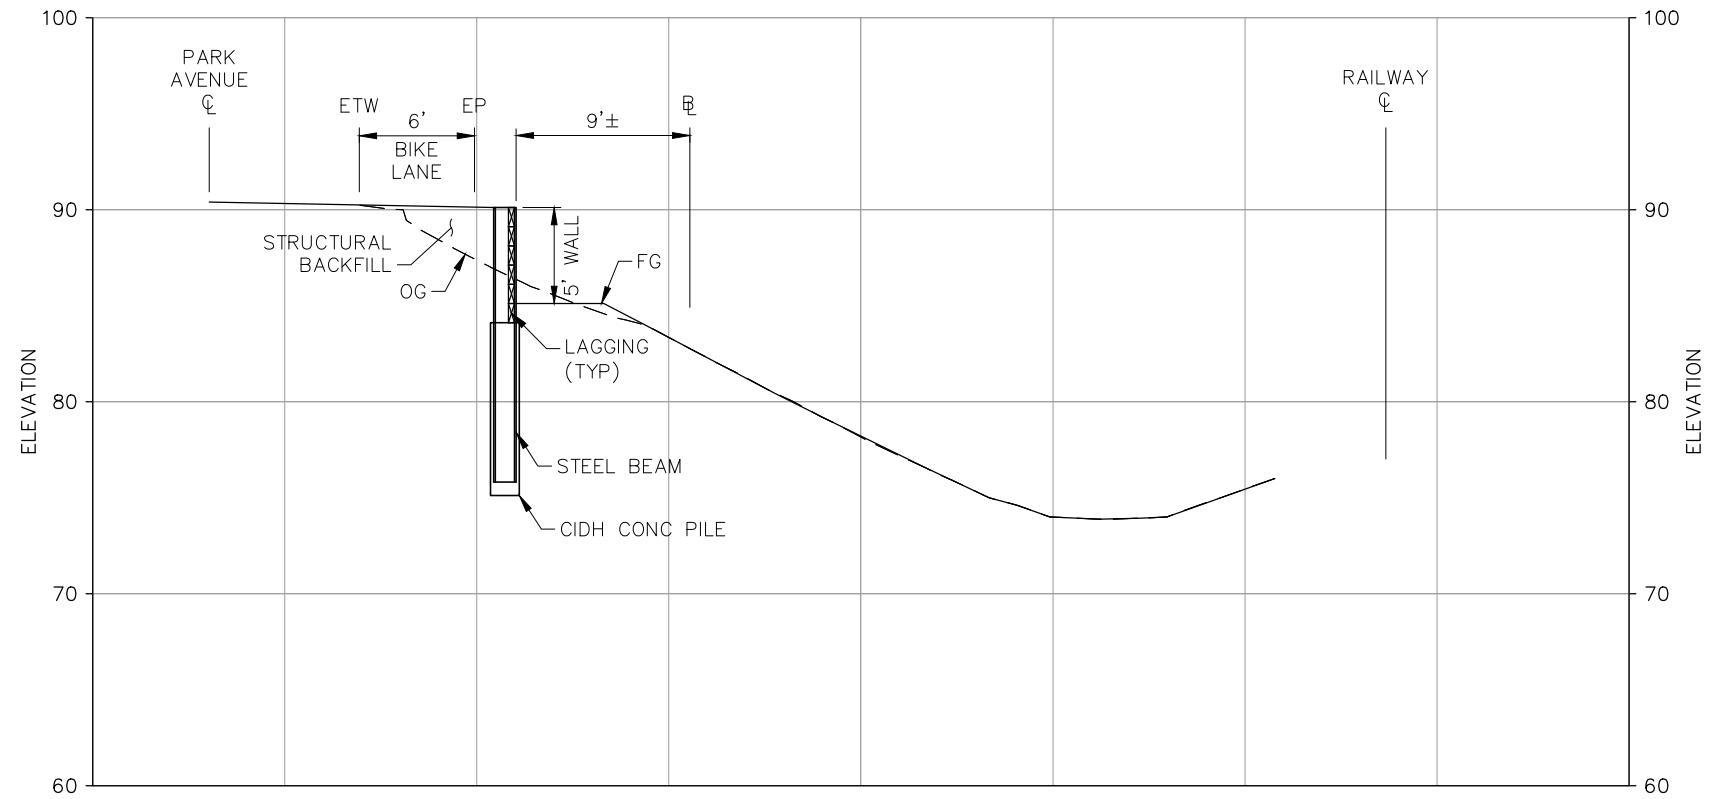
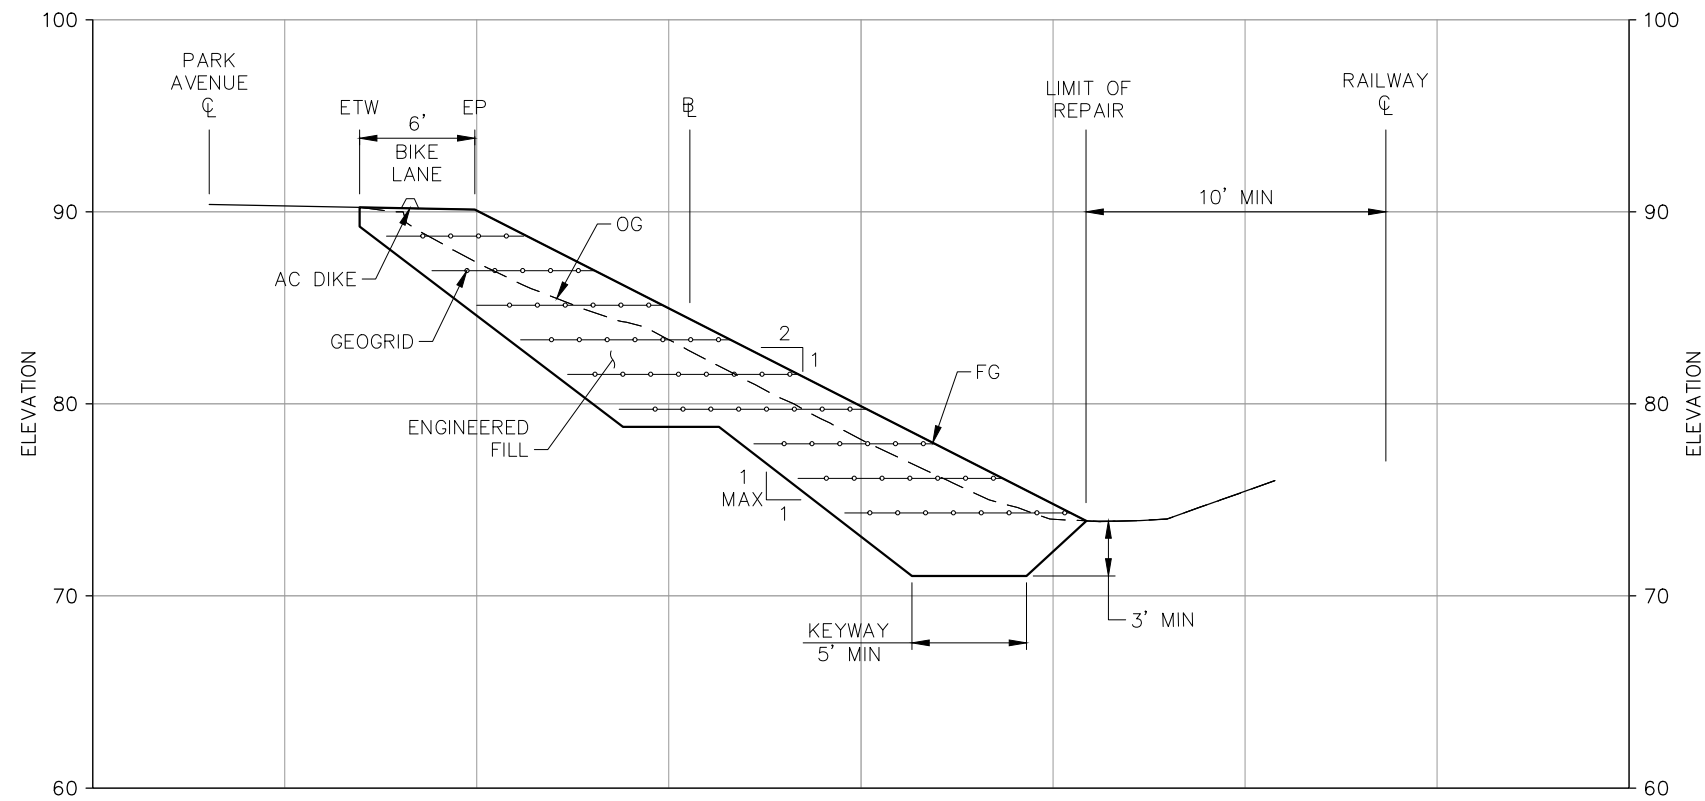
<b>PARK AVENUE SLOPE REPAIR</b> BETWEEN CORONADO ST. AND KENNEDY DR. CAPITOLA, CALIFORNIA		
<b>CONCEPTUAL TYPICAL SECTIONS</b>		
180920	FEBRUARY 2019	FIGURE 3

Loose materials in the damaged areas would be excavated and suitable on-site material would be recompacted to rebuild the slope. The reconstructed slope would be benched and keyed into competent material underlying the loose surficial and subsurface material. Geosynthetics such as geotextile fabric and/or geogrid reinforcement will be required to be incorporated to provide additional resistance for slope stability and/or to provide slope face stability along steepened slopes. The rebuilt slope would conform to the adjacent slopes at each lateral margin. Erosion protection would be incorporated to prevent surficial sluffs and materials from migrating downward. The top of the rebuilt slope will likely extend laterally into the roadway shoulder/bike lane, as segments of pavement have been damaged and will need to be repaved. An Engineer from CE&G should be present during excavation operations to verify depth and limit of disturbed and loose material. A typical section schematic of a reinforced earth repair is shown on Figure 3.

Soldier pile and lagging wall would generally consist of drilling cast-in-drilled-hole (CIDH) piles offset from the edge of pavement, installing lagging (i.e. timber or precast concrete lagging), and regrading and recompacting loose material below the wall. Based on our site reconnaissance, it is judged that overhead clearance would not pose a challenge for

Based on the understanding that the SCBRL will be fully cooperative with the repair efforts and that a stable slope can be constructed within the existing right-of-way, the likely preferred alternative would include rebuilding the damaged slope with an engineered reinforced-earth slope repair. The dormant SCBRL corridor can potentially be used for construction staging and temporary stockpiling of excavated soils. Constructing an engineered slope repair for this project is relatively cost effective and can be constructed using conventional construction equipment. The repair is also likely to blend with slopes adjacent to the project area when compared to a retaining wall alternative.
