SOQUEL CREEK LAGOON MONITORING REPORT, 1990-91

**CITY OF CAPITOLA
420 Capitola Avenue
Capitola, California 95010**

D.W. ALLEY & ASSOCIATES, Aquatic Biology

February 22, 1992

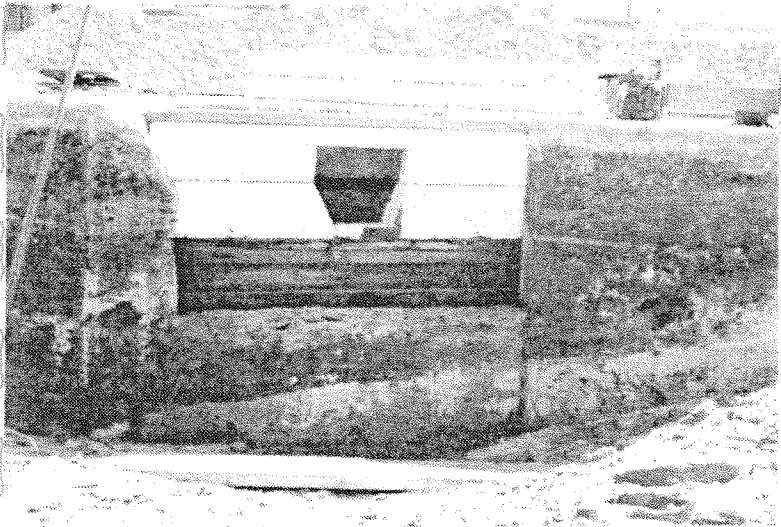
Side Portal for Adult Fish

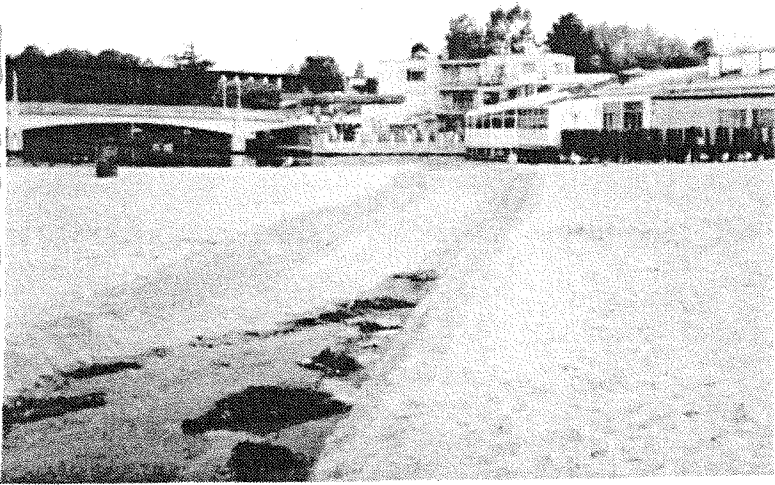
Notch in Sandbar, Early Fall, 1990

- 1) Recommend that the owners of 443 Riverview need to build a better bulk head to replace the old sandbag wall.
- 2) The notch in the sandbar should be cut slightly lower than the piling bolt. A new piling bolt for triggering sandbar breaching should be installed 6 inches below the old one. This will cause sooner breaching of the sandbar and allow a greater rise in lagoon elevation without flooding between the time the water begins to enter the notch in the sandbar and the time the notch begins to widen and deepen from streamflow.

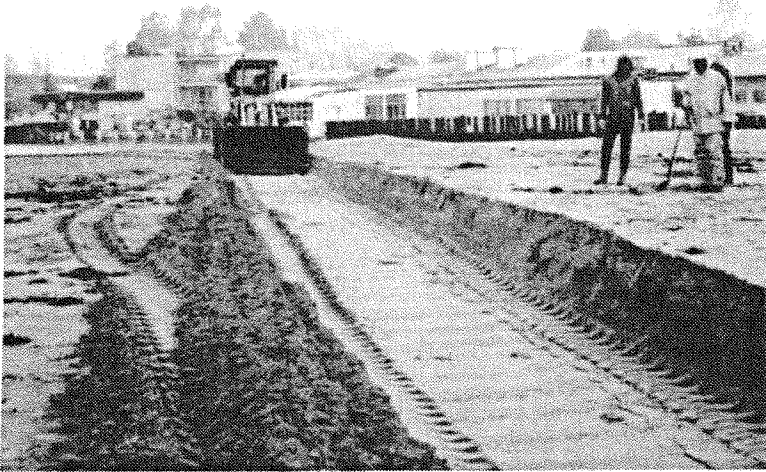
7 February 1991. Small storms had occurred before this date. However, the flume was able to handle the flow. During one event, the first manhole cover on the top of the flume had been opened. The lagoon began breaching at 0830 hr. The water began flowing through the notch in the beach when the lagoon level was 2 inches above the piling bolt. At this point, 6 inches of free-board existed to the berm at 443 Riverview Avenue. No water was on the patio. By 0900 hr, the lagoon elevation was 8 inches above the piling bolt and the patio at 443 Riverview had 2 inches of standing water. Water was leaking through old sandbags forming a wall adjacent to the berm. We took sandbags off the top of the wall and jammed them in behind the wall to stop the leakage. The water level in the lagoon was 4-6 inches above the elevation of the patio. Water did not enter the house. By 0930 hr, the lagoon level was 3 inches below the piling pin as the lagoon was emptying. The notch in the sandbar was then 20-25 feet wide with a flow of over 100 cfs flowing out (Appendix A-3).

New Notch, Late-Season Breach, 7Feb91
