**2004 SOQUEL CREEK LAGOON  
MANAGEMENT AND ENHANCEMENT PLAN UPDATE**

**June 2004**

**Project #192-01**

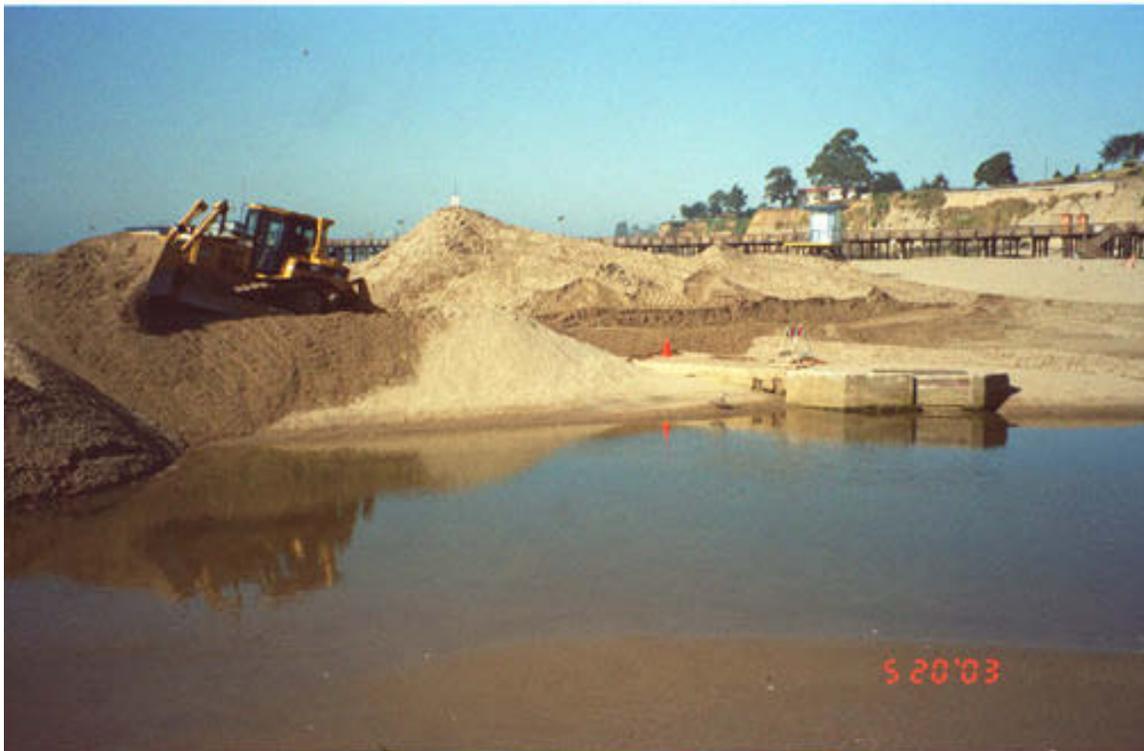
**Photo 1. Sandbar Construction Typically Done Before Memorial Day Weekend**

The original 1990 Management Plan prescribed how to construct the sandbar, when to make the flume passable for steelhead migration, and how to breach the sandbar in the fall in an emergency to prevent flooding. The Plan prescribed how to maximize survival of smolting steelhead as they passed through the lagoon. It provided guidelines to protect young steelhead using the summer lagoon as nursery habitat. The plan recommended ways to minimize the pollutants entering the

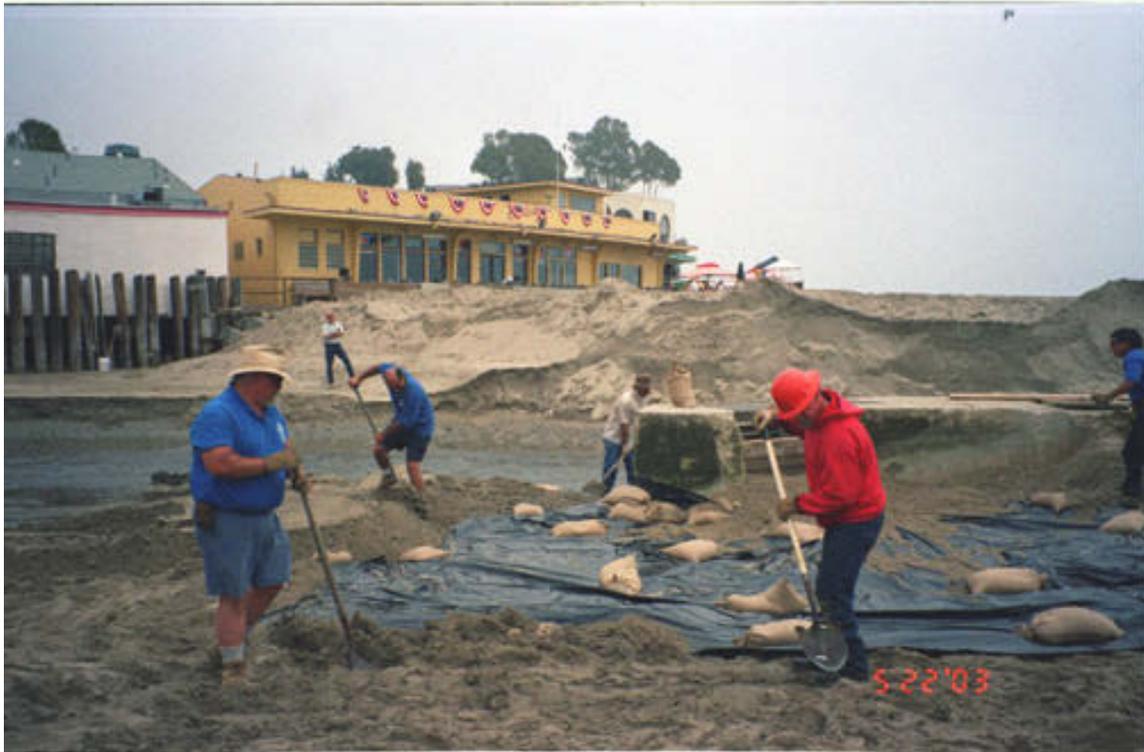
**Photo 2. Public Works Personnel Prepare the Flume Inlet Prior to Sandbar Closure**

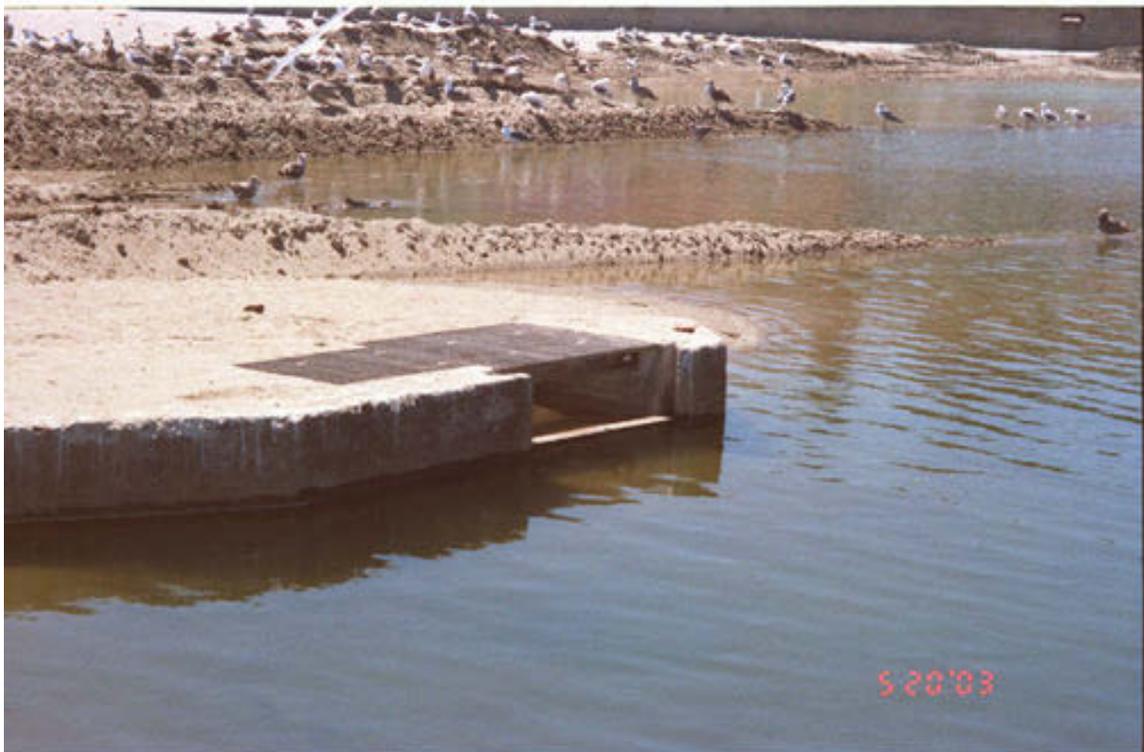
**Photo 5. Newly Installed Opening on the Ceiling of the Flume Inlet in 2003**

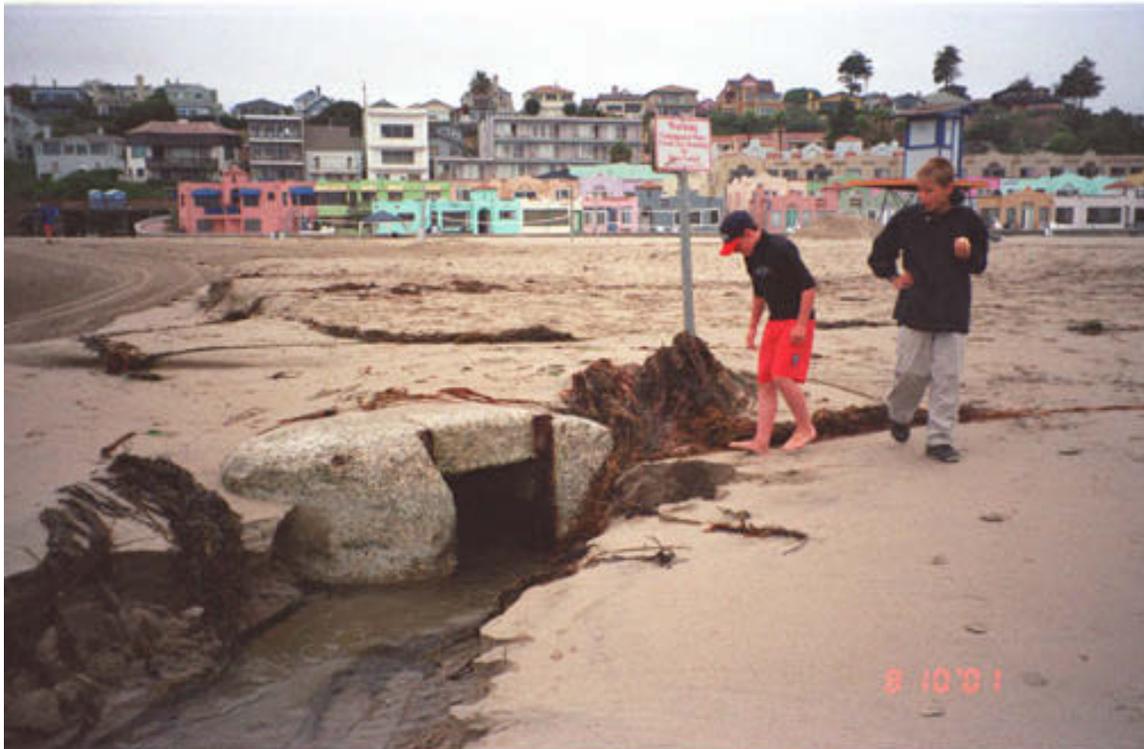
**Photo 7. Flume Exit to the Monterey Bay in August 2001**

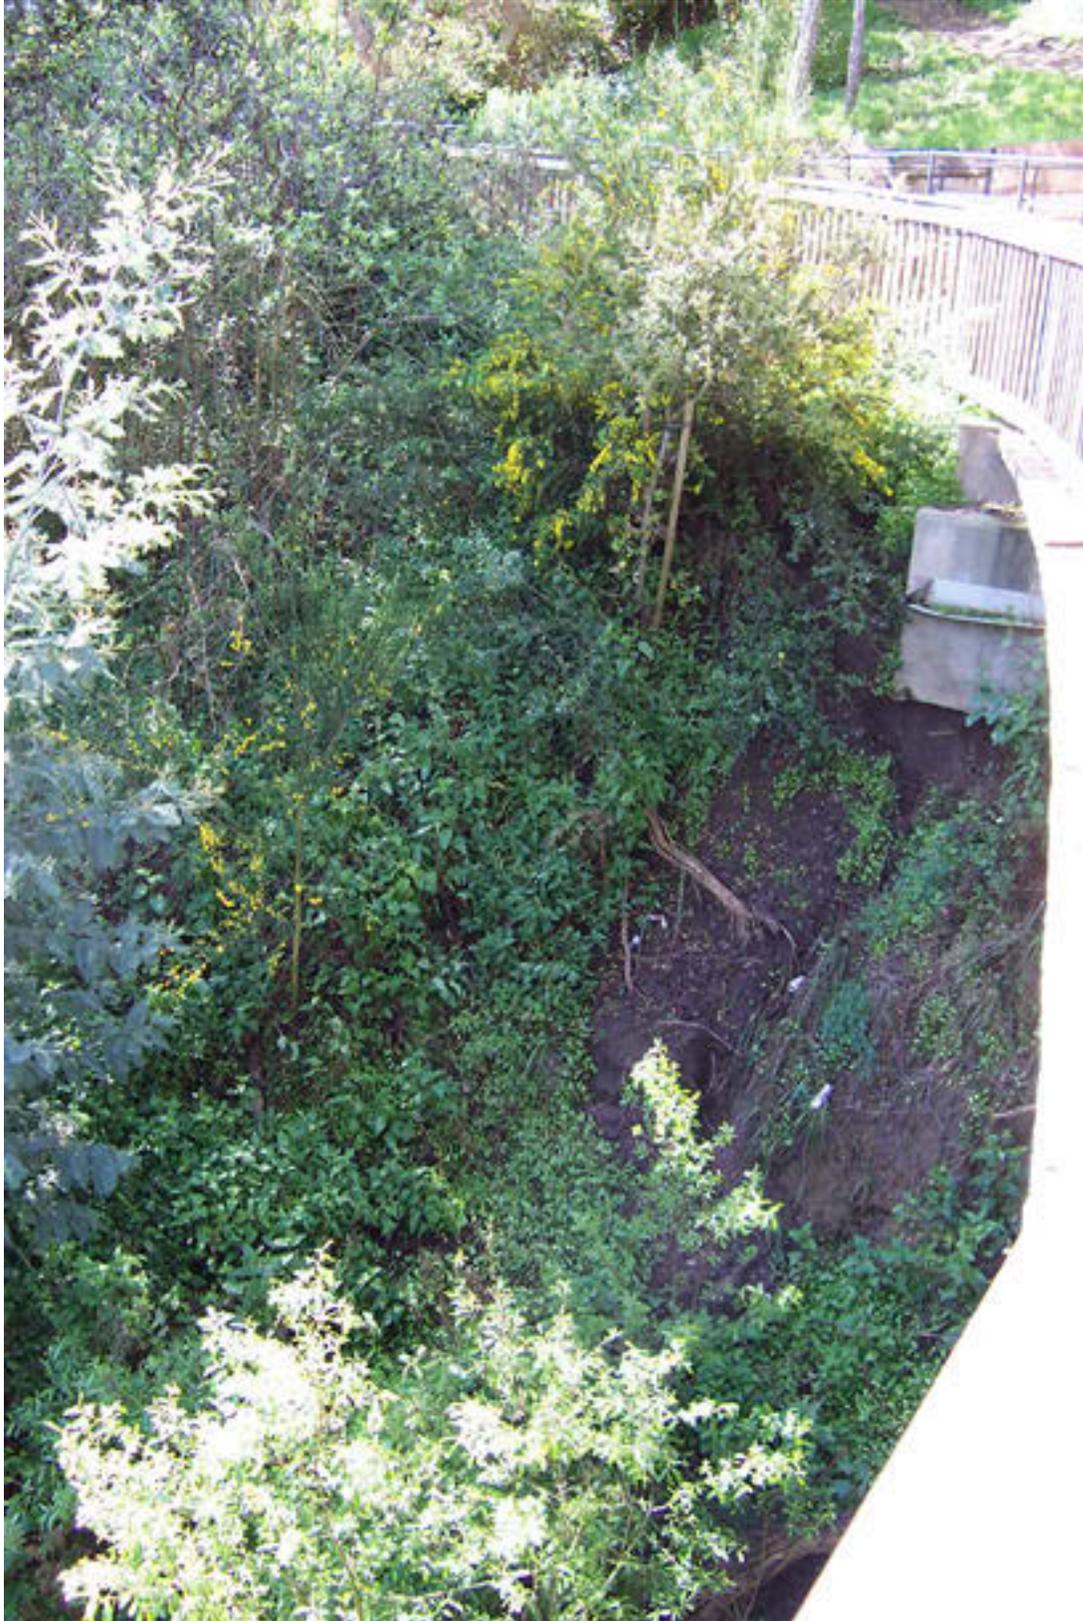
**Photo 18. Undermined Peery Park Bridge Abutment**

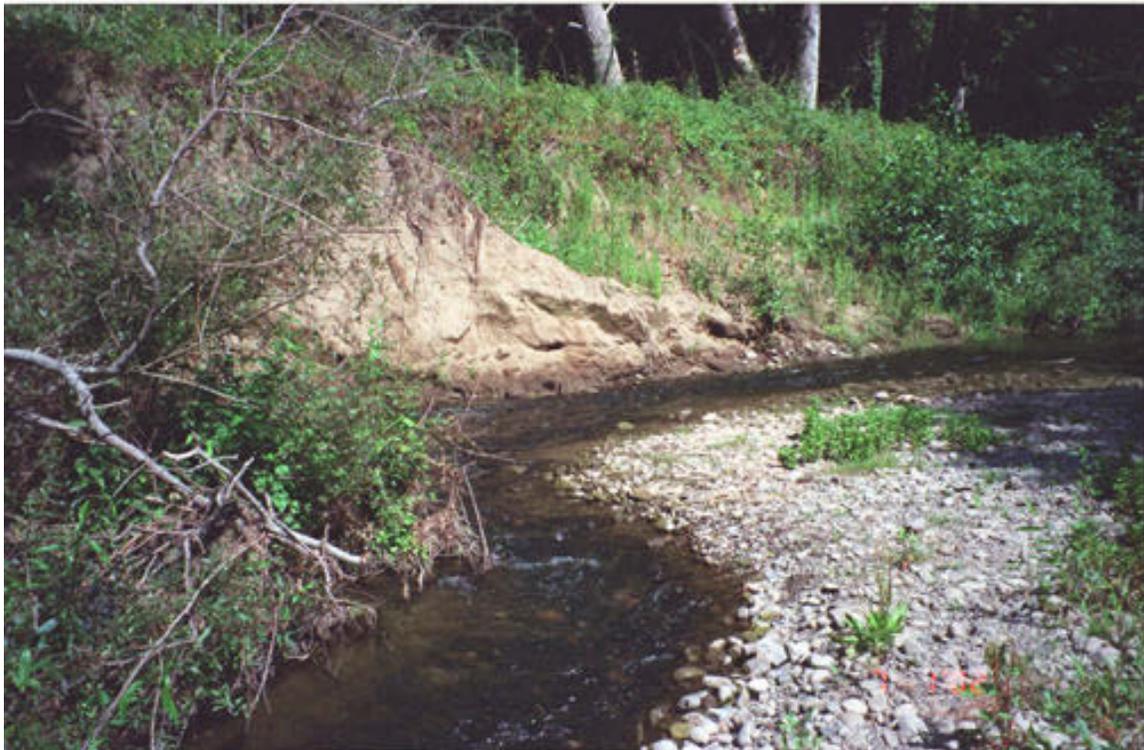
**Photo 20. Eroding Streambank on Soquel Creek in the Nob Hill Reach Above the Lagoon in 2002**

**Situation:** The west bank of Soquel Creek as it approaches the lagoon has experienced substantial erosion over the past 4-5 years (**Photo 20**; page 89; **Figure 5**; page 162). Several mature cottonwoods that existed on the terrace above the creek have fallen into the channel. Several others are in danger of being lost if the erosion continues. More tree canopy will be lost and water temperatures may be expected to increase, as more riparian shading is lost. Water temperatures in the lagoon are already warm in the summer lagoon, and further loss of riparian forest will exacerbate this water quality problem. Also, Soquel Creek Lagoon has been designated by the State Water Quality Control Board as a sediment-impaired reach. Further streambank erosion immediately upstream of the lagoon will result in further impairment.

The primary reason for present day erosion of the west bank through the Nob Hill reach (between the bedrock outcrop adjacent to the sewage lift station and Highway 1) is the current location of the bar along the eastern bank, as illustrated in **Figures 6 and 7** (pages 163-164). At high flows, this bar diverts flow towards the western bank, thereby providing the energy to erode the bank. This bar is theorized to have migrated downstream from the position of bar 2 as

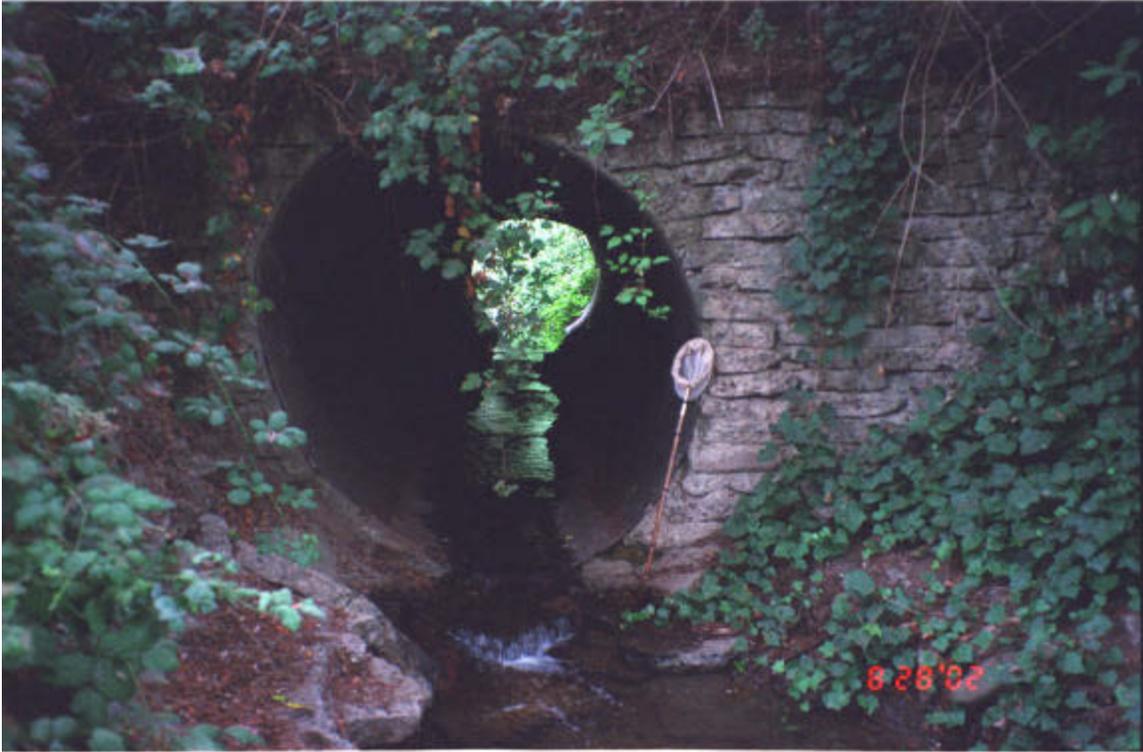
**Main Street Bridge Culvert, Bates Creek**

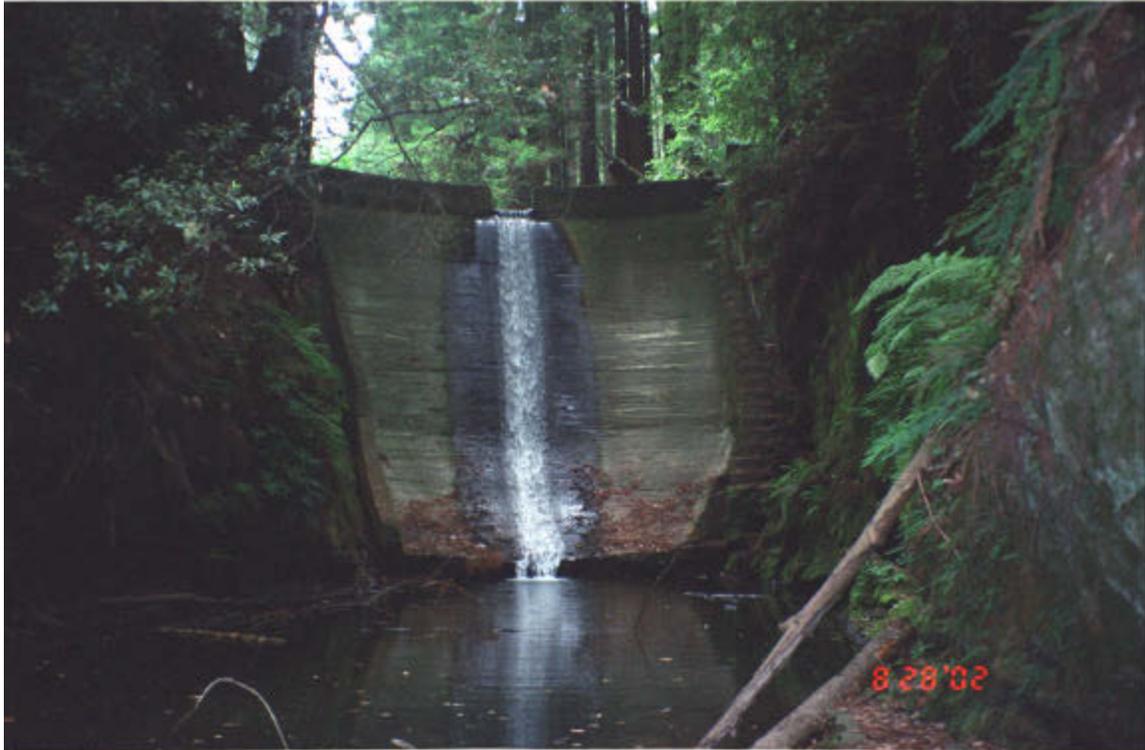
**Bates Creek Dam (26 ft high), 6,900 ft Above Main Street 28 August 2002**

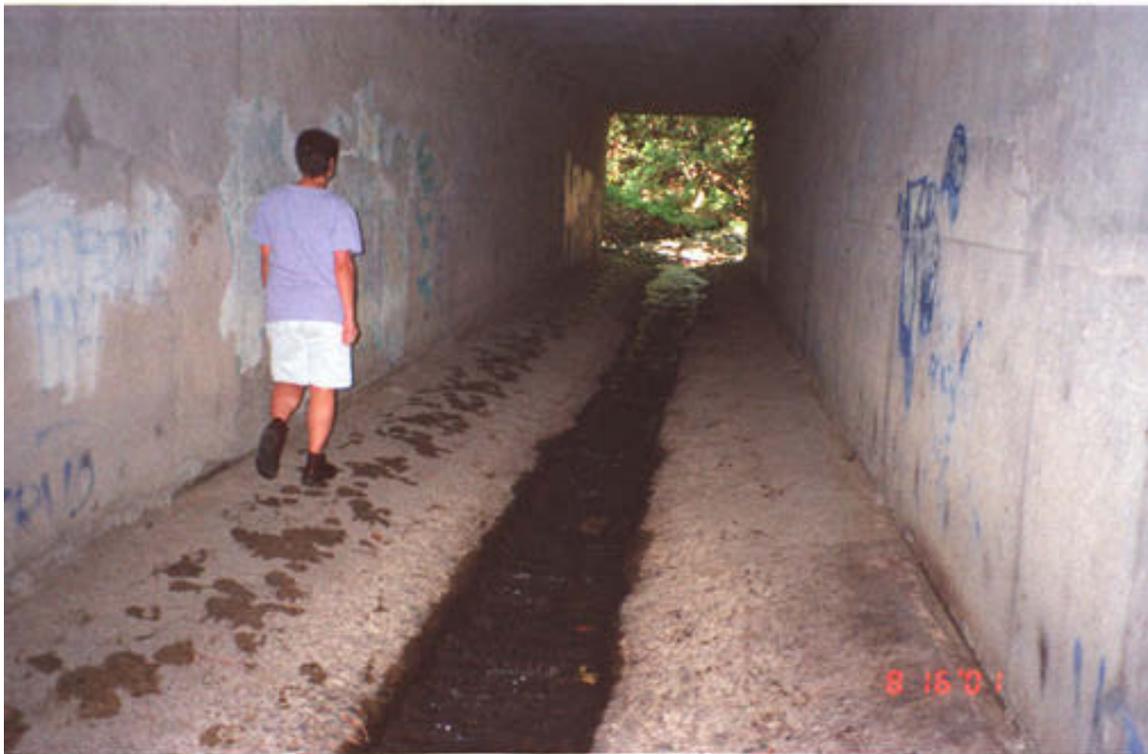
**Soquel-San Jose Road Box Culvert Over Hester Creek 16 August 2001**

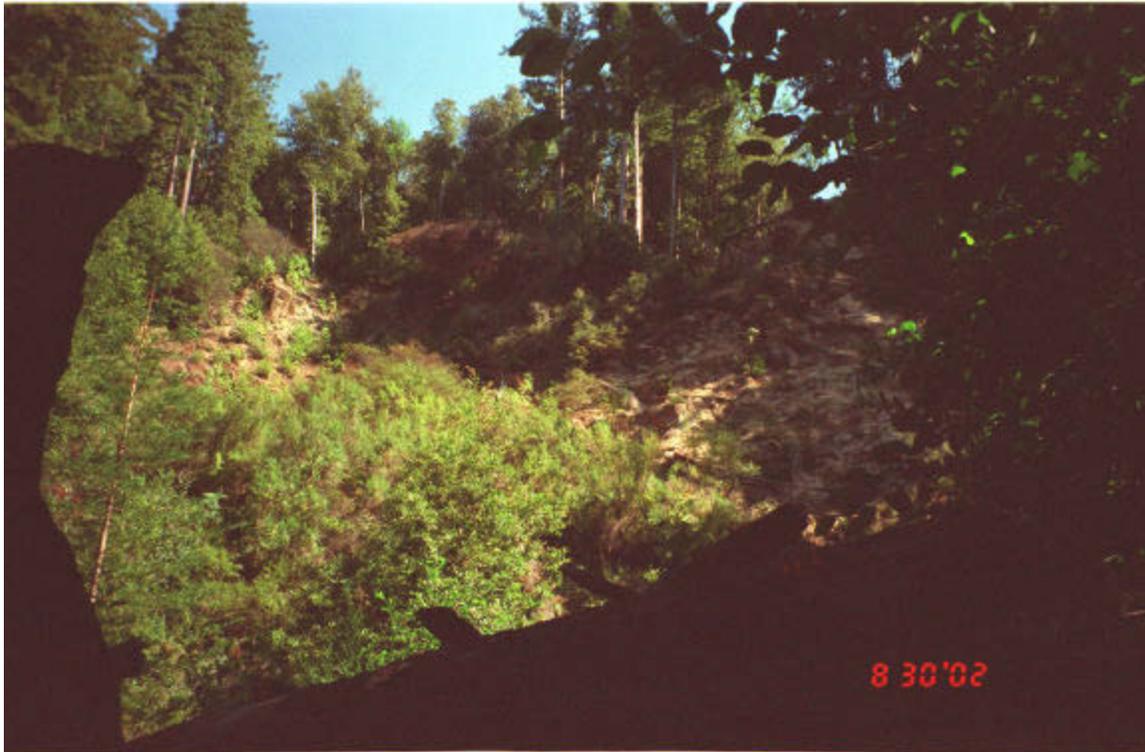
**West Branch Landslide #26, 200-250 ft high, 422 ft wide, Active, 12,350 ft  
Above Olsen Rd 30 August 2002**

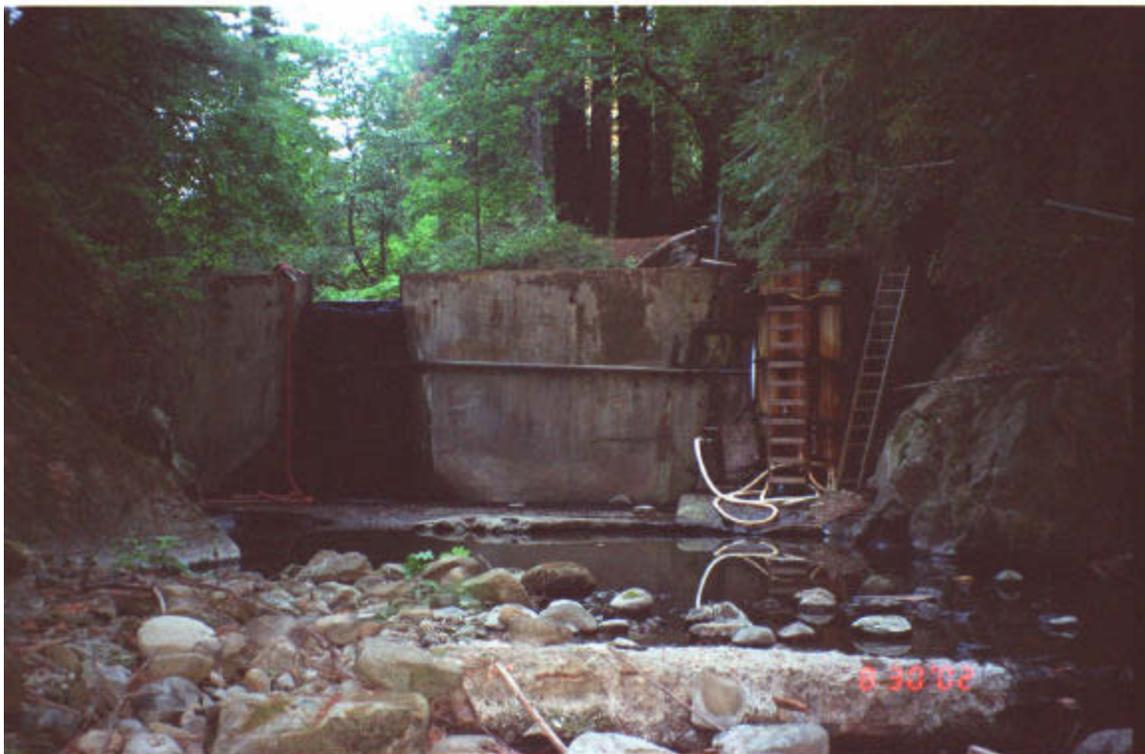
**West Branch- Laurel Mill Dam (Concrete) 12 ft High at Notch, 45 ft Wide  
30 August 2002**

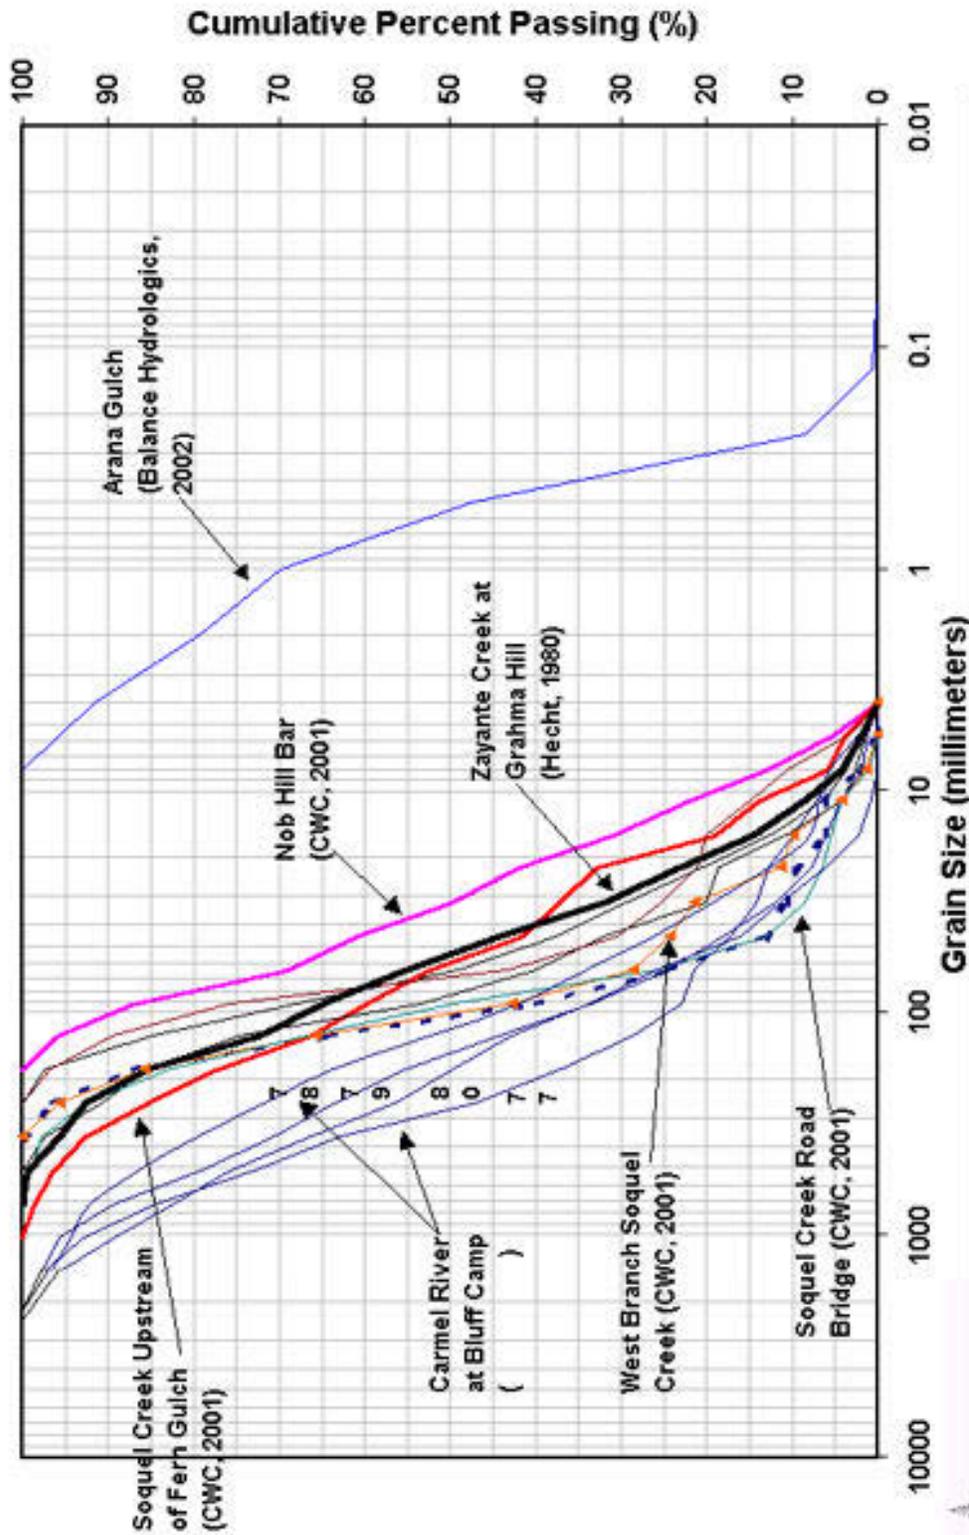
Figure 9: Surficial bed material size distribution for 8 locations in Soquel Creek with distributions for the Carmel River, Arana Gulch and Zayante Creek also shown. Surficial bed material was sampled in Soquel Creek during the fall of 2001 by the Coastal Watershed Council as a part of our joint watershed assessment efforts.

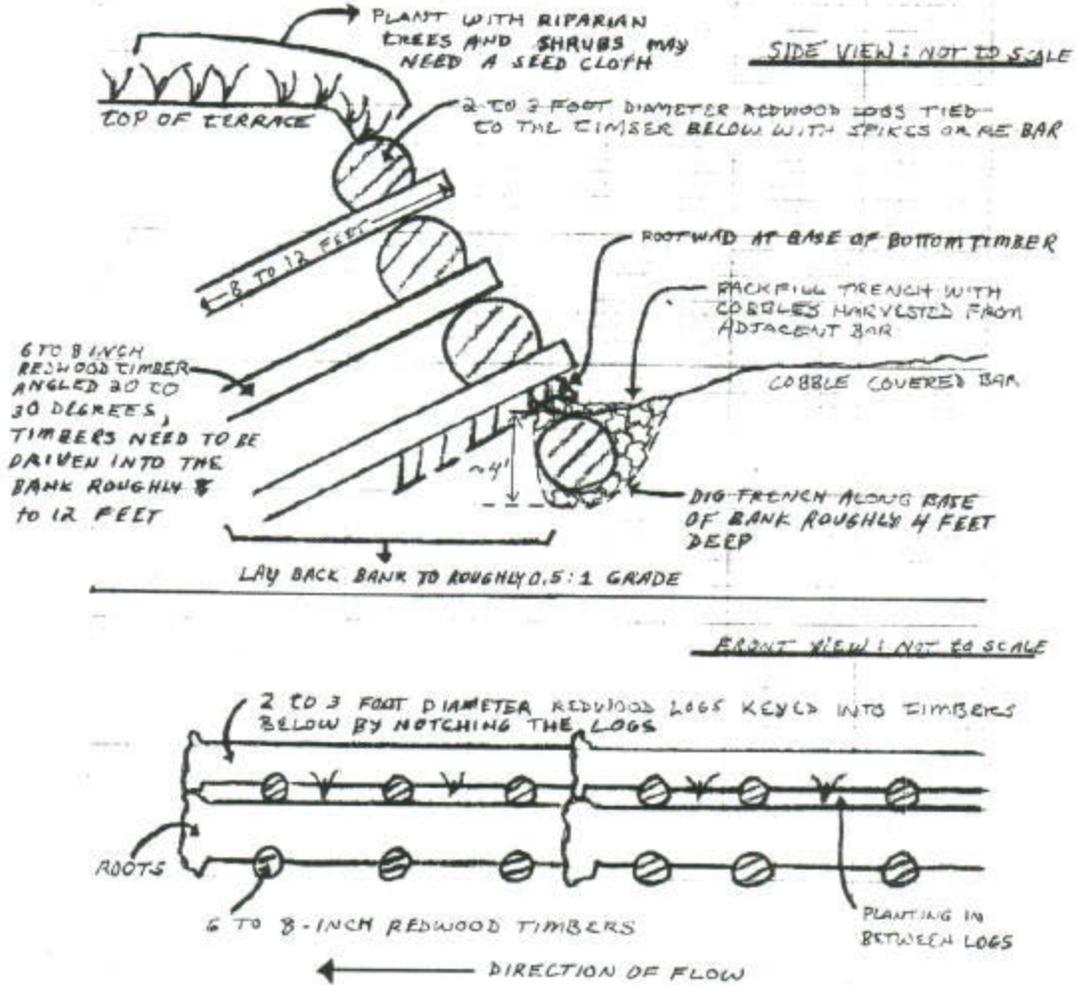
FIGURE 14: CONCEPTUAL CRIB WALL DESIGN

DESIGN NOT TO SCALE, INTENDED FOR PLANNING PURPOSES ONLY.
