Soquel Lagoon Monitoring Report- 2013

**CITY OF CAPITOLA
420 Capitola Avenue
Capitola, California 95010**

March 2014

Project # 106-23

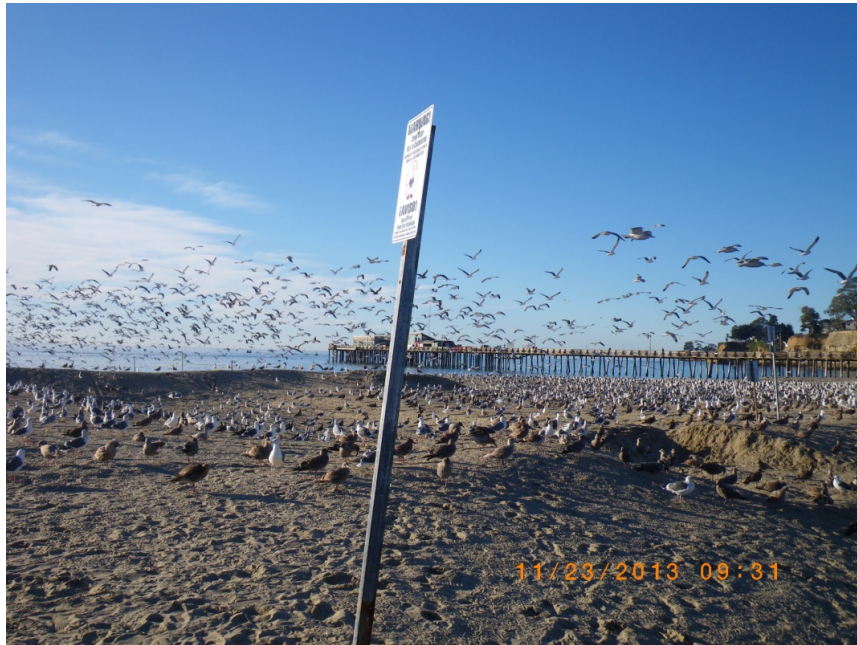
Abundance of gulls on the beach. 23 November 2013.

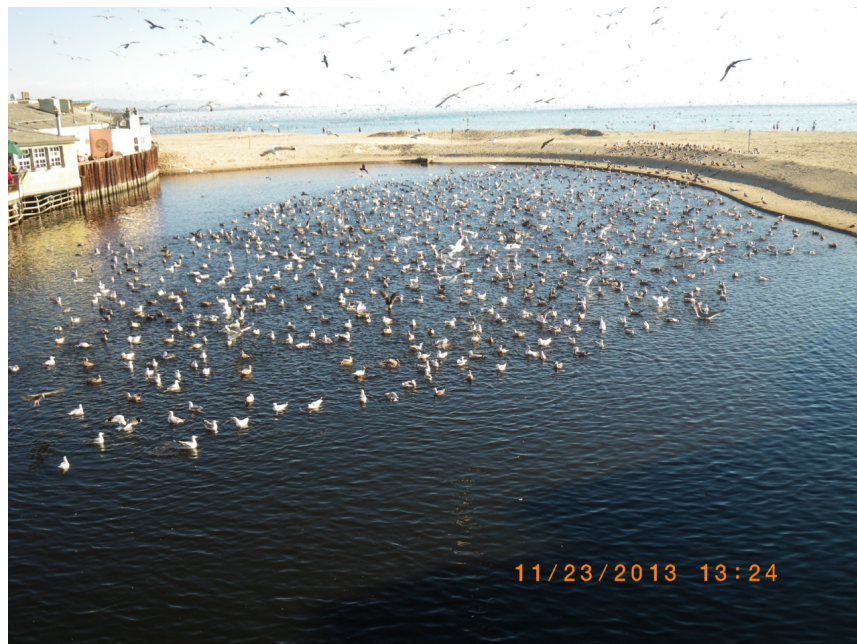
Abundance of gulls bathing in the lagoon. 23 November 2013.

sources in 2013. The lagoon near the beach was closed to human contact due to bacterial levels above the maximum acceptable level. The gulls are a primary source of pollution, both for bio-stimulating nutrients and bacteria. They forage through the human refuse left on the beach. They bathe and defecate in the lagoon. They roost and defecate on the buildings surrounding the lagoon. The gull population in summer/fall 2013 was the largest observed in 23 years of monitoring. There was an abundance of anchovies in the Monterey Bay, attracting hundreds of brown pelicans and other marine life. Reducing the gull population at Soquel Creek Lagoon would be a major step in reducing pollution. By minimizing the summer stream inflow from Noble Gulch, nutrients and bacteria entering the lagoon would be reduced.

32. Look into installing gull sweeps on restaurant roofs. The stringing of wire above roofs as observed over the Paradise Grill Restaurant should continue and be expanded to other restaurants to successfully prevent gull roosting there.

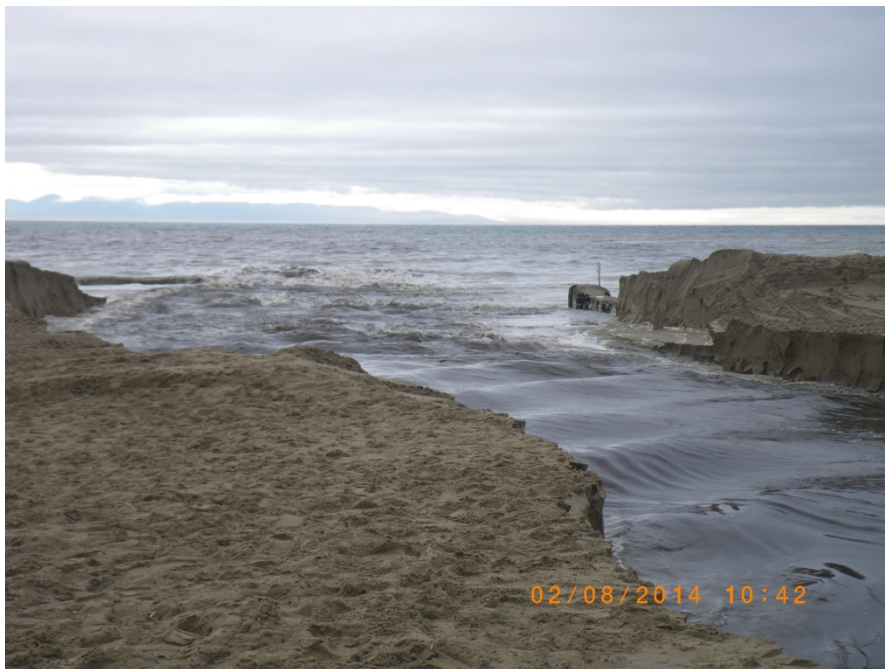
Estuary outlet channel after facilitated breach on 8 February 2014
(Time printed on the photo was 1 hour later than actual time of 0942 hr.)

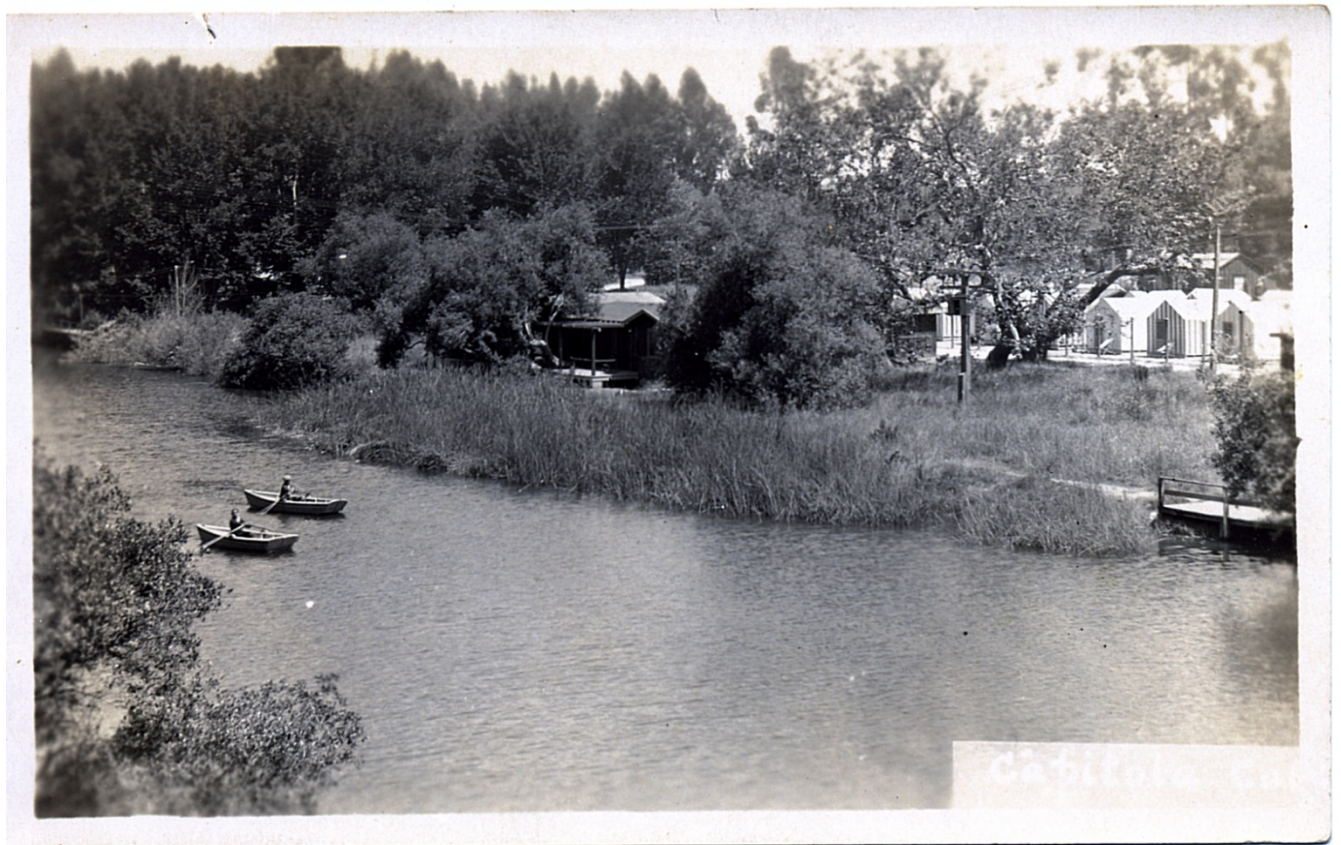
The historical lagoon had large tule beds prior to construction of the bulkheads following the 1955 flood. Tules are commonly used in managed wetlands to remove nutrients and other pollutants from wastewater effluent. Re-establishment of tule marsh in Soquel Lagoon would reduce nutrient pollution and may reduce bacterial counts. Tule re-establishment would also provide fish habitat in Soquel Lagoon.

Capitola's Soquel Lagoon with tule marsh.
(circa 1927; Provided by the Capitola Historical Museum.)

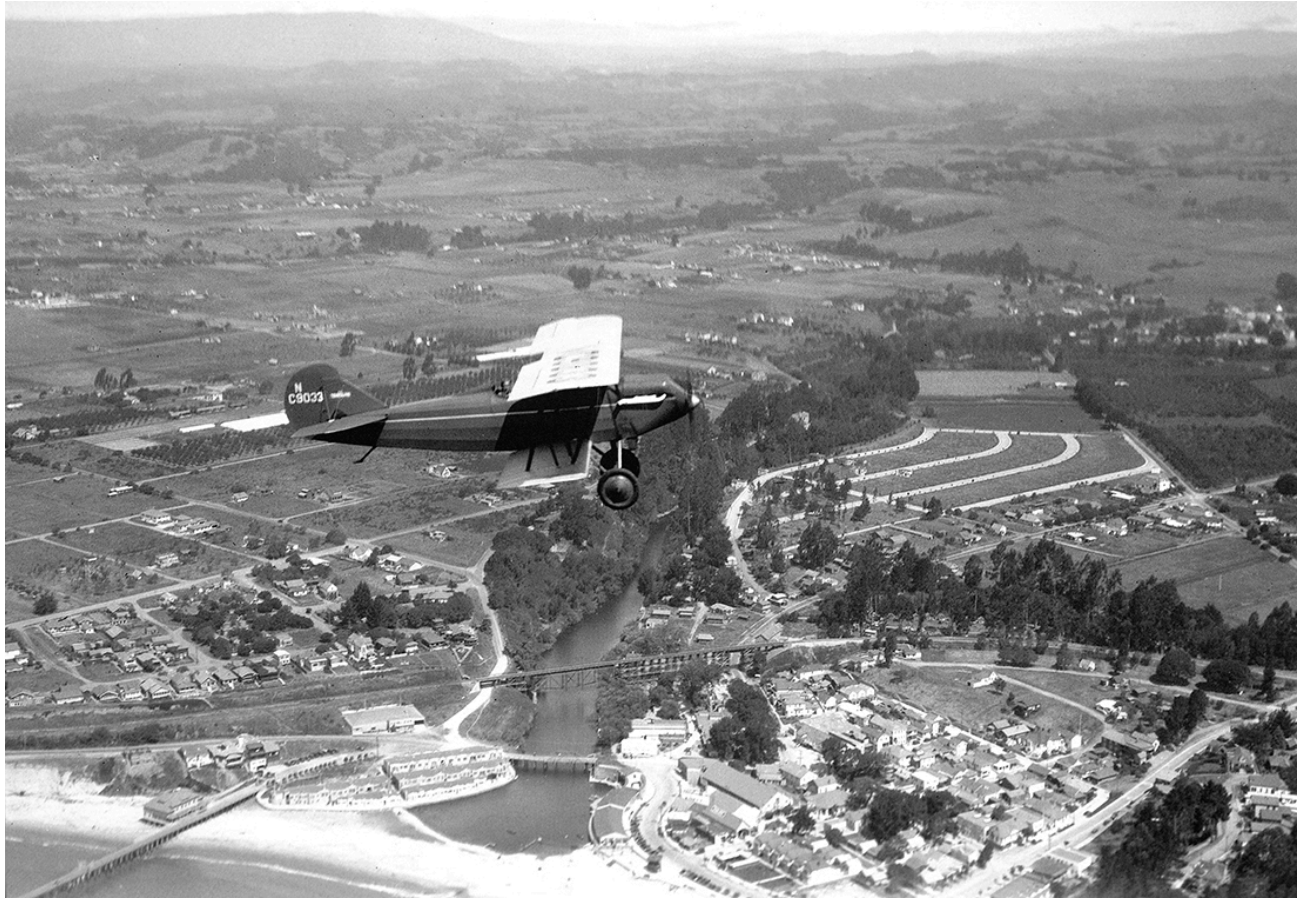
Soquel Lagoon Post-Venetian Court Construction- Older Stockton Avenue Bridge and prior to expanded development on eastern margin of the Lagoon, above and below the Railroad Trestle; circa 1931.
(Courtesy of the Capitola Historical Museum)

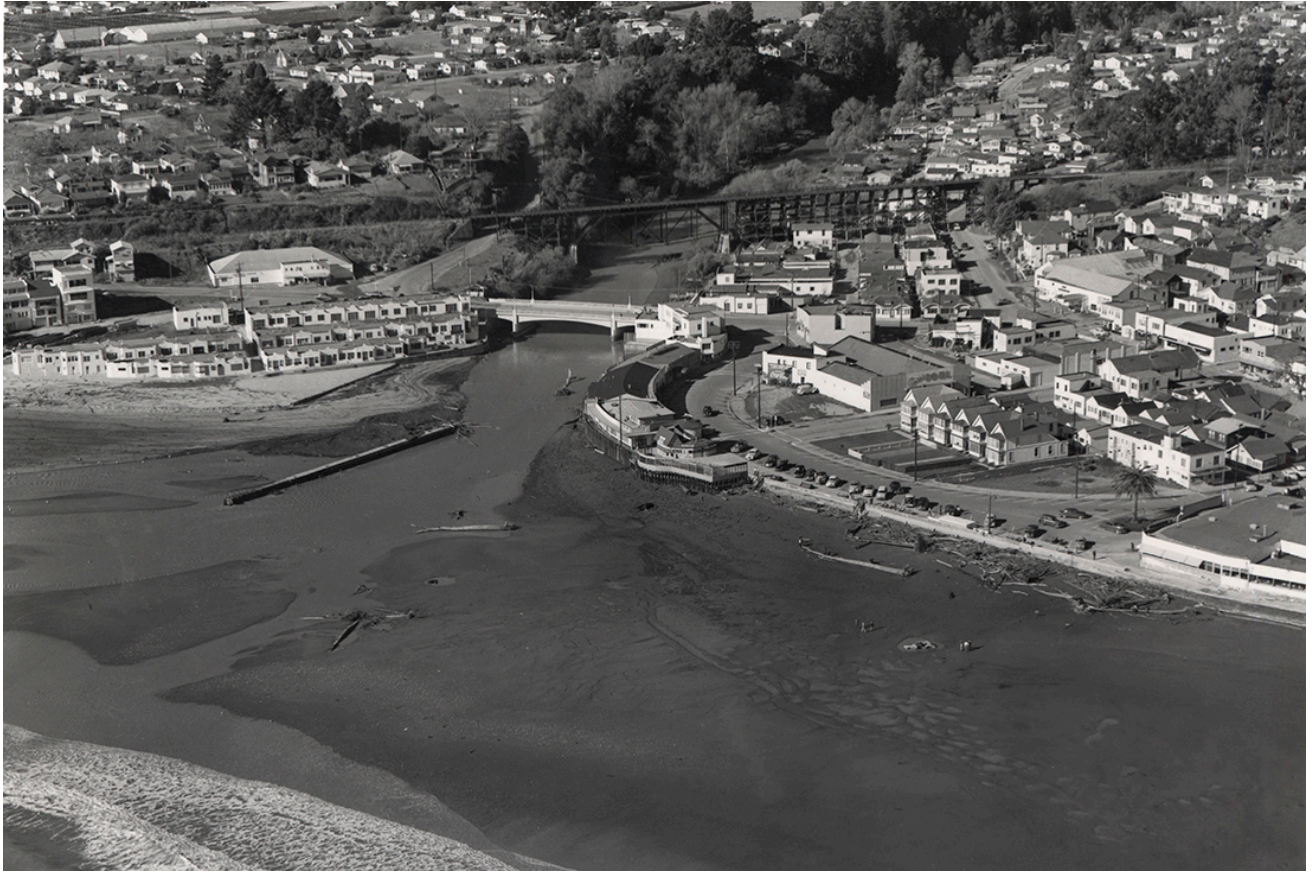
Post-World War II Soquel Creek Estuary at very low tide (present-day Stockton Bridge with flume exposed on the beach after the December 1955 flood). Riparian corridor re-established on west side above Stockton Bridge; circa 1955-56 after the flood.
(Courtesy of the Capitola Historical Museum)

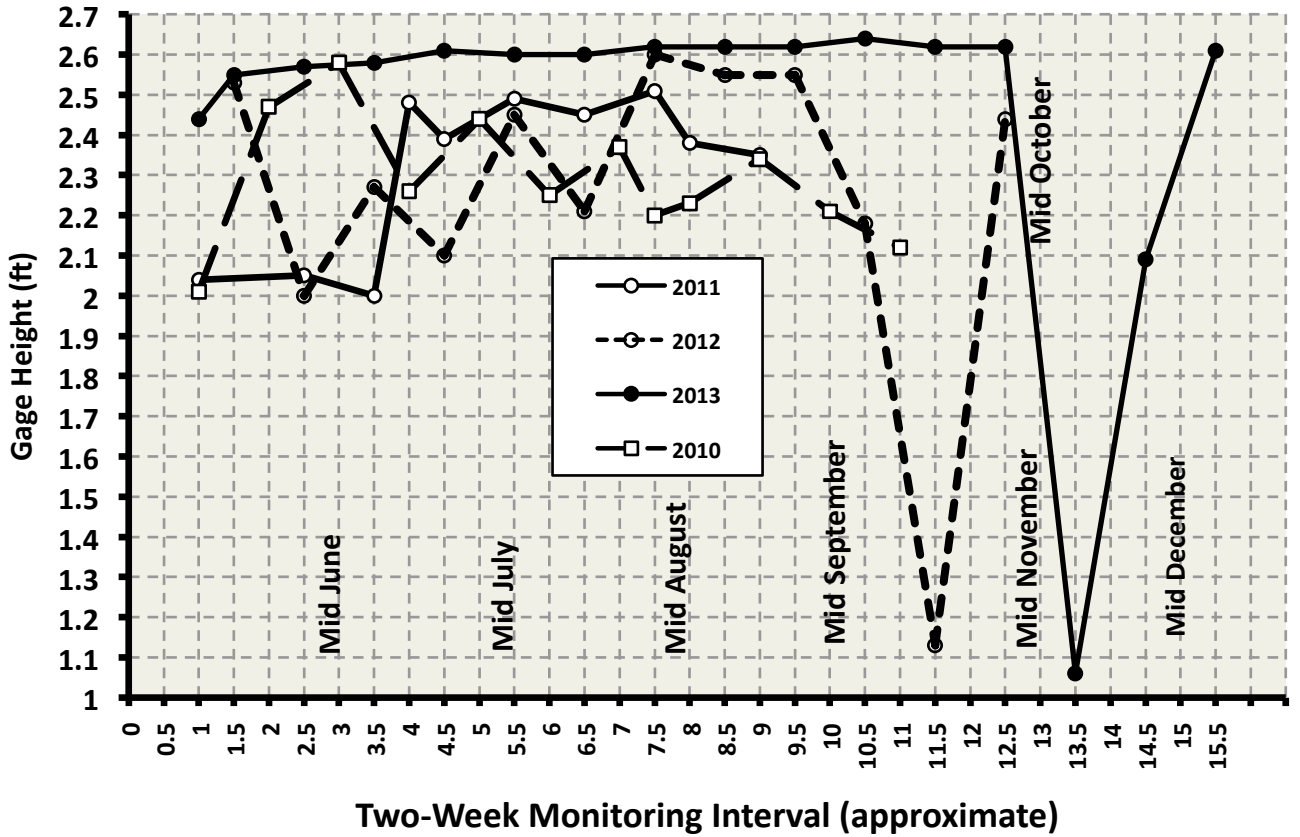
Figure 2. Soquel Lagoon Gage Height at Stockton Avenue Bridge, From Late May to Early December 2010-2013.

Appendix A provides detailed water quality and lagoon height data. **Table 3** rates habitat conditions according to a rating scale (**Table 2**). The lagoon level was maintained in the good range for the summer and during the Begonia Festival. It remained good into the fall until after the first rain in November (**Figure 26**). Lagoon water level was lowered to a critical level after the 20 November stormflow that colored the water, forcing the management technique of reducing depth until water penetrated the bottom to allow continued photosynthesis. A “fair” rating was noted on 8 December (gage height = 2.09 ft) after boards had been removed to pass the second stormflow of the season occurring on 7 December. Another “fair” rating was noted on 9 December (gage height = 1.85) during a water clarity check in the morning. Two flashboards were added to the flume inlet in the afternoon. The lagoon level was monitored 18 times in 2-week intervals from 8 June 2013 to 1 February 2014. For 2013, lagoon levels as measured on the staff gage were rated "good" (**Table 2**) on 16 two-week monitorings, “fair” on one monitoring and “critical” on another (**Table 3; Figure 2**).

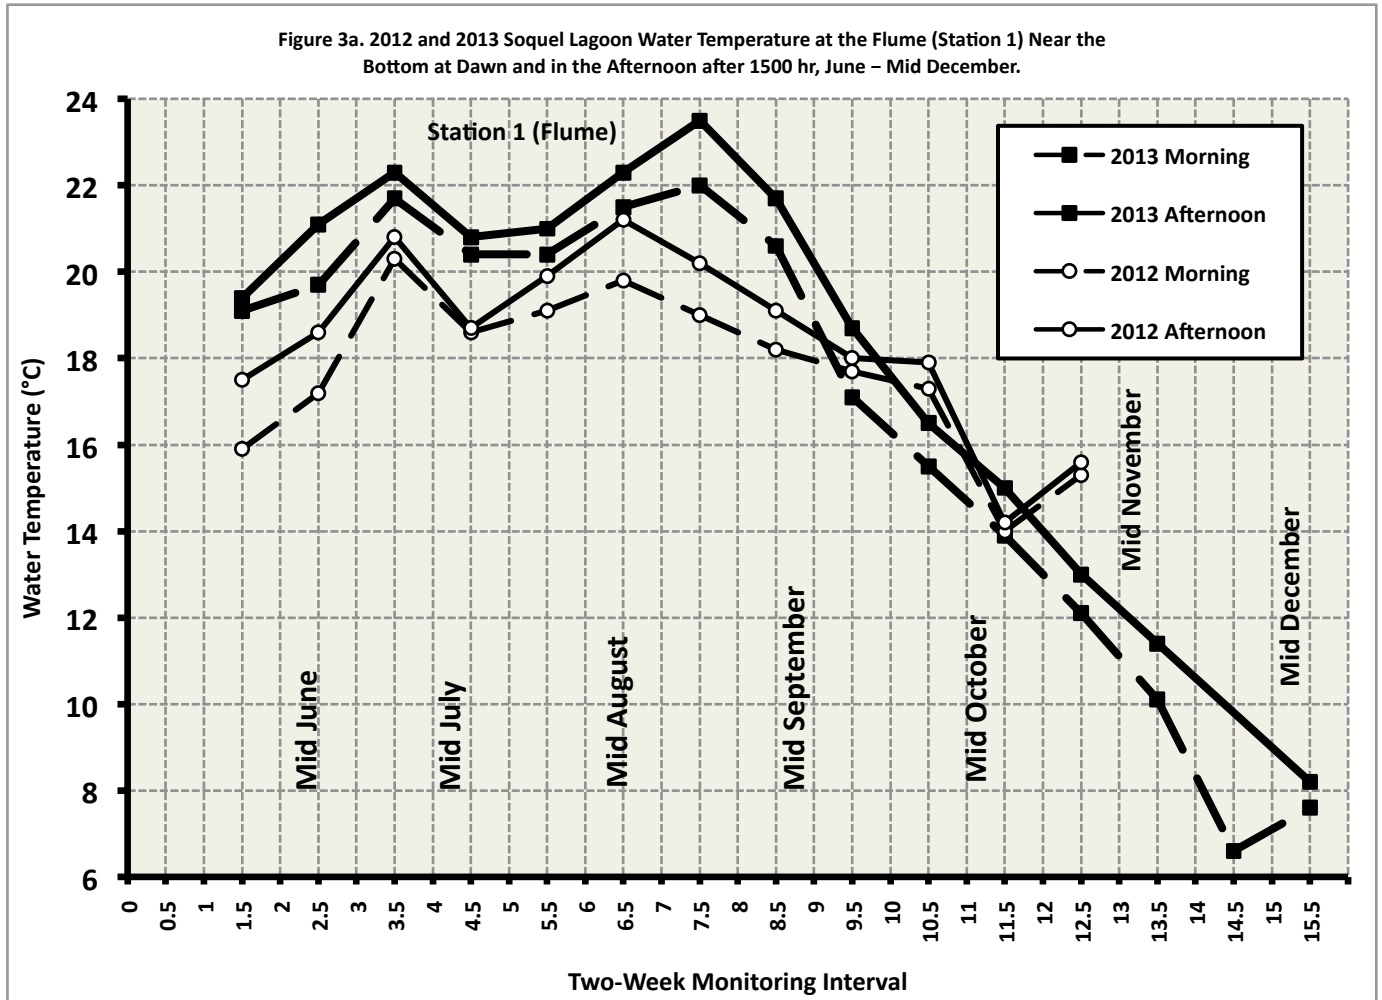
Figure 3a. 2012 and 2013 Soquel Lagoon Water Temperature at the Flume (Station 1) Near the Bottom at Dawn and in the Afternoon after 1500 hr, June – Mid December.

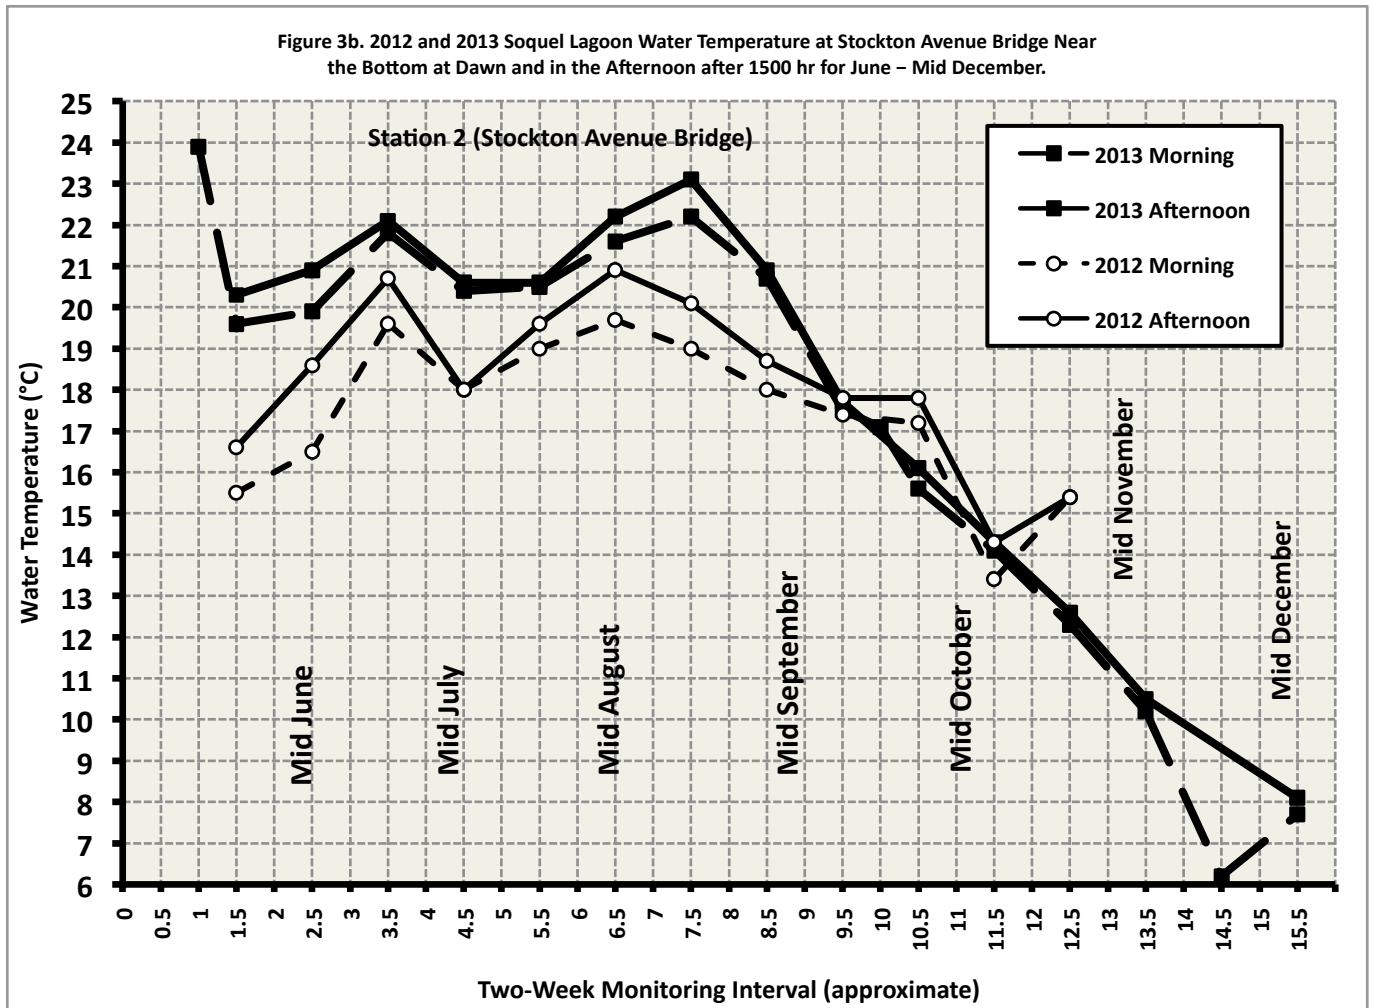
Figure 3b. 2012 and 2013 Soquel Lagoon Water Temperature at Stockton Avenue Bridge Near the Bottom at Dawn and in the Afternoon after 1500 hr for June – Mid December.

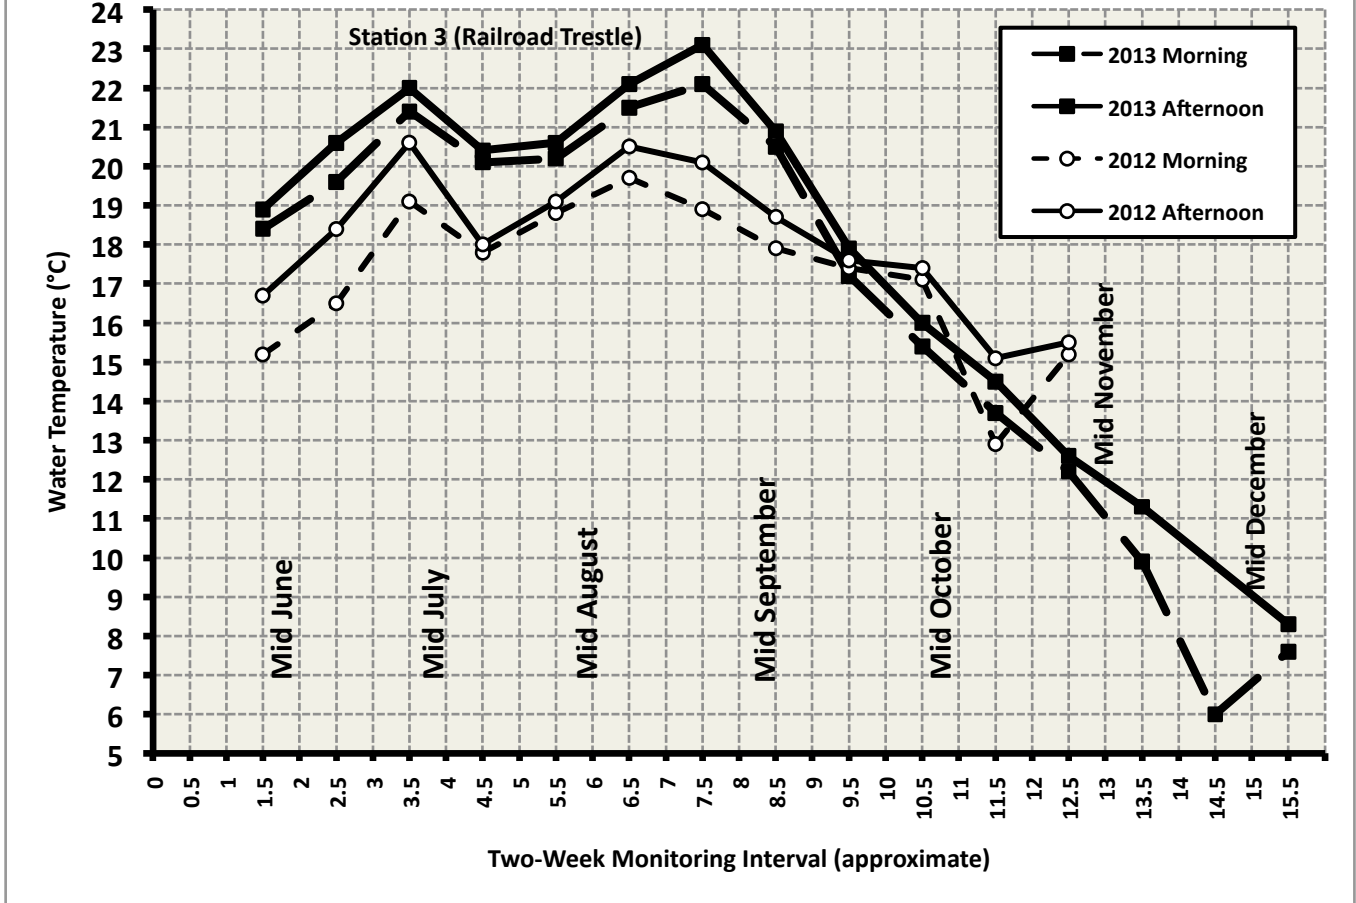
Figure 3c. 2013 and 2012 Soquel Lagoon Water Temperature at the Railroad Trestle (Station 3)
Near the Bottom at Dawn and in the Afternoon after 1500 hr for June– Mid December.

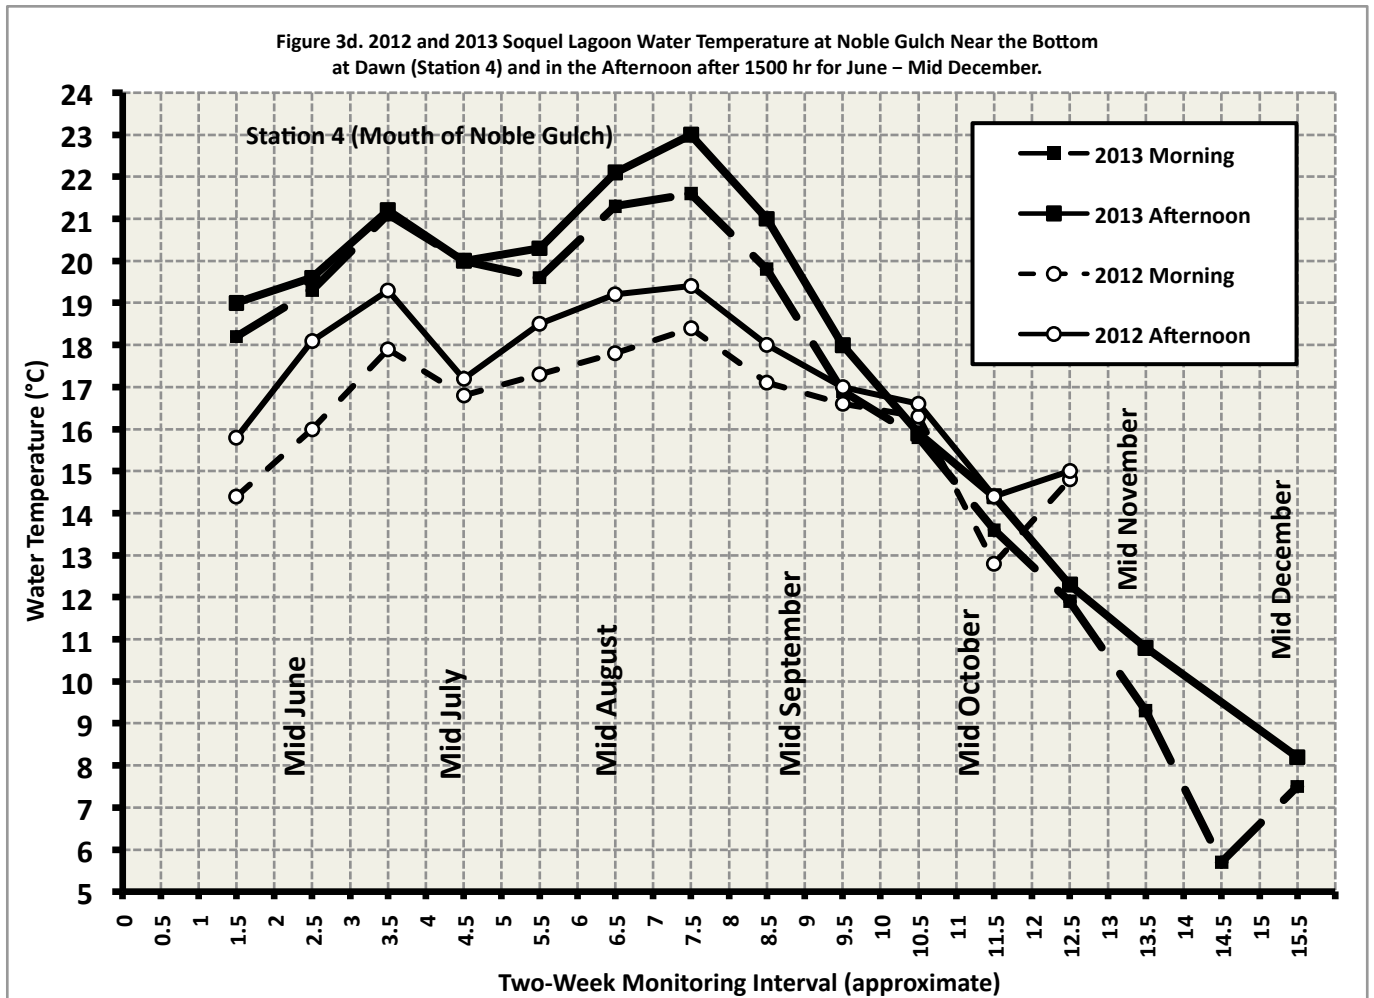
Figure 3d. 2012 and 2013 Soquel Lagoon Water Temperature at Noble Gulch Near the Bottom at Dawn (Station 4) and in the Afternoon after 1500 hr for June – Mid December.

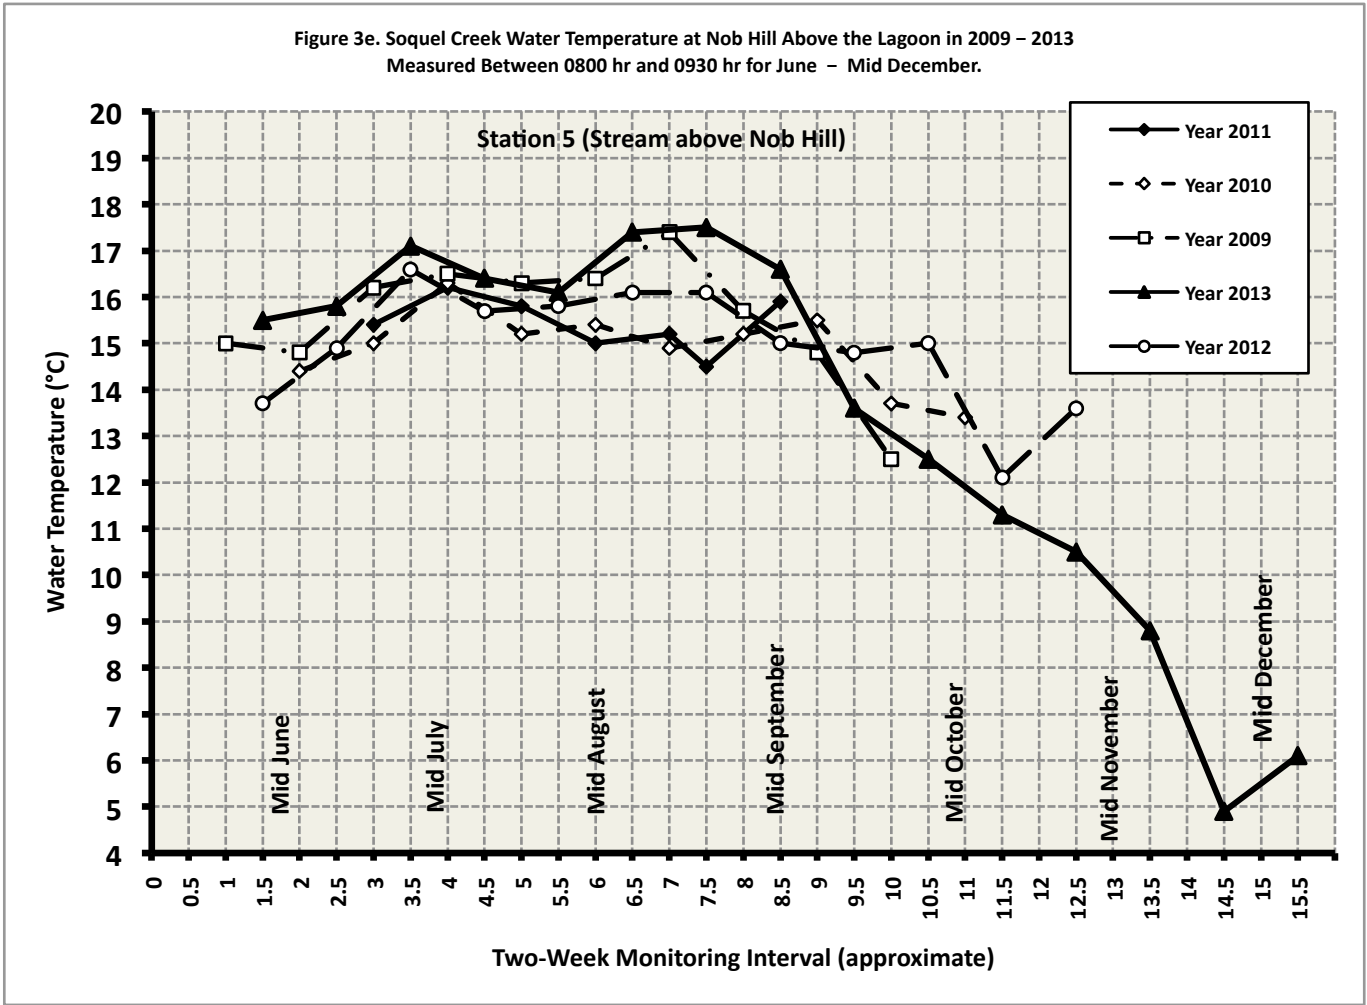
Figure 3e. Soquel Creek Water Temperature at Nob Hill Above the Lagoon in 2009 – 2013
 Measured Between 0800 hr and 0930 hr for June – Mid December.

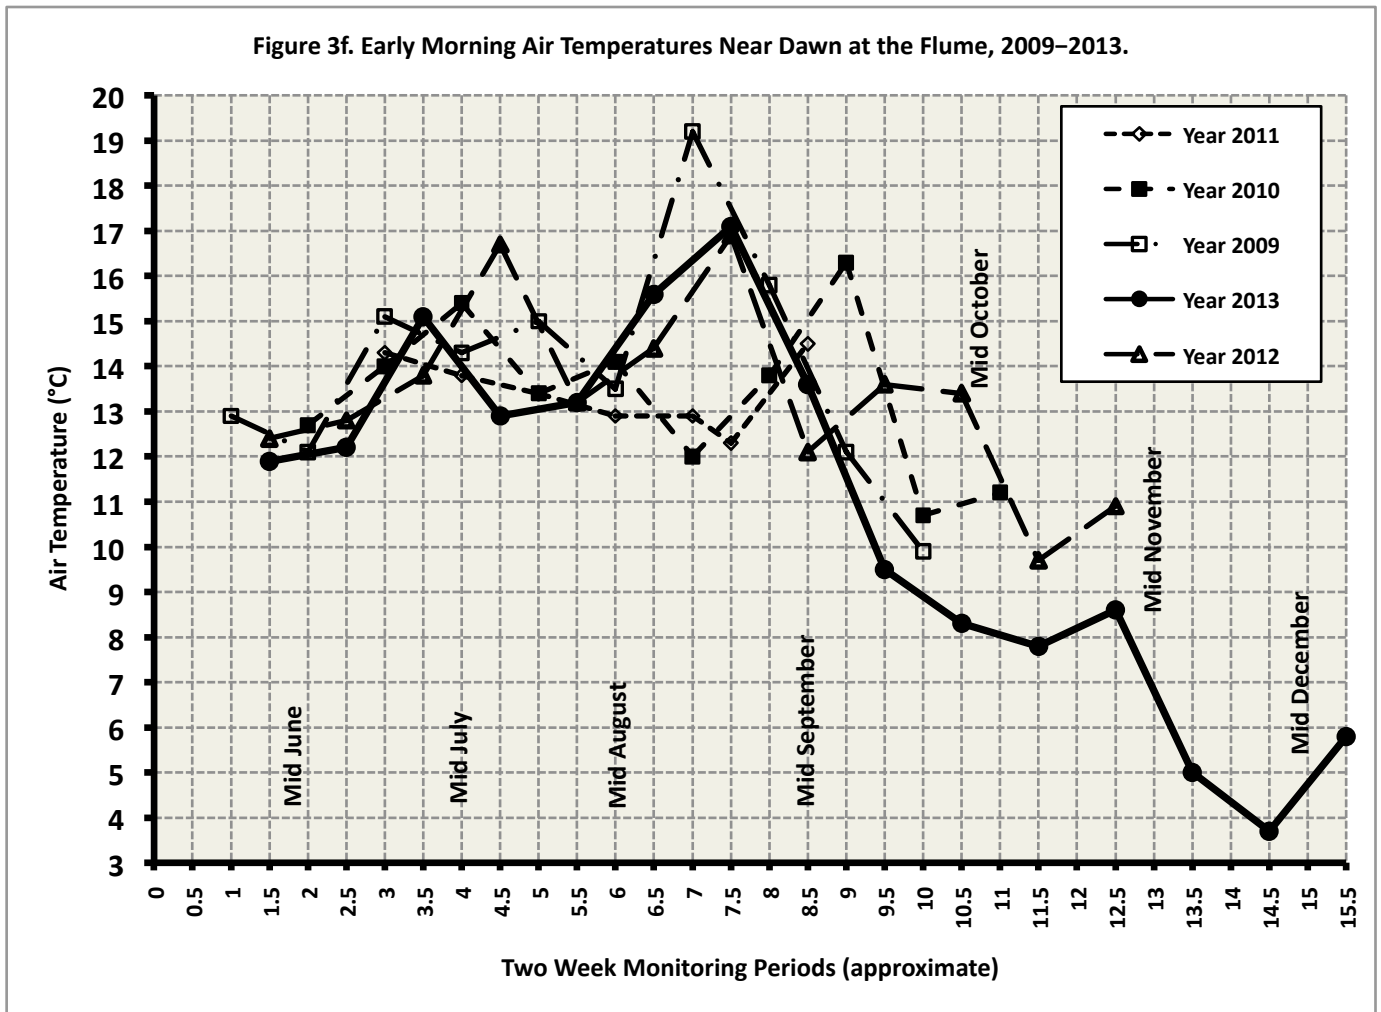
Figure 3f. Early Morning Air Temperatures Near Dawn at the Flume, 2009–2013.

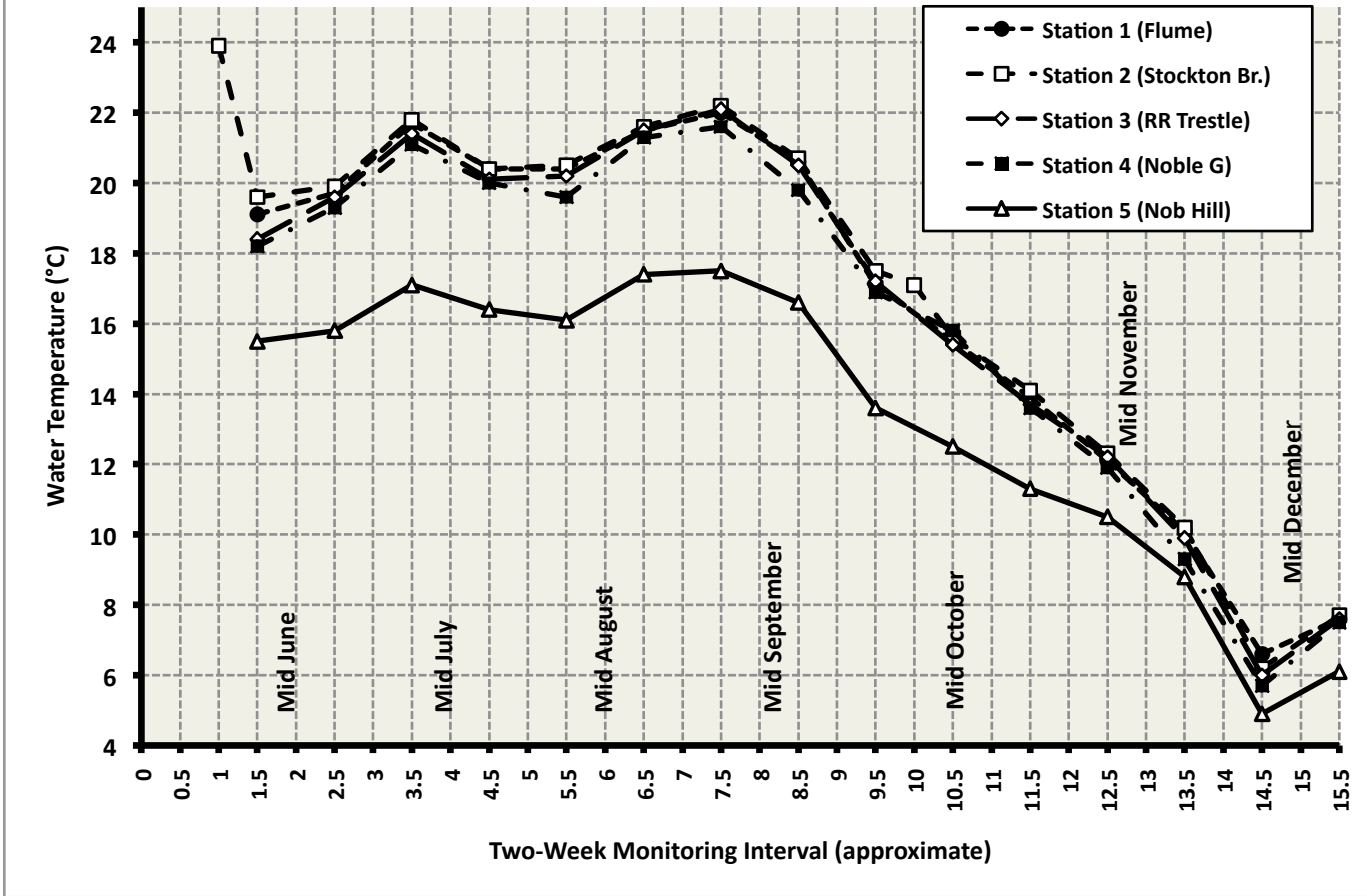
Figure 3g. Water Temperature at Dawn at Four Lagoon Stations Near the Bottom and Upstream from June to December 2013.

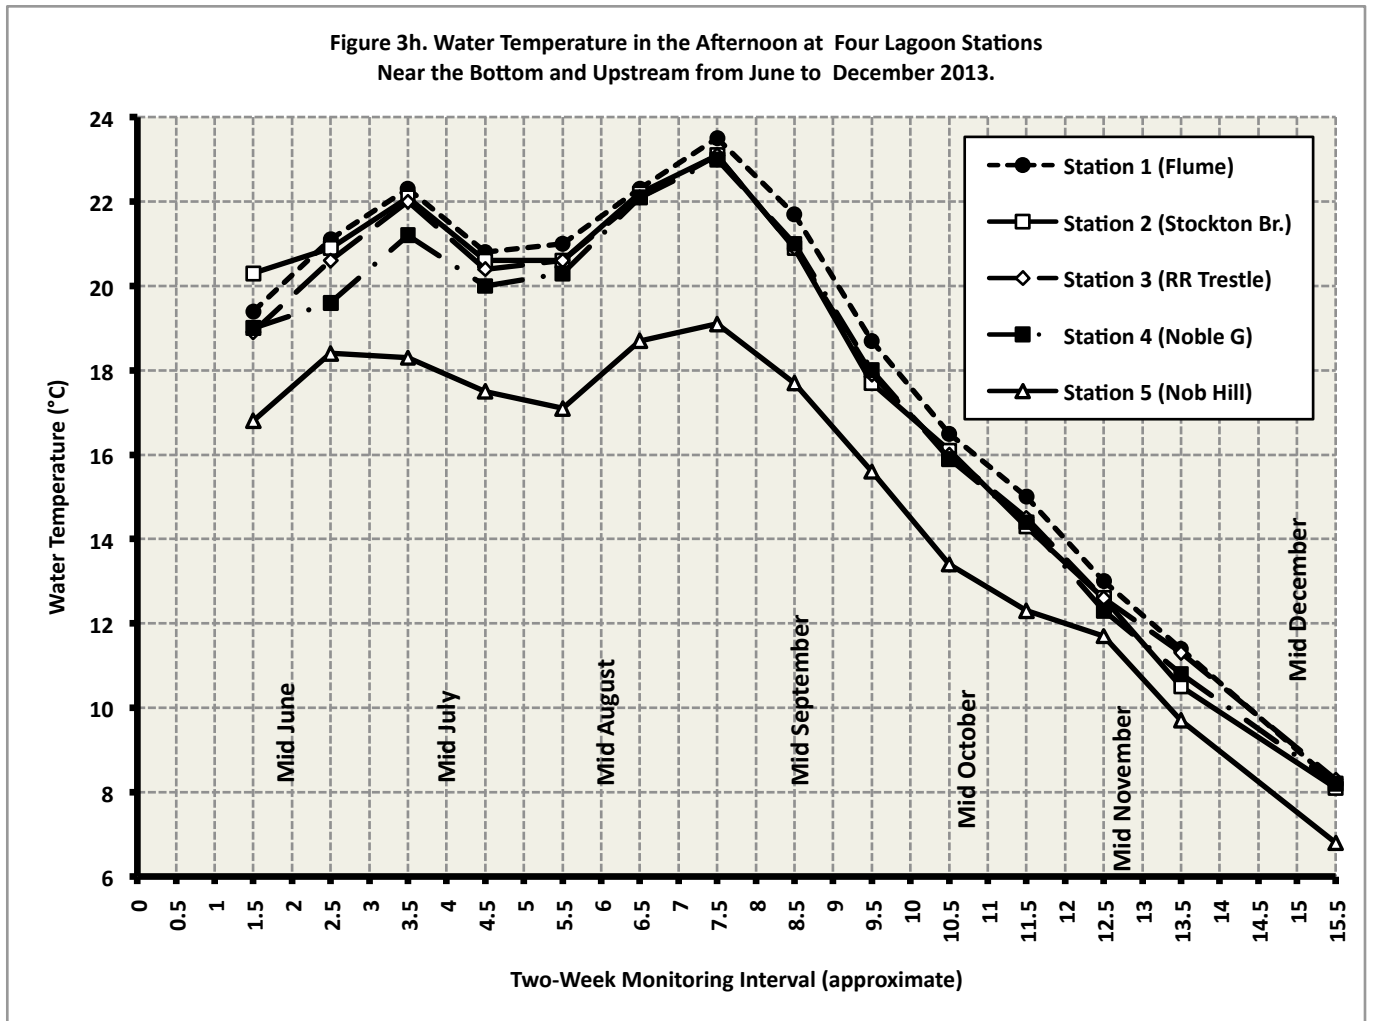
Figure 3h. Water Temperature in the Afternoon at Four Lagoon Stations Near the Bottom and Upstream from June to December 2013.

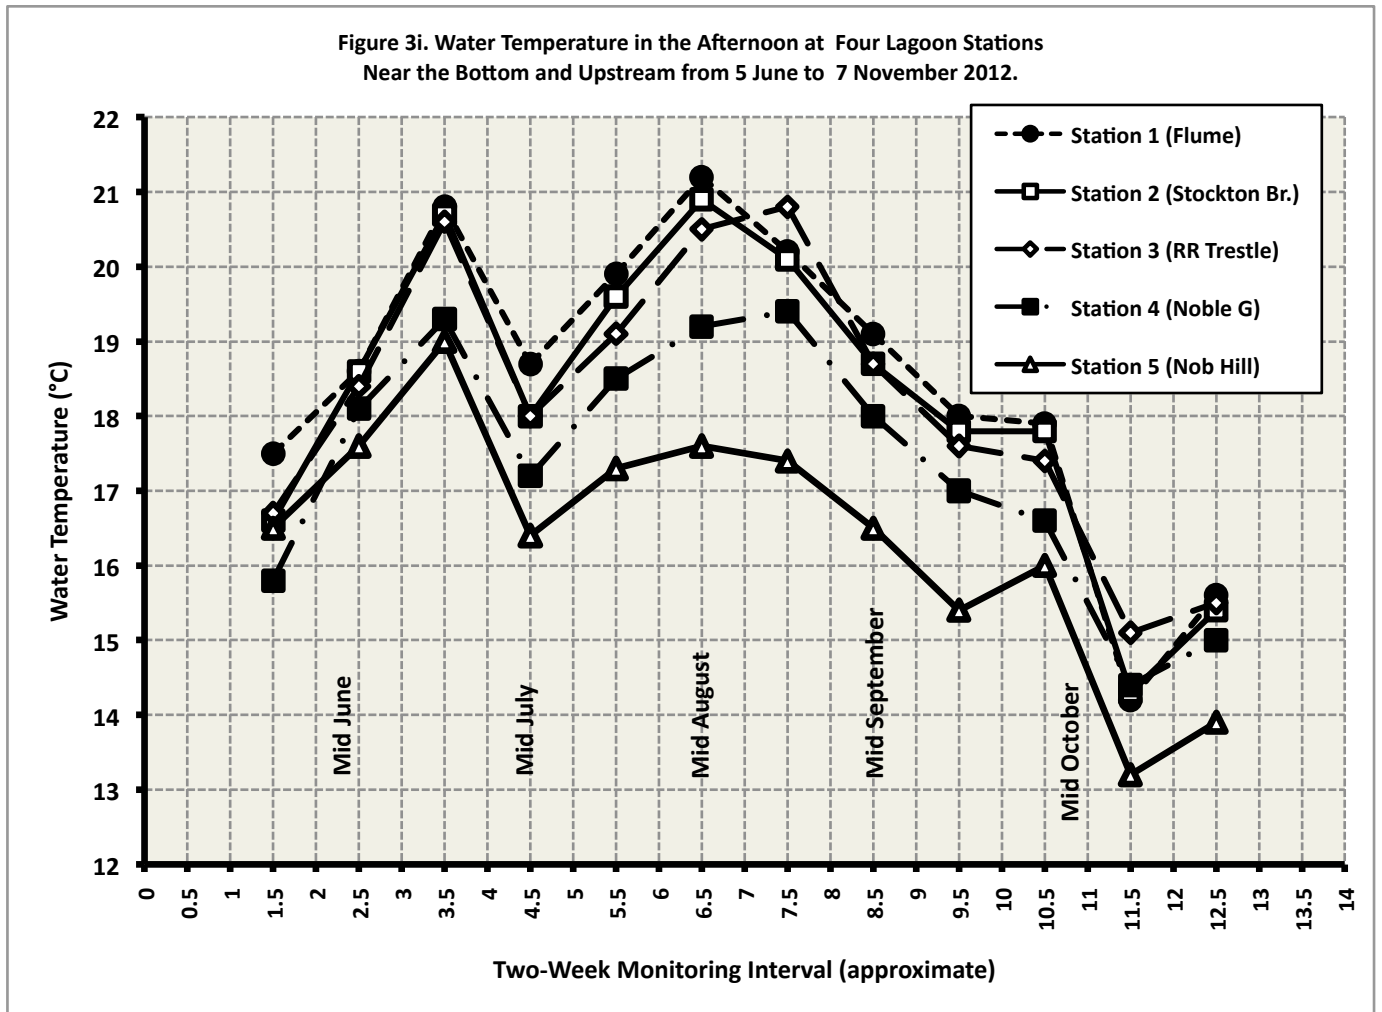
Figure 3i. Water Temperature in the Afternoon at Four Lagoon Stations Near the Bottom and Upstream from 5 June to 7 November 2012.

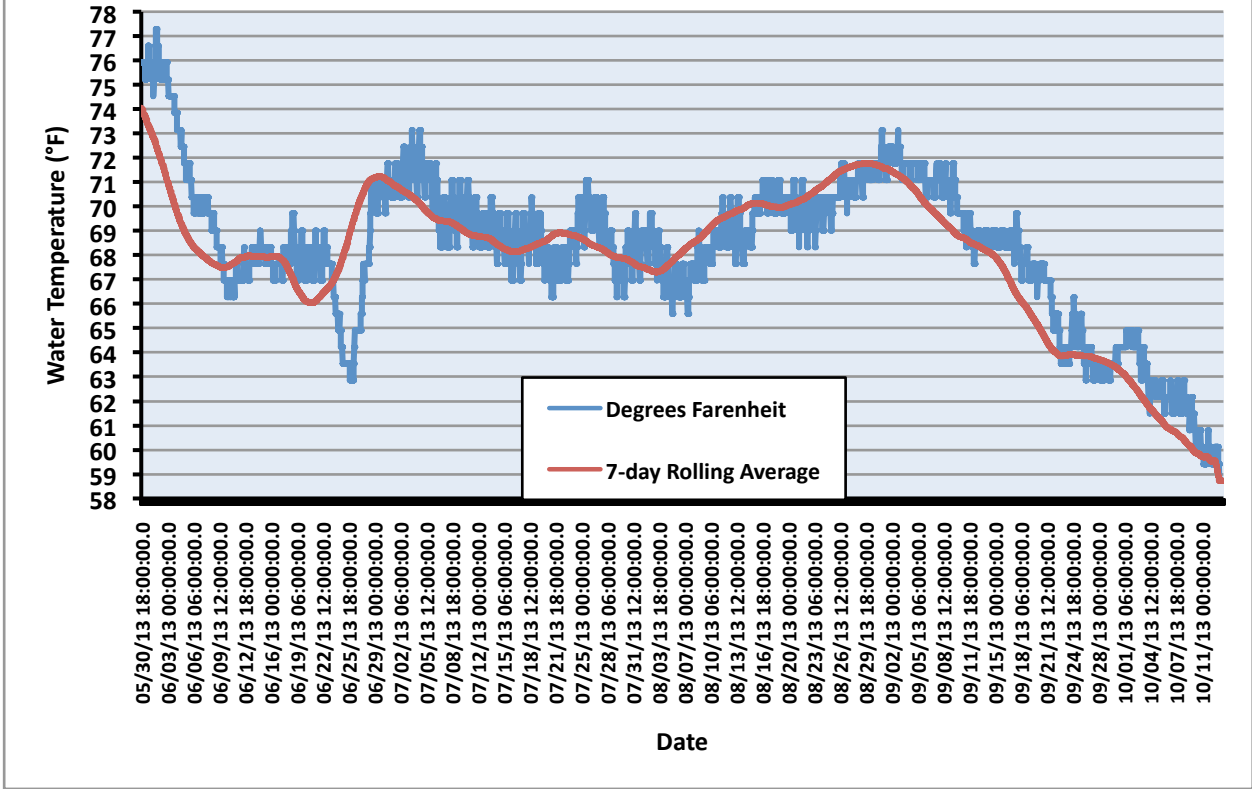
Figure 4b. Water Temperature (°F) Down from Trestle, 0.5 ft from Bottom, 30 May – 13 October 2013 (30-minute Interval).

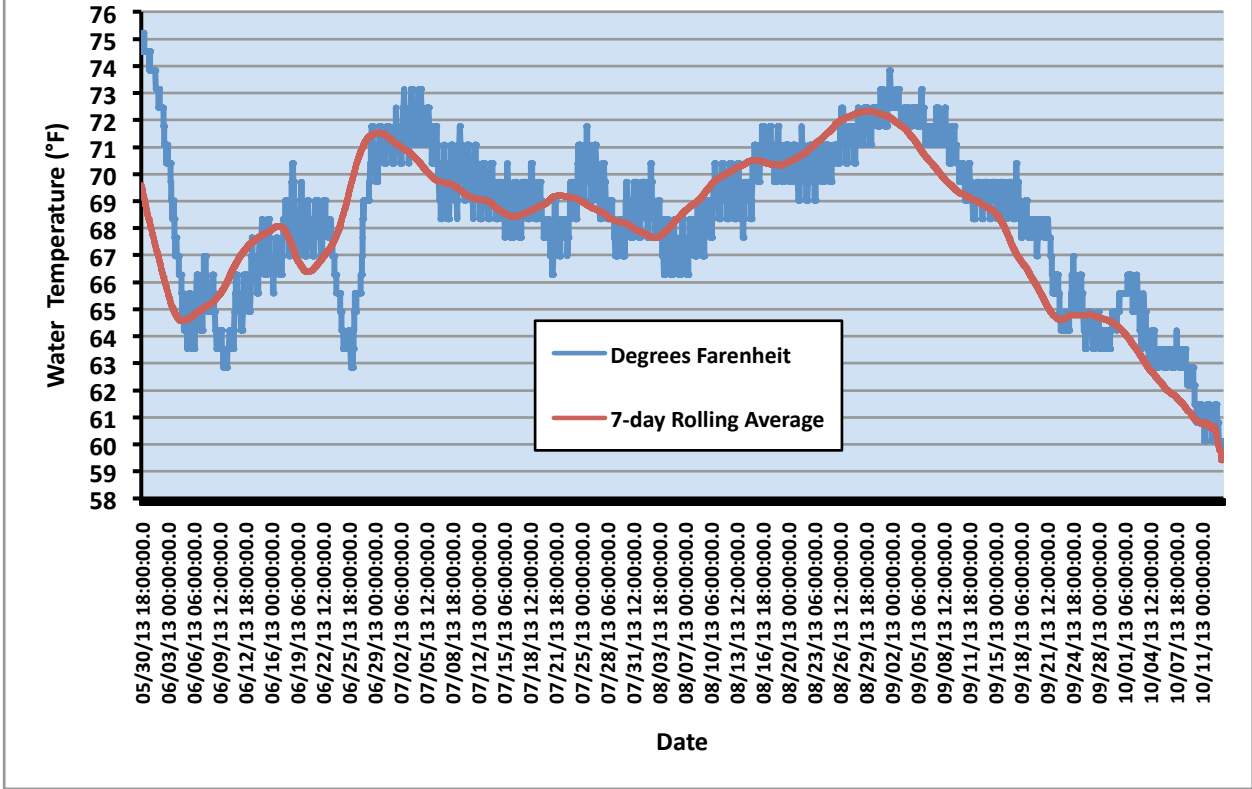
Figure 4d. Water Temperature (°F) Down from Trestle, 1.5 ft from Bottom, 30 May – 13 October 2013 (30-minute Interval).

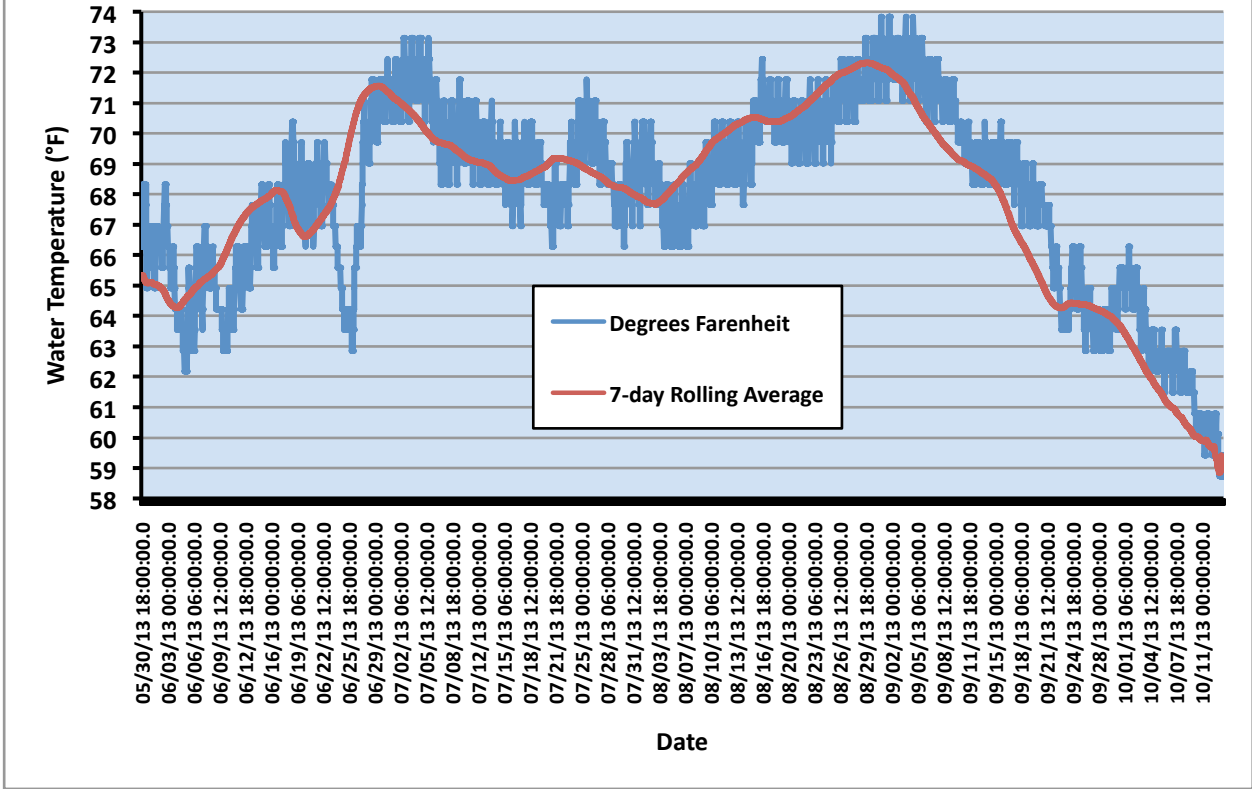
Figure 4f. Water Temperature (°F) Down from Trestle, 2.5 ft from Bottom, 30 May – 13 October 2013 (30-minute Interval).
