Soquel Lagoon Monitoring Report- 2013

**CITY OF CAPITOLA
420 Capitola Avenue
Capitola, California 95010**

March 2014

Project # 106-23

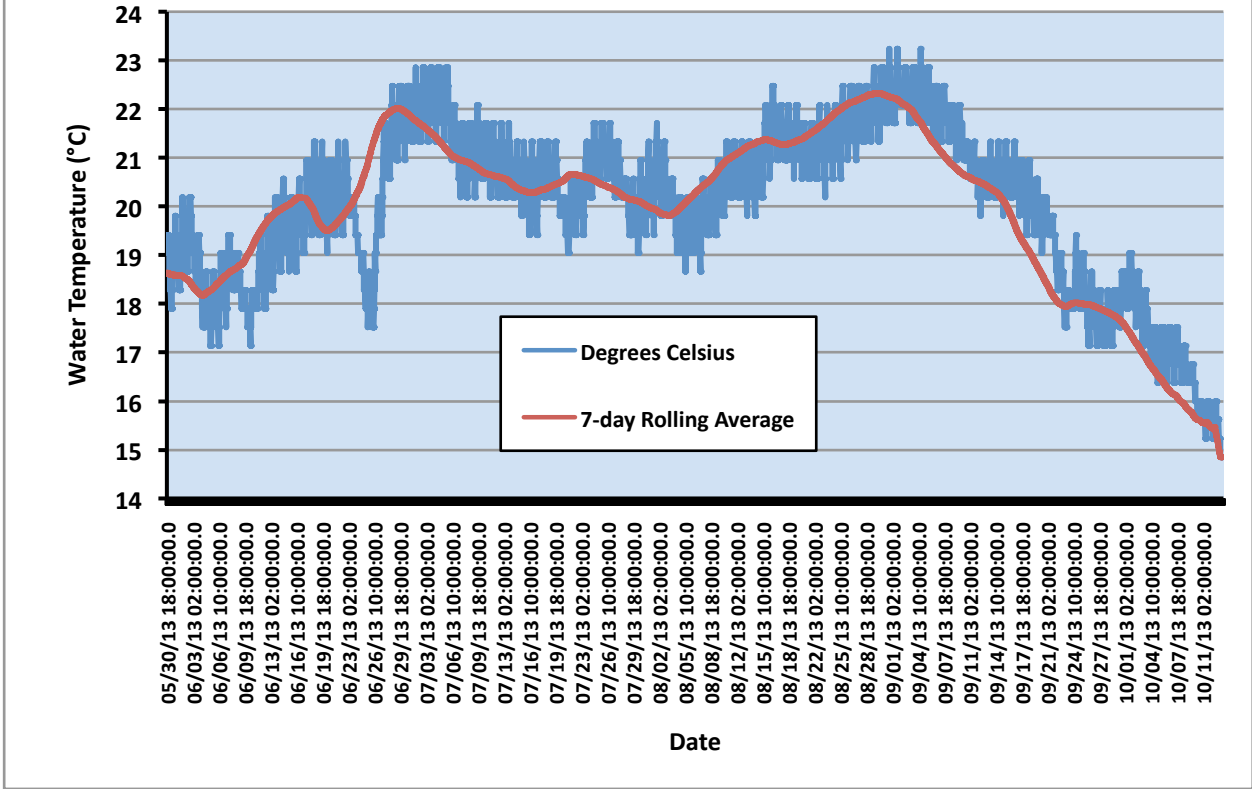
Figure 4g. Water Temperature (°C) Down from Trestle, 3.5 ft from Bottom, 30 May –13 October 2013 (30-minute Interval).

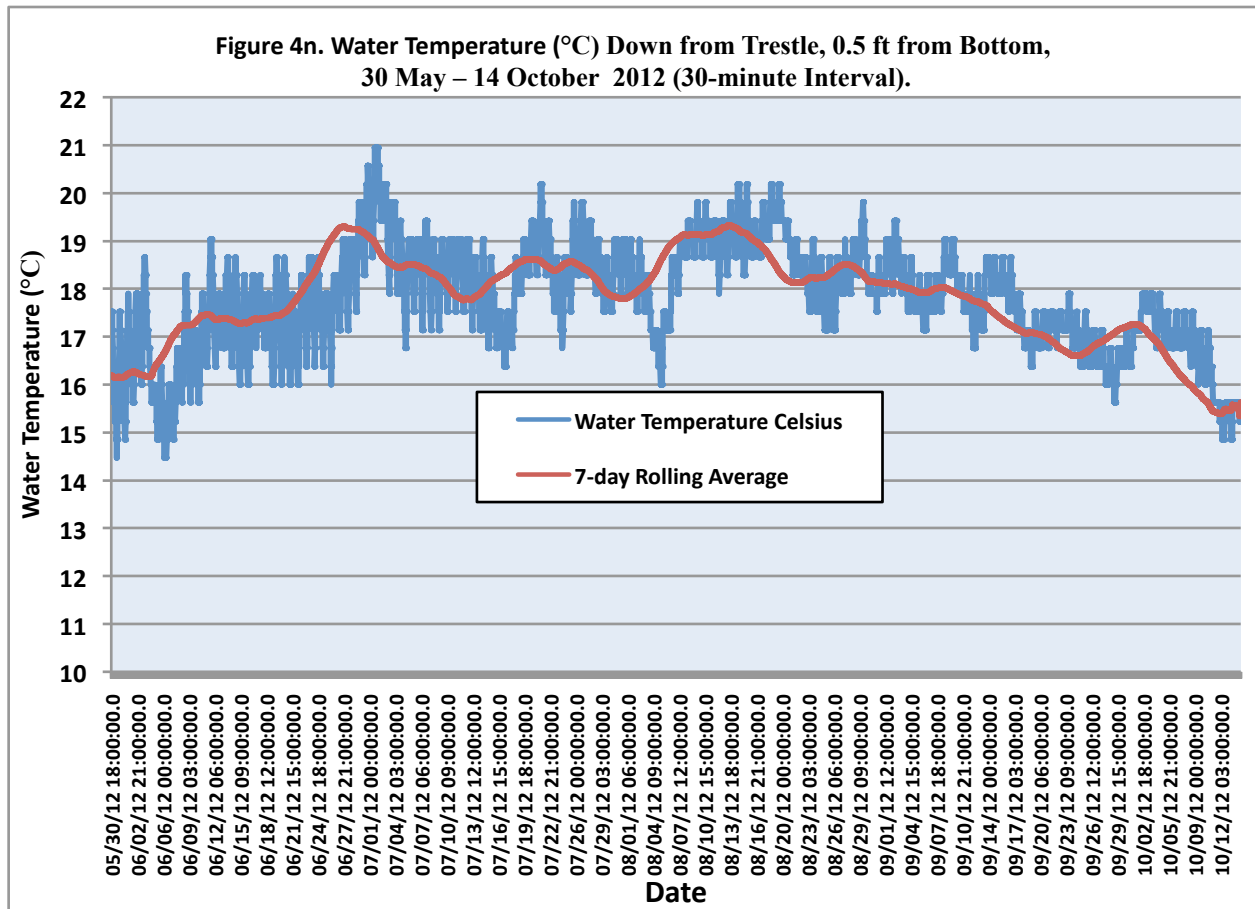
Figure 4n. Water Temperature (°C) Down from Trestle, 0.5 ft from Bottom, 30 May – 14 October 2012 (30-minute Interval).

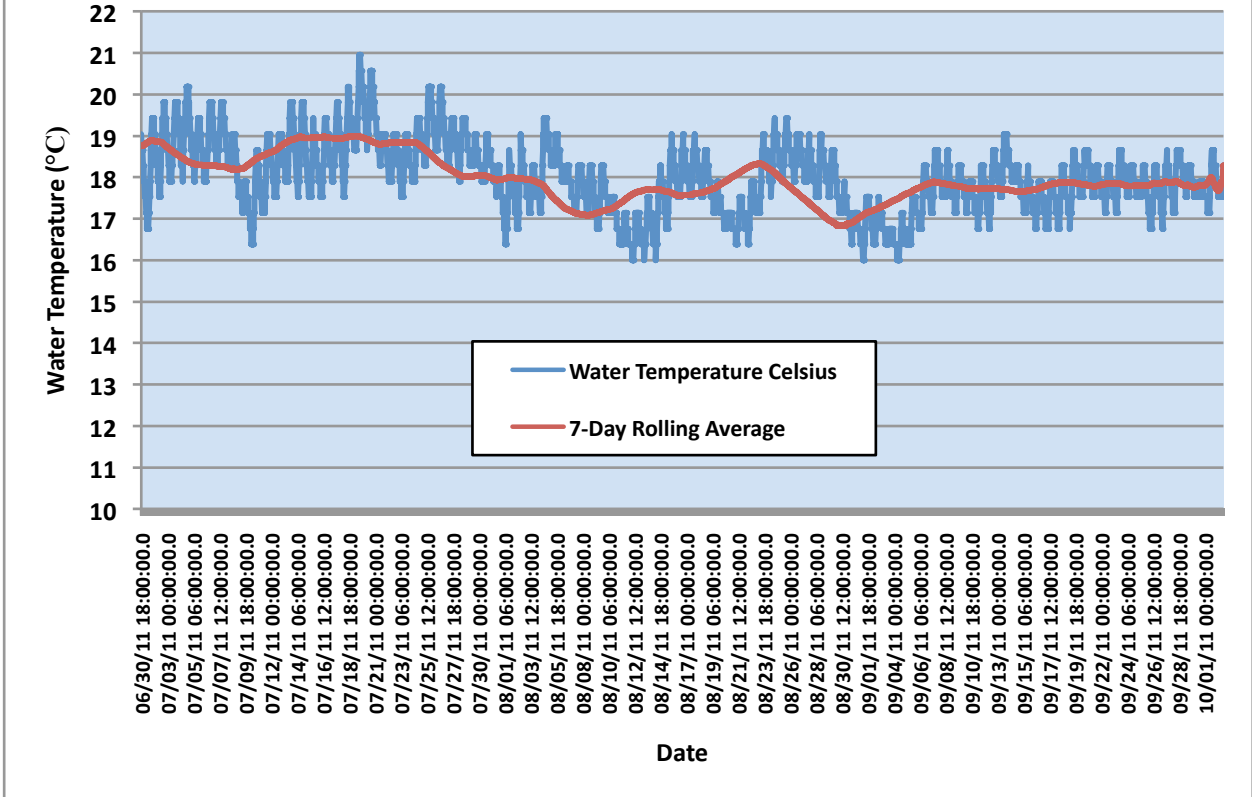
Figure 4o. Water Temperature (°C) Down from Trestle, 5.5 ft from Bottom, 30 June – 2 October 2011 (30-minute interval).

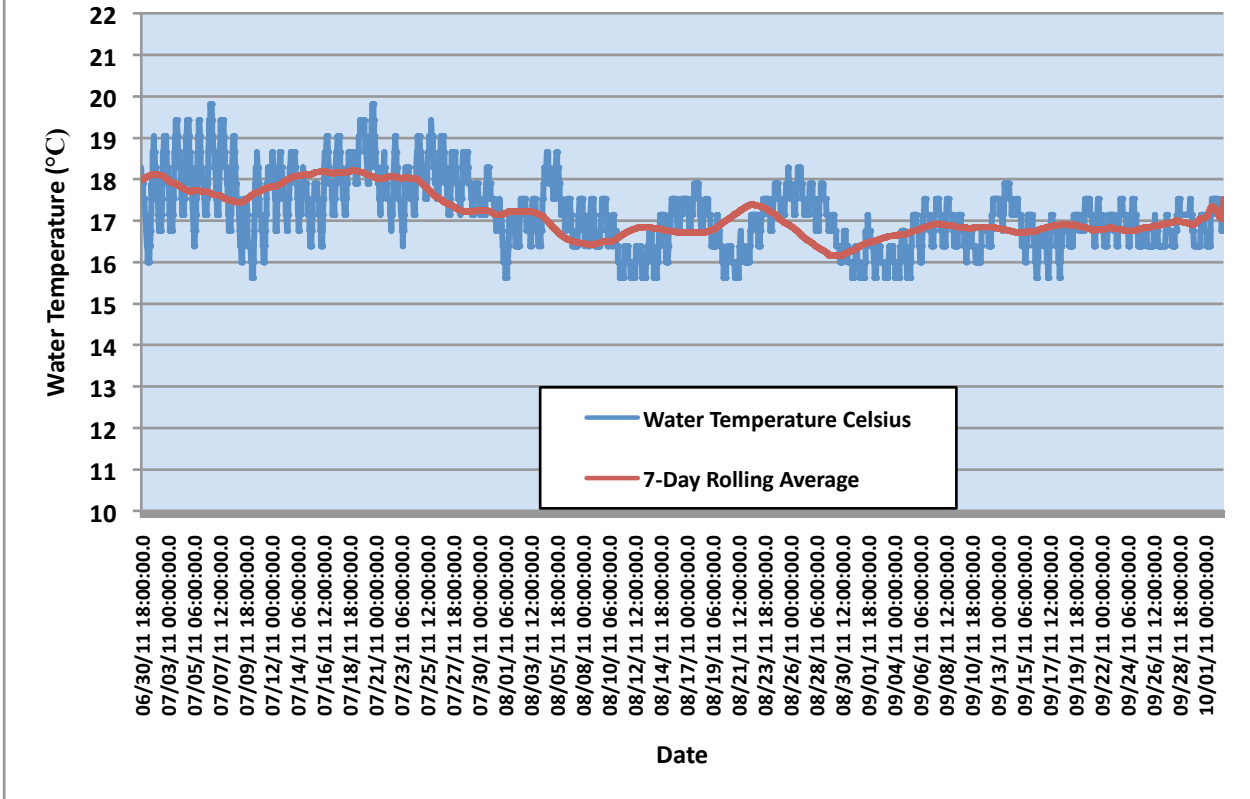
Figure 4p. Water Temperature (°C) Down from Trestle, 0.5 ft from Bottom, 30 June – 2 October 2011 (30-minute interval).

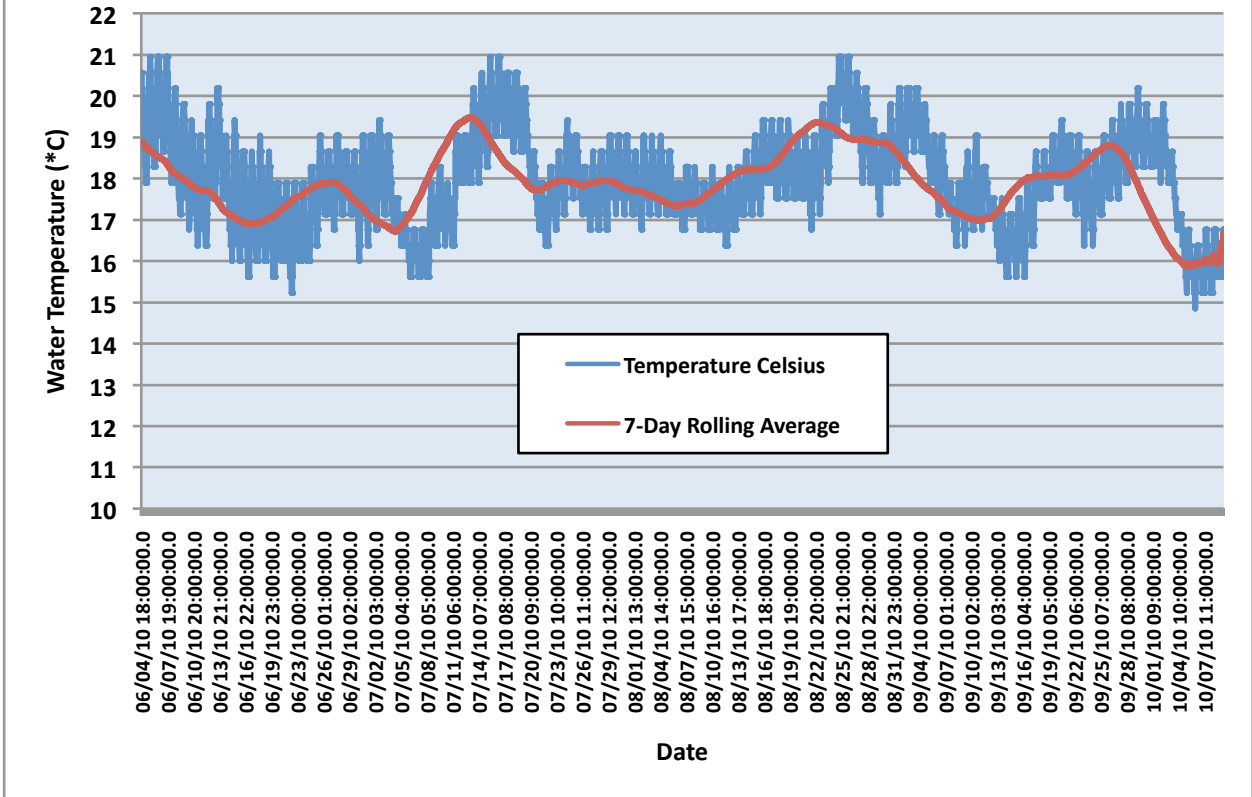
Figure 4q. Water Temperature (*C) Down from Trestle, 5.5 ft from Bottom, 4 June - 9 October 2010 (30-minute interval).

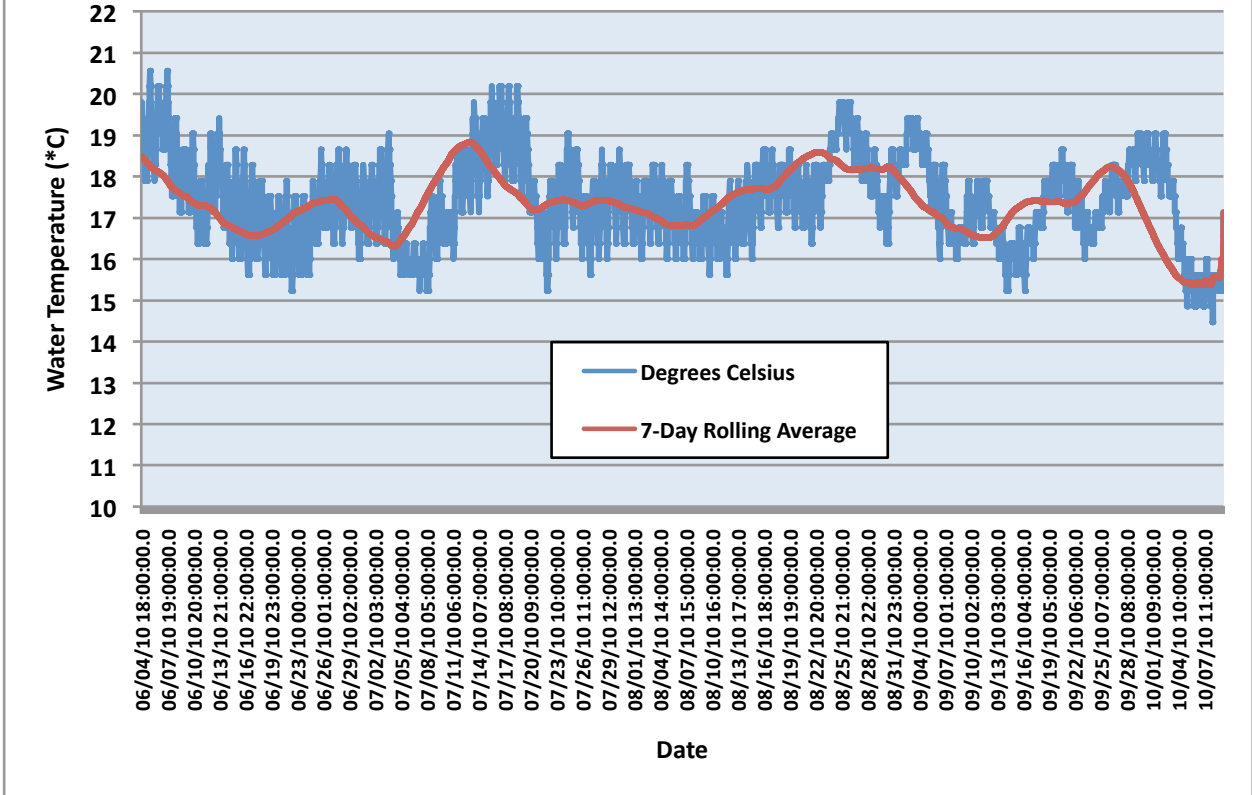
Figure 4r. Water Temperature (*C) Down from Trestle, 0.5 ft from Bottom, 4 June - 9 October 2010 (30-minute interval).

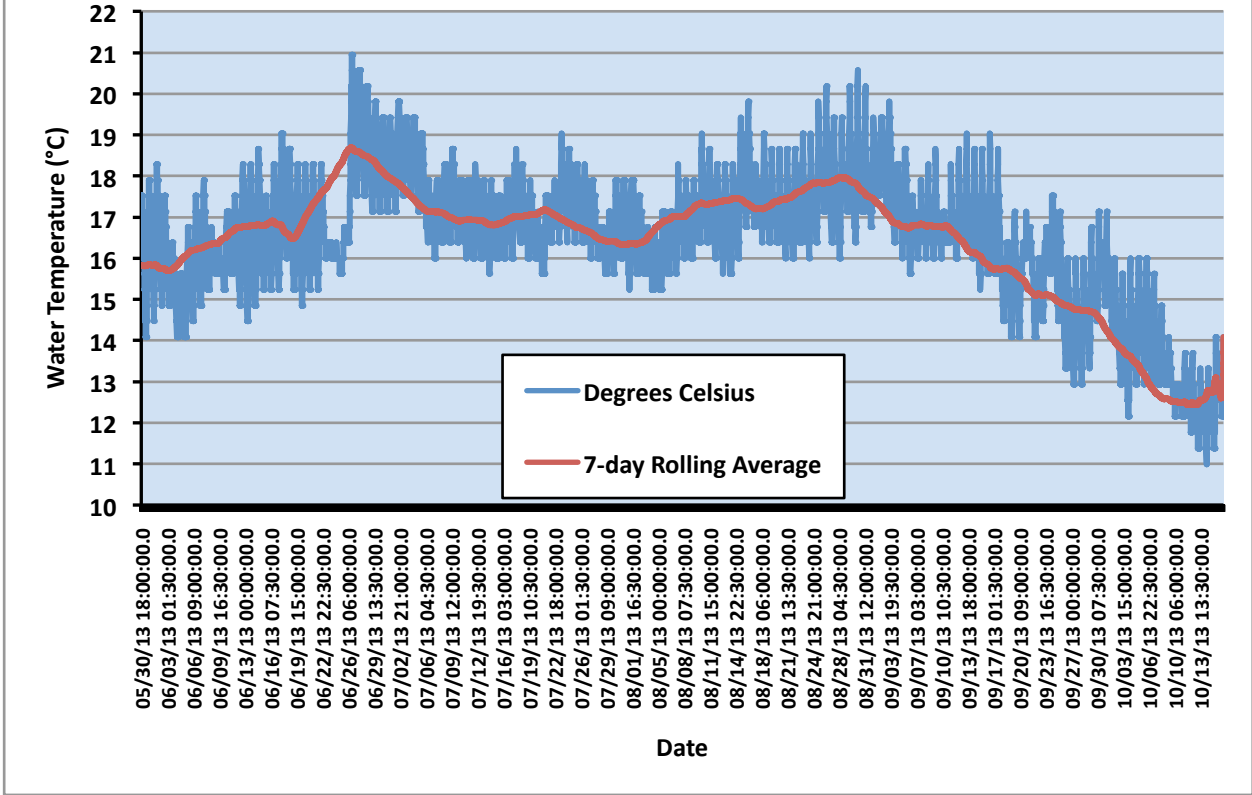
Figure 5a. Water Temperature (°C) Above the Lagoon (Nob Hill) in Soquel Creek, 30 May – 16 October 2013 (30-minute Interval).

At the creek site near Nob Hill in 2013, the stream management goal was met for steelhead of *no more than 4 hours a day at greater than 20°C (68°F)* was met except for 1 day (**0.7%**) (**Figure 5a**). In 2009–2012, the stream management goal was met for steelhead (**Figures 5c–5e**) and failed on only 1 day (**0.8%**) in 2008 (**Alley 2013**). In 2013, water temperature reached 20°C on 7

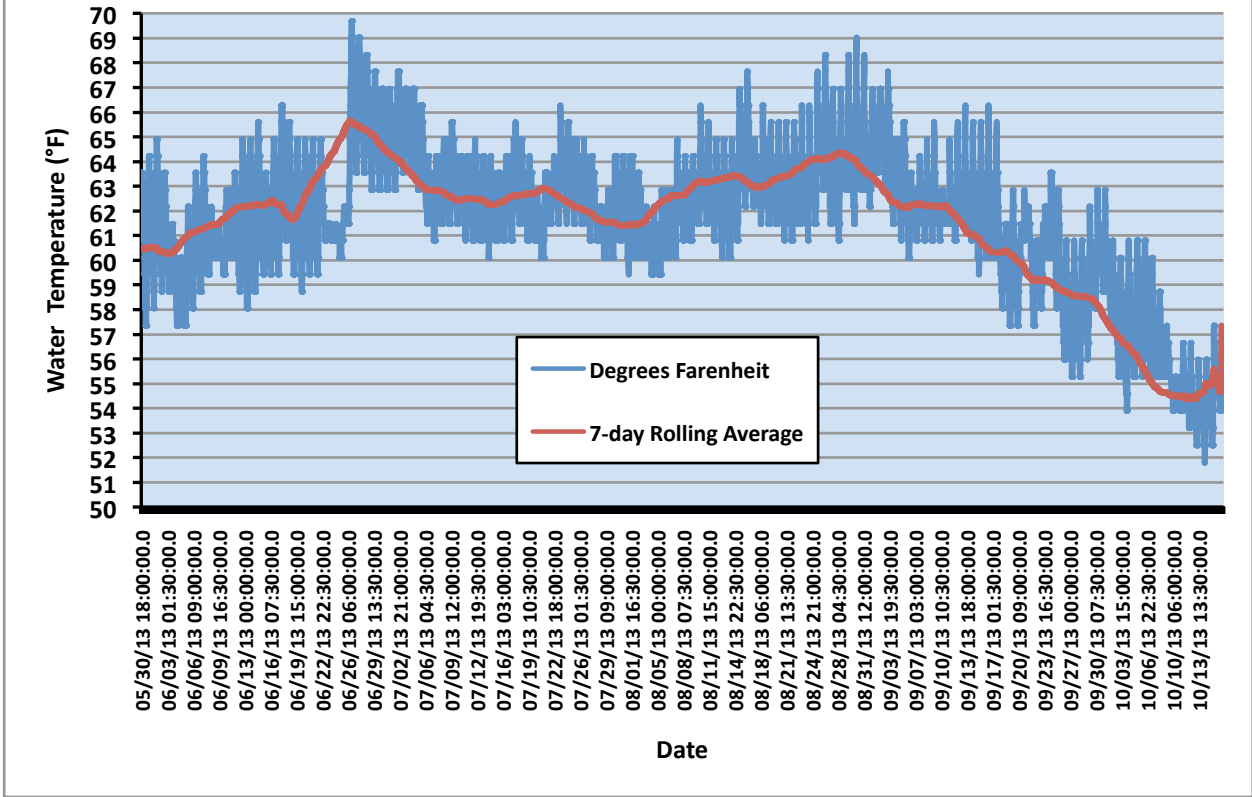
Figure 5b. Water Temperature (°F) Above the Lagoon (Nob Hill) in Soquel Creek, 30 May – 16 October 2013 (30-minute Interval).

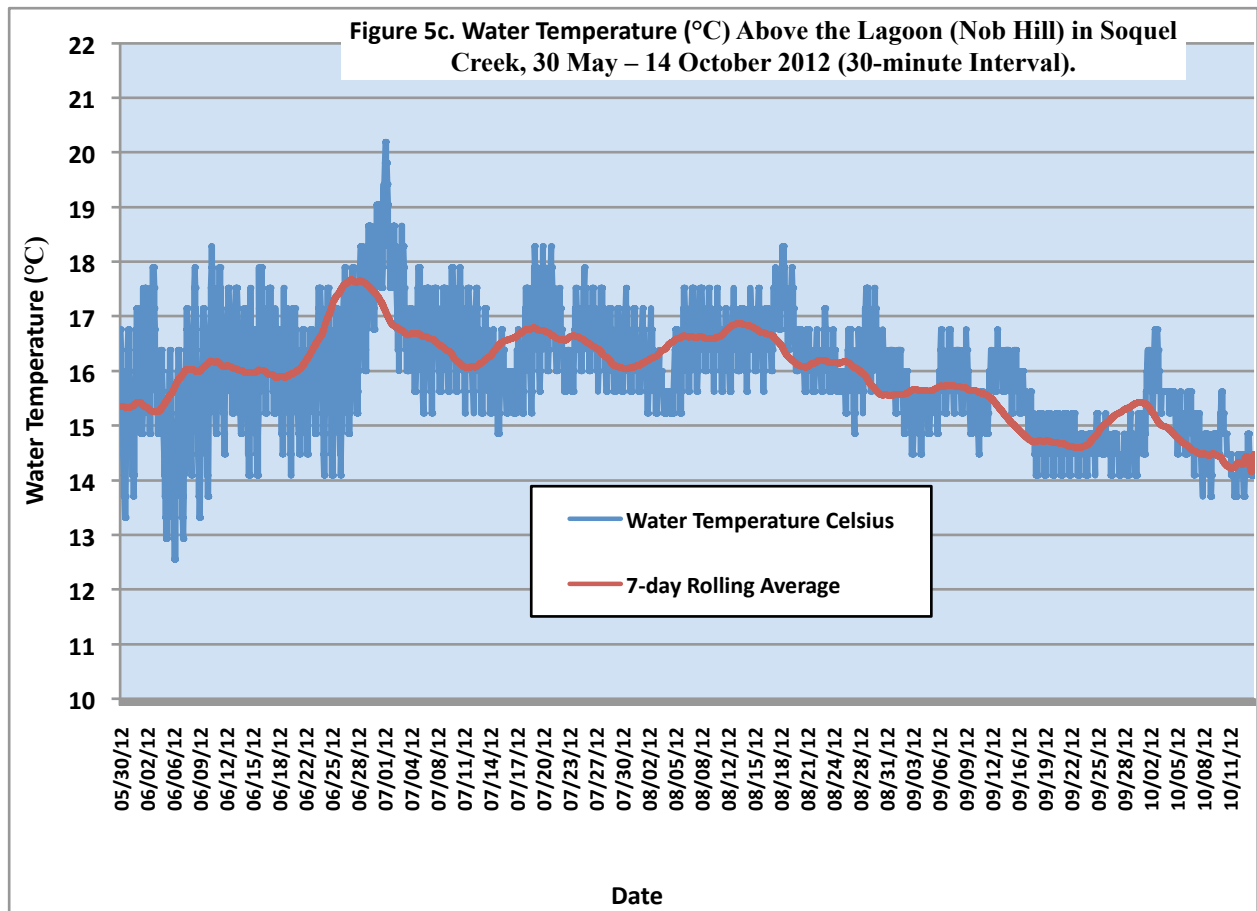
Figure 5c. Water Temperature (°C) Above the Lagoon (Nob Hill) in Soquel Creek, 30 May – 14 October 2012 (30-minute Interval).

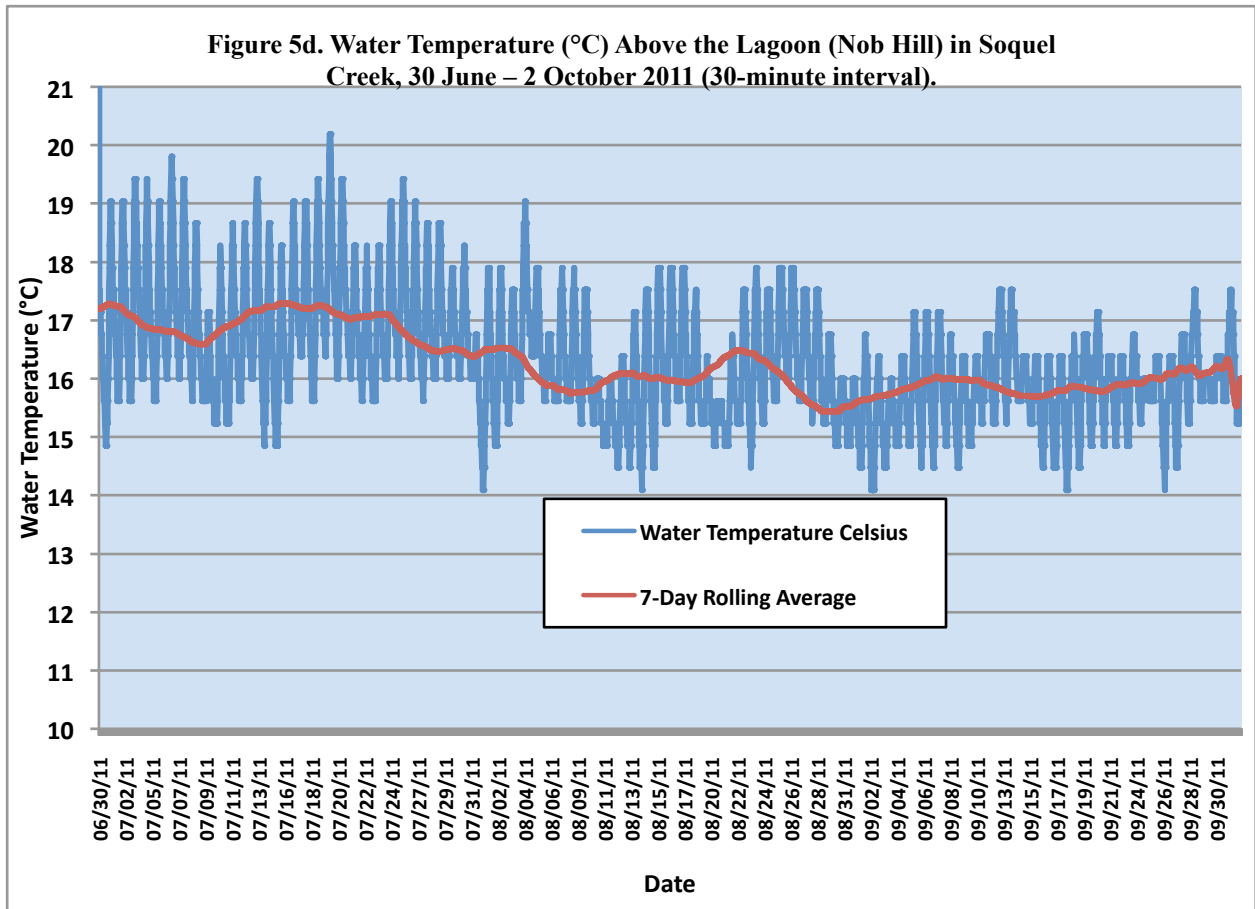
Figure 5d. Water Temperature (°C) Above the Lagoon (Nob Hill) in Soquel Creek, 30 June – 2 October 2011 (30-minute interval).

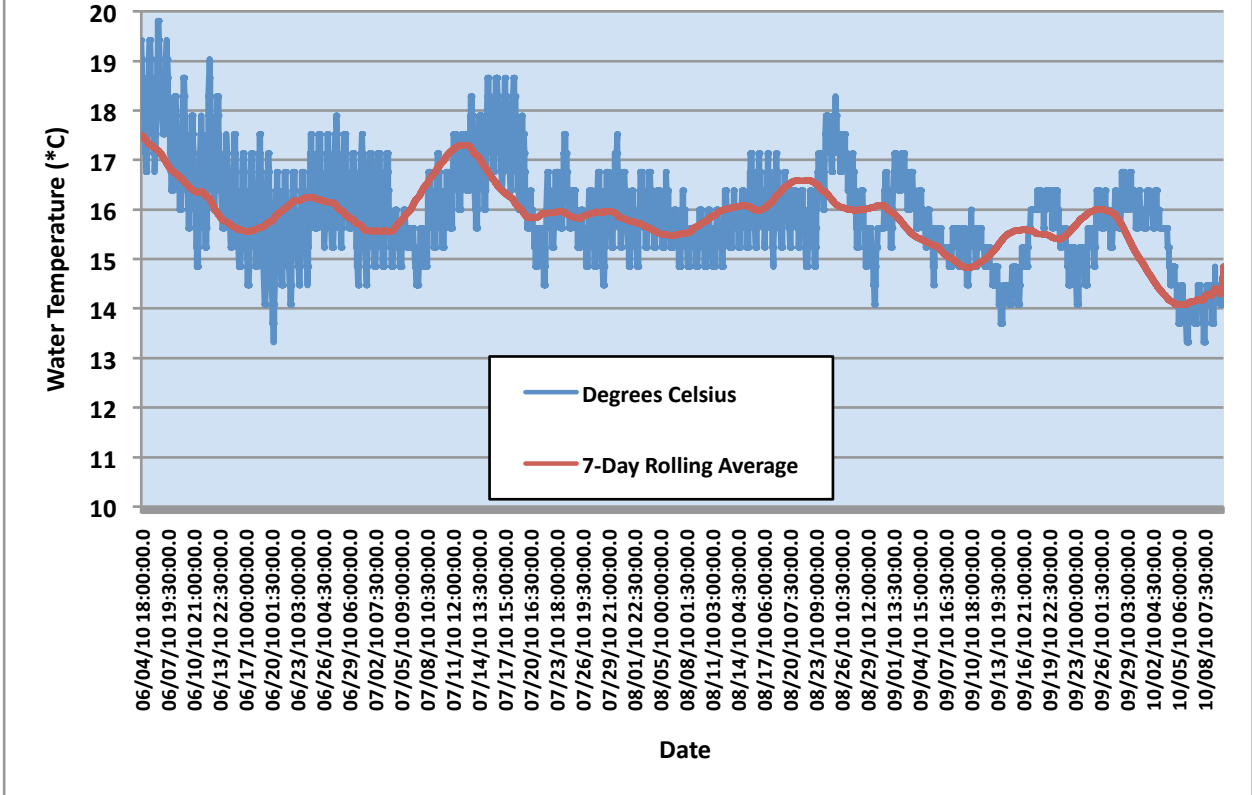
Figure 5e. Water Temperature (*C) Above the Lagoon (Nob Hill) in Soquel Creek, 4 June - 9 October 2010 (30-minute interval).

days. In 2011 and 2012, water temperature reached 20°C on one day while, in 2009 and 2010, water temperature did not reach 20°C. In 2007, water temperature failed to meet this management goal on 4% of the days (**Figure 5e**) compared to 12% in 2006 (**Figure 5f**). At the creek site in 2005, water temperature failed to meet the management goal 5% of the days (**Alley 2005**). In 2004, 7% of the days did not meet the goal. September was unusually cool in 2004 and 2005 (**Alley 2005**). At the Creek site in 2003, 17% of the days failed to meet the management goal (**Alley 2005**).

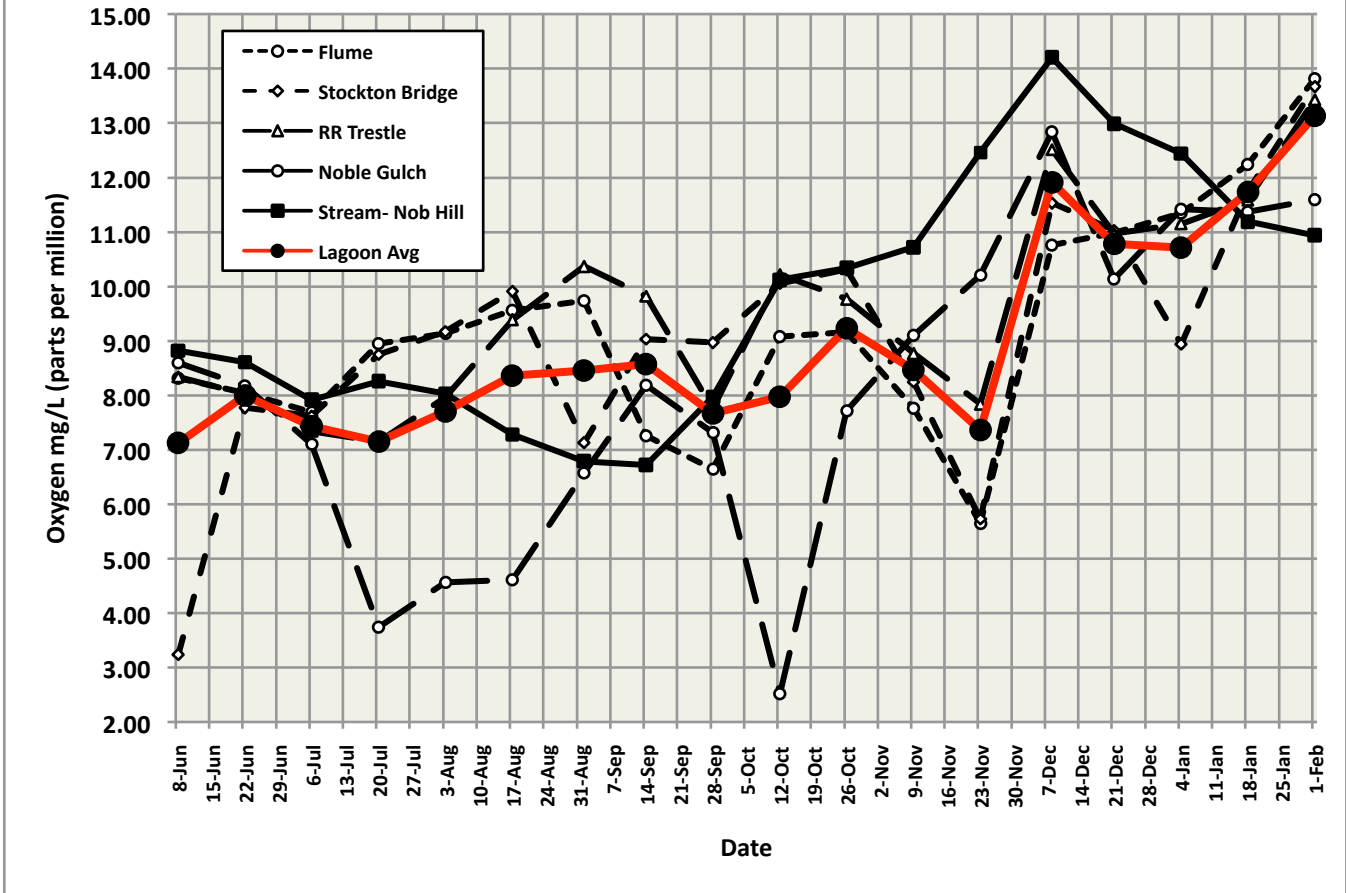
Figure 6a-1. Soquel Lagoon/Stream Oxygen Concentration at Dawn Within 0.25m of the Bottom at Five Monitoring Stations, 8 June – 1 February 2014.

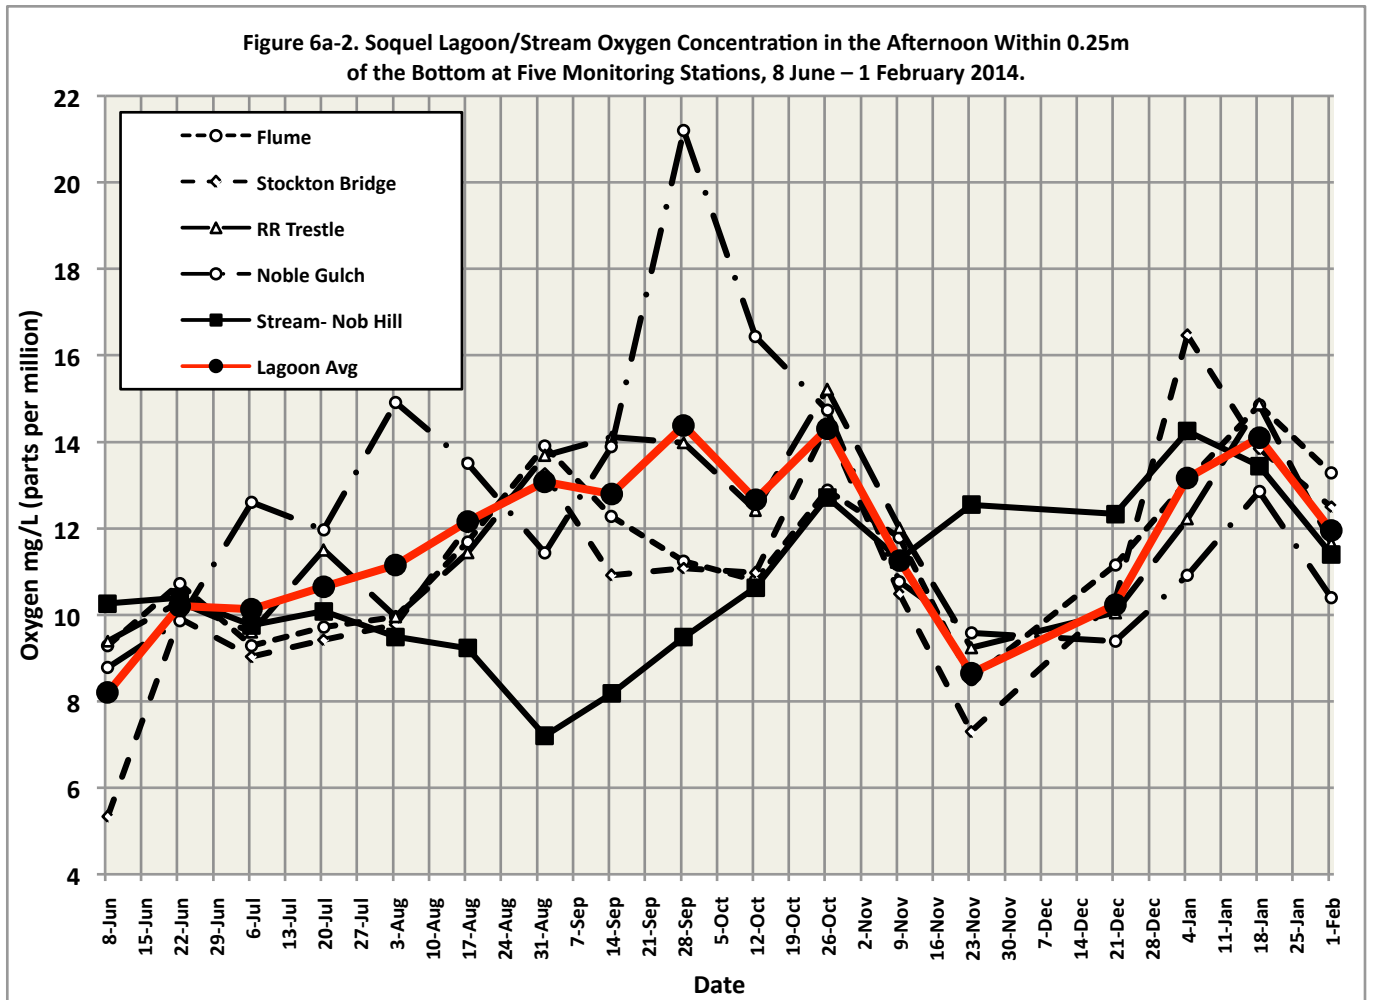
Figure 6a-2. Soquel Lagoon/Stream Oxygen Concentration in the Afternoon Within 0.25m of the Bottom at Five Monitoring Stations, 8 June – 1 February 2014.

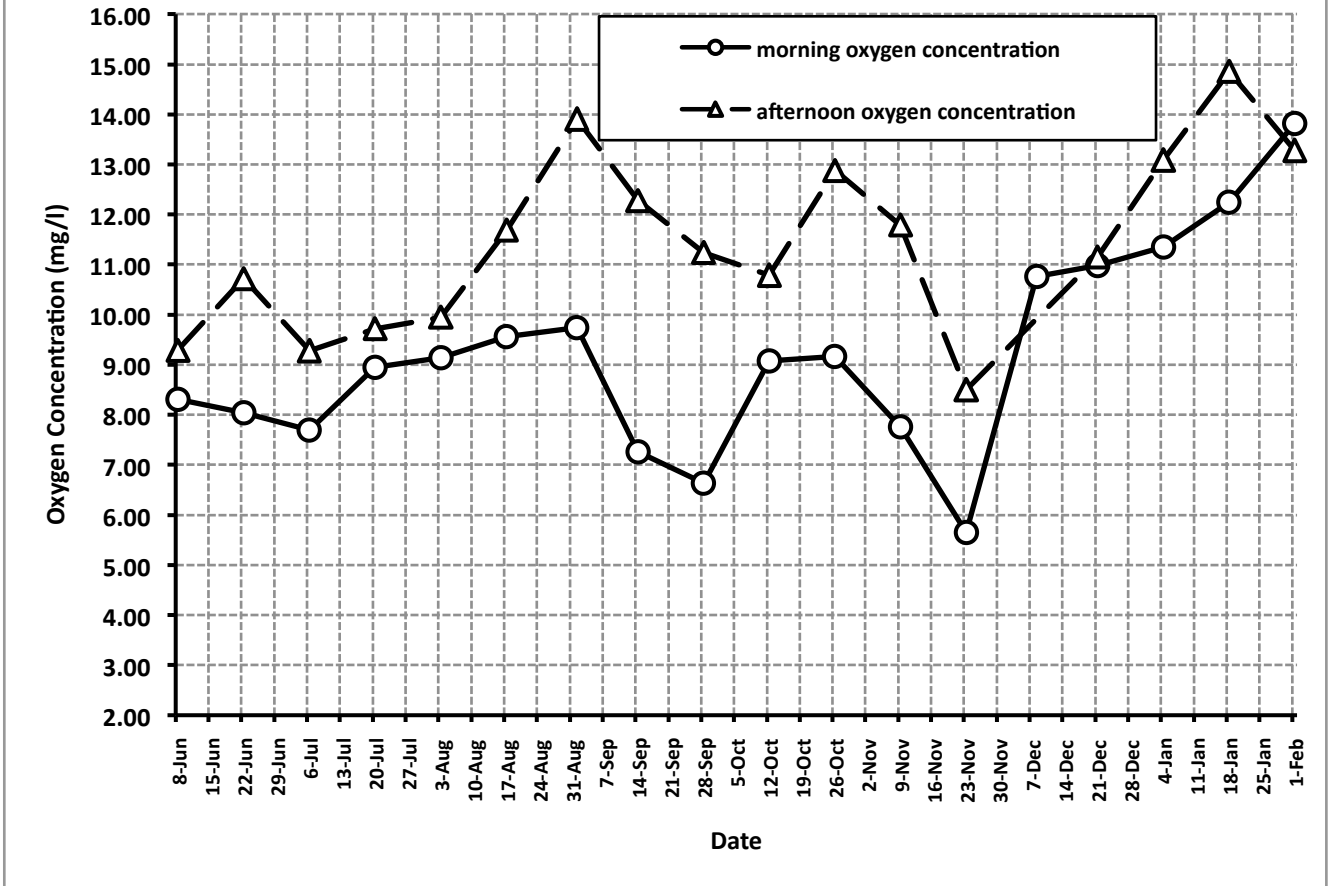
Figure 6b. Soquel Lagoon Oxygen Concentration in the Morning and Afternoon within 0.25 Meters of the Bottom at Station 1, the Flume Inlet, 8 June – 2 February 2014.

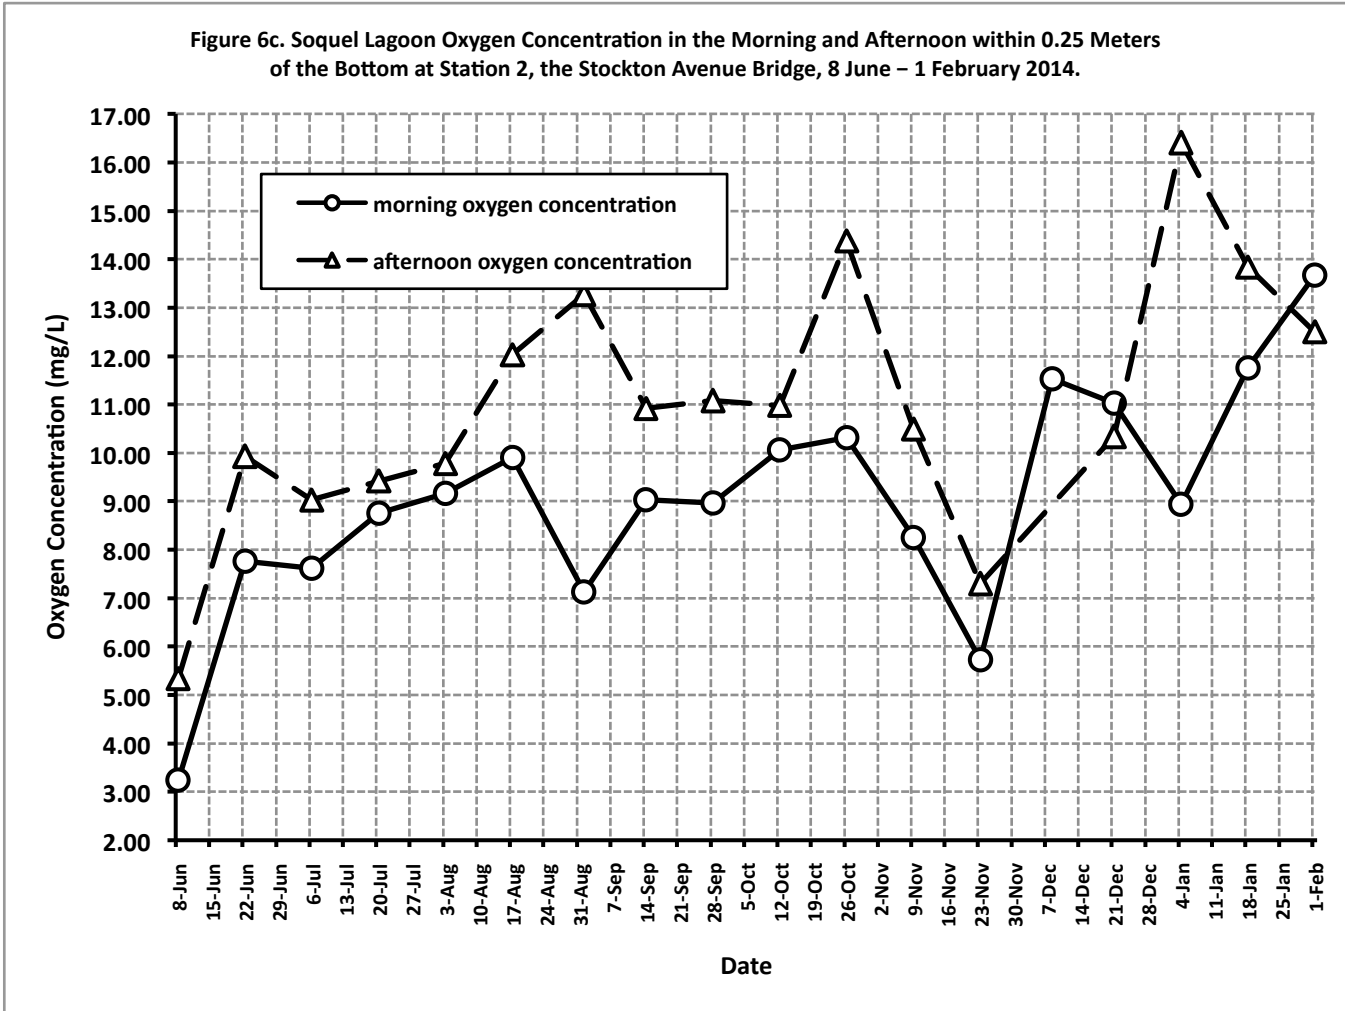
Figure 6c. Soquel Lagoon Oxygen Concentration in the Morning and Afternoon within 0.25 Meters of the Bottom at Station 2, the Stockton Avenue Bridge, 8 June – 1 February 2014.

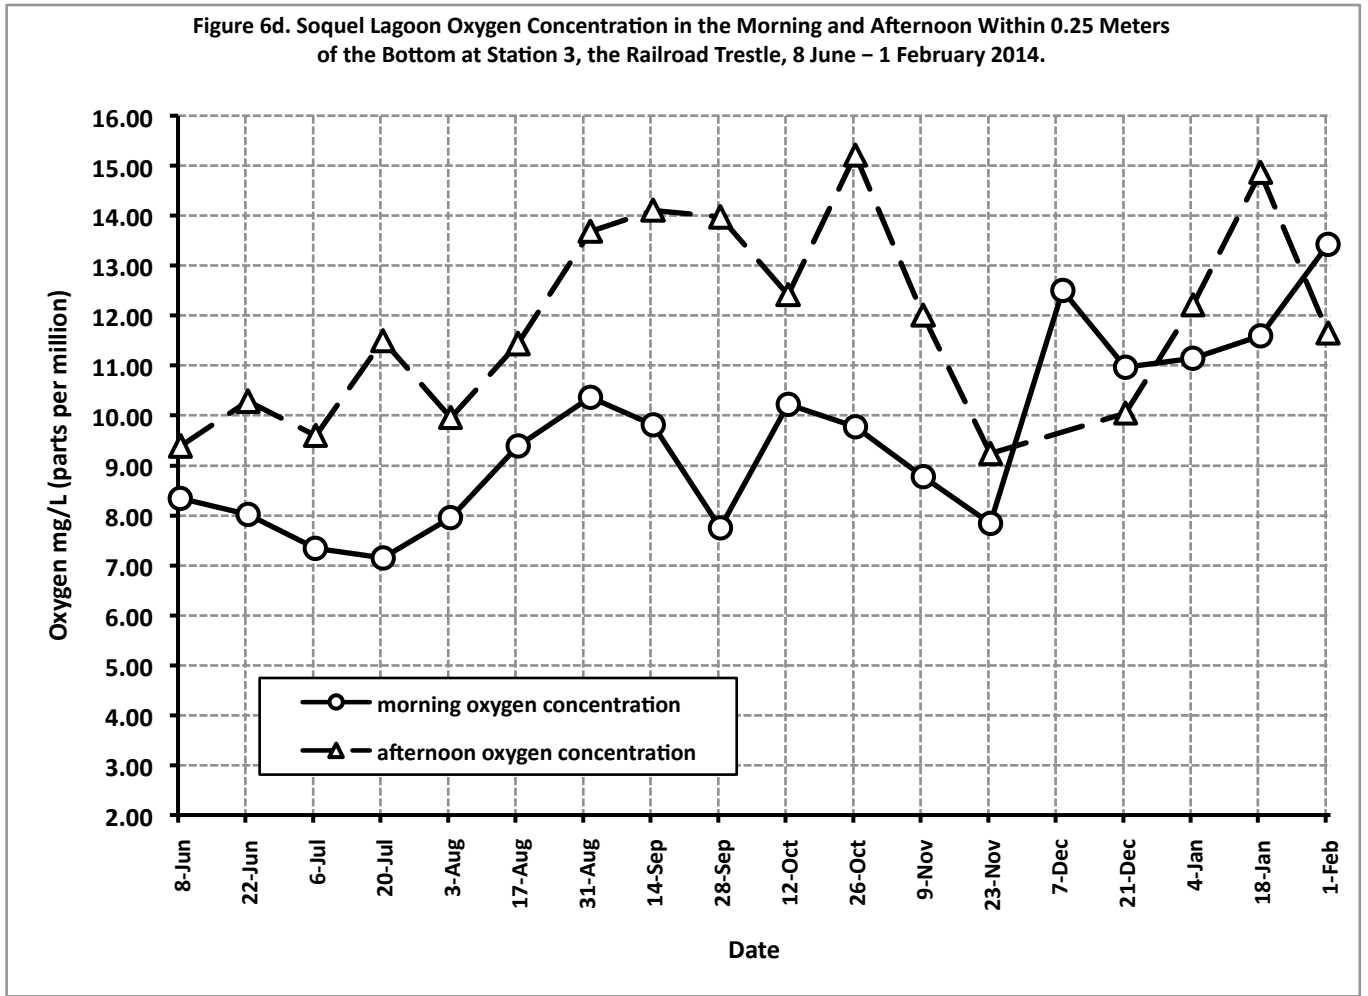
Figure 6d. Soquel Lagoon Oxygen Concentration in the Morning and Afternoon Within 0.25 Meters of the Bottom at Station 3, the Railroad Trestle, 8 June – 1 February 2014.

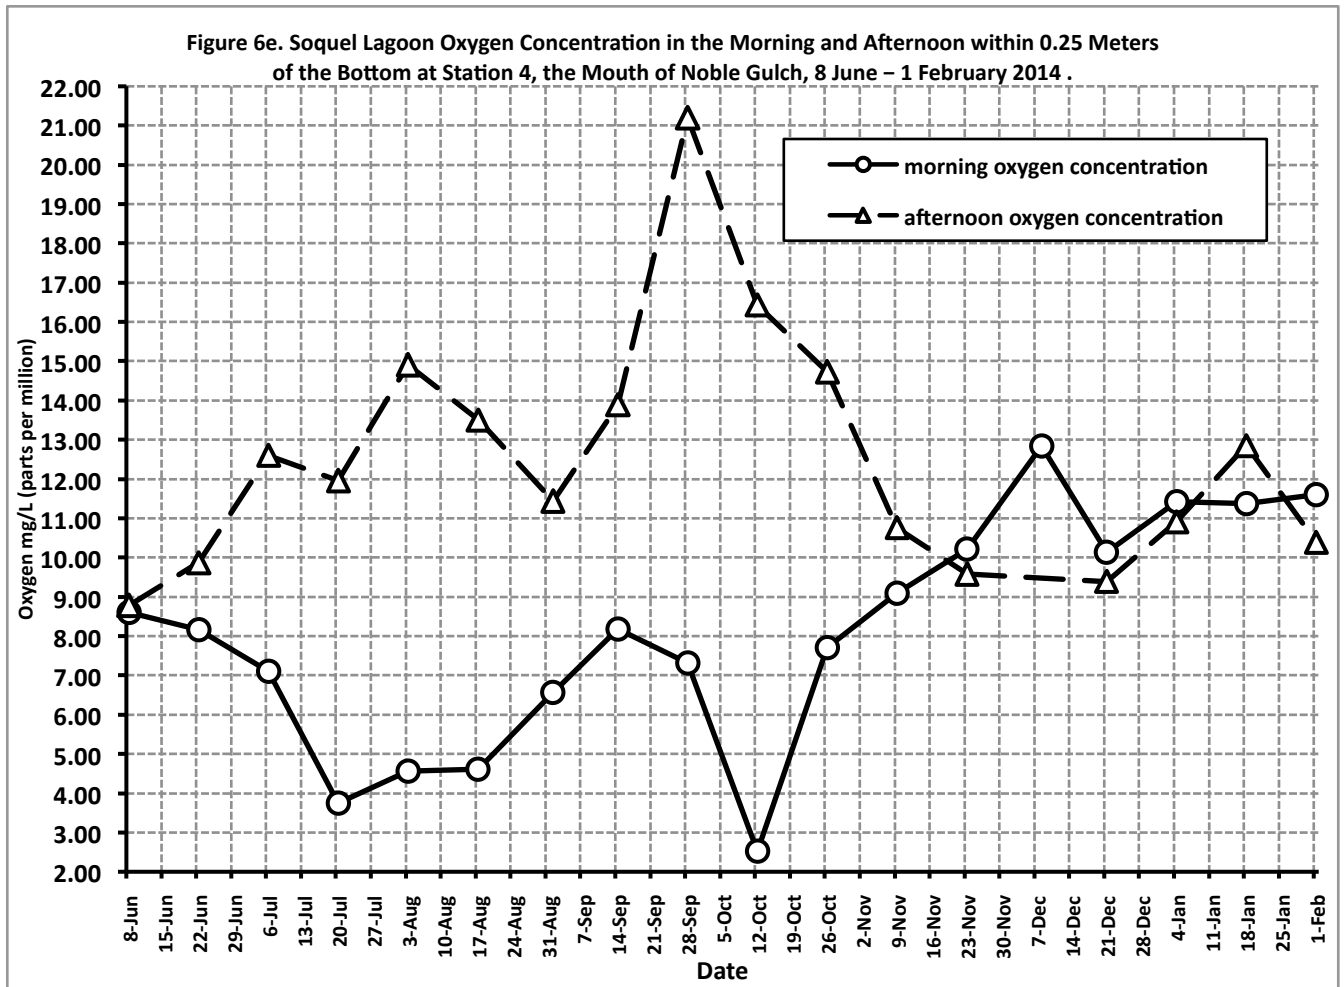
Figure 6e. Soquel Lagoon Oxygen Concentration in the Morning and Afternoon within 0.25 Meters of the Bottom at Station 4, the Mouth of Noble Gulch, 8 June – 1 February 2014 .

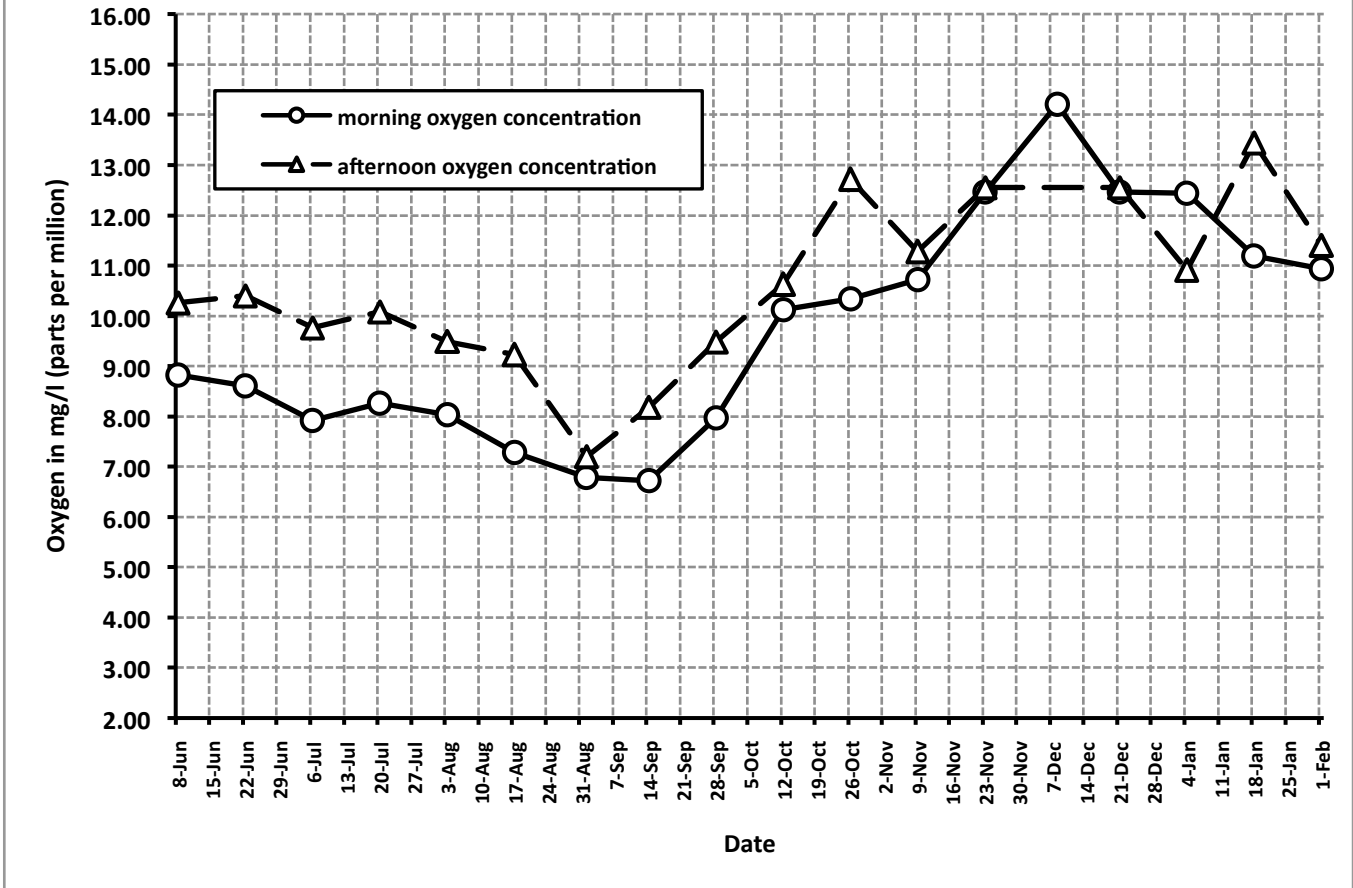
Figure 6f. Soquel Creek Oxygen Concentration in the Morning and Afternoon within 0.25 Meters of the Bottom at Station 5, Nob Hill, 8 June – 1 February 2014.

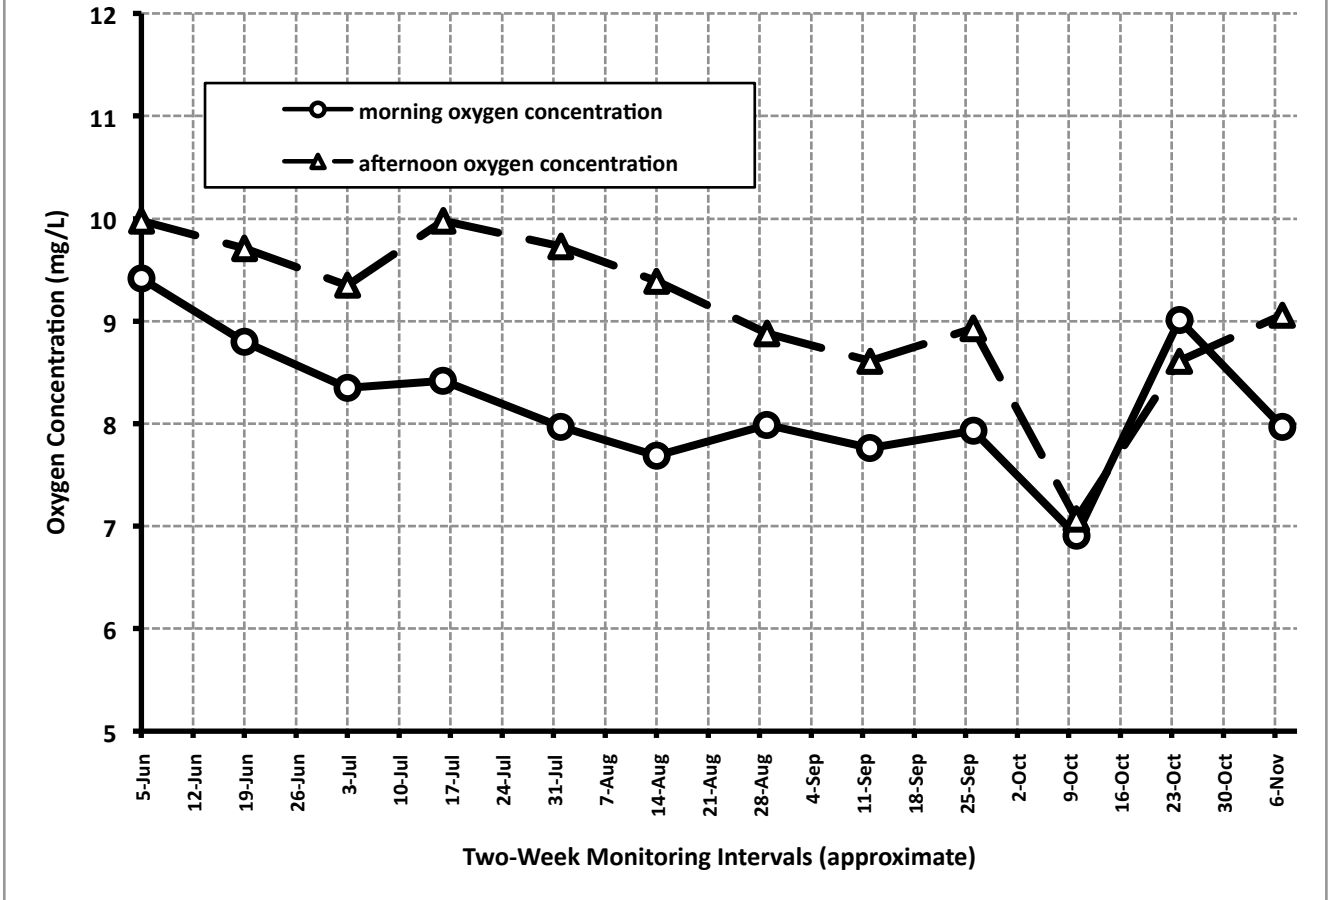
Figure 6g. Soquel Creek Oxygen Concentration in the Morning and Afternoon within 0.25 meters of the Bottom at Station 5, Nob Hill, 5 June – 7 November 2012.
