Soquel Lagoon Monitoring Report- 2013

**CITY OF CAPITOLA
420 Capitola Avenue
Capitola, California 95010**

March 2014

Project # 106-23

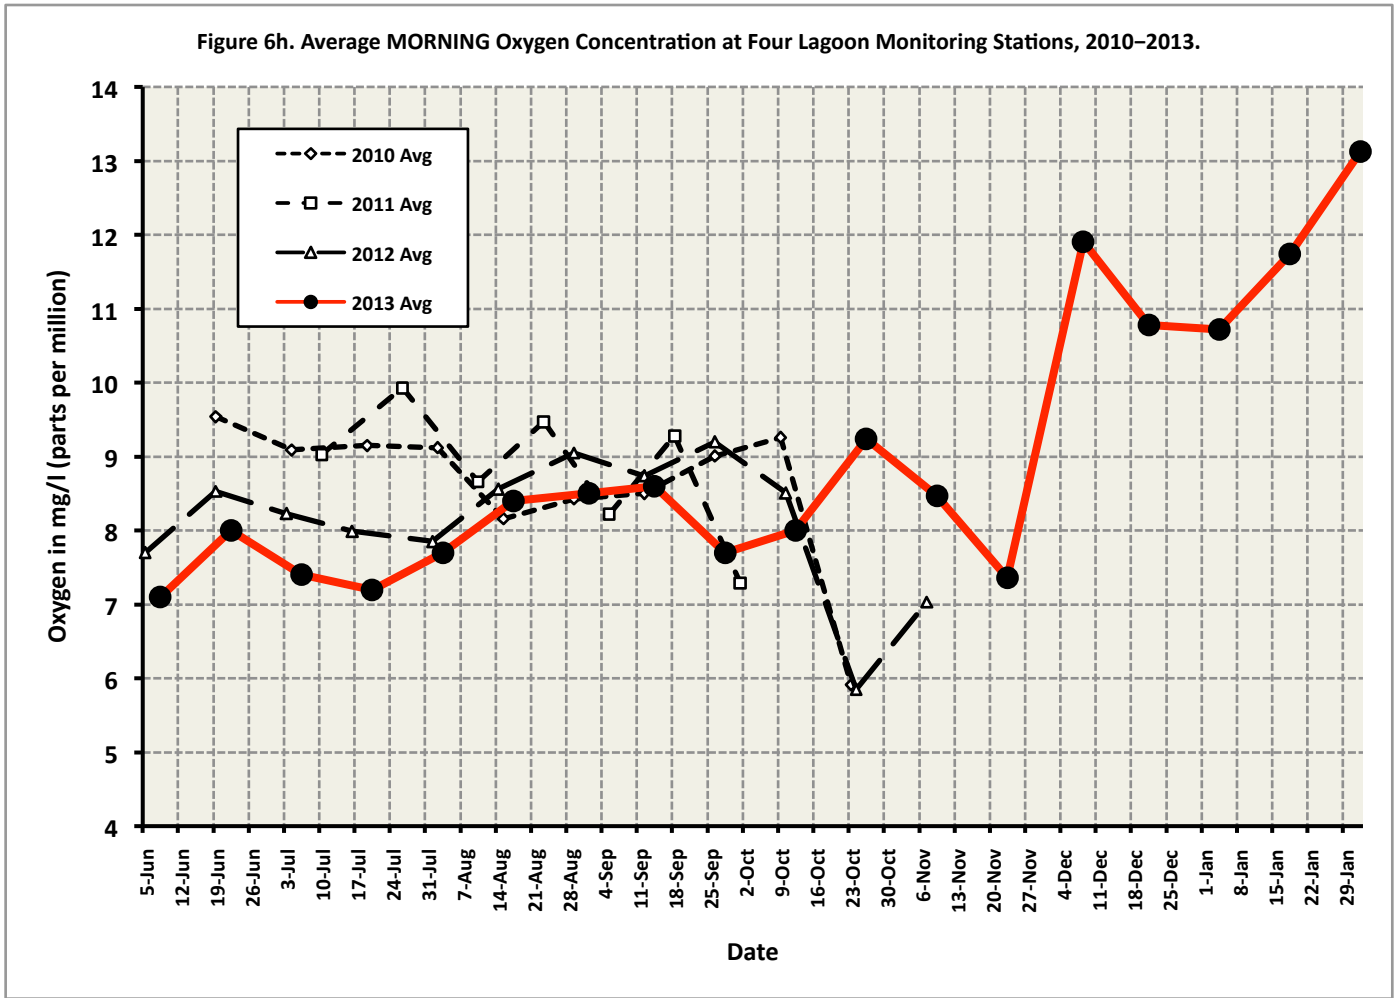
Figure 6h. Average MORNING Oxygen Concentration at Four Lagoon Monitoring Stations, 2010–2013.

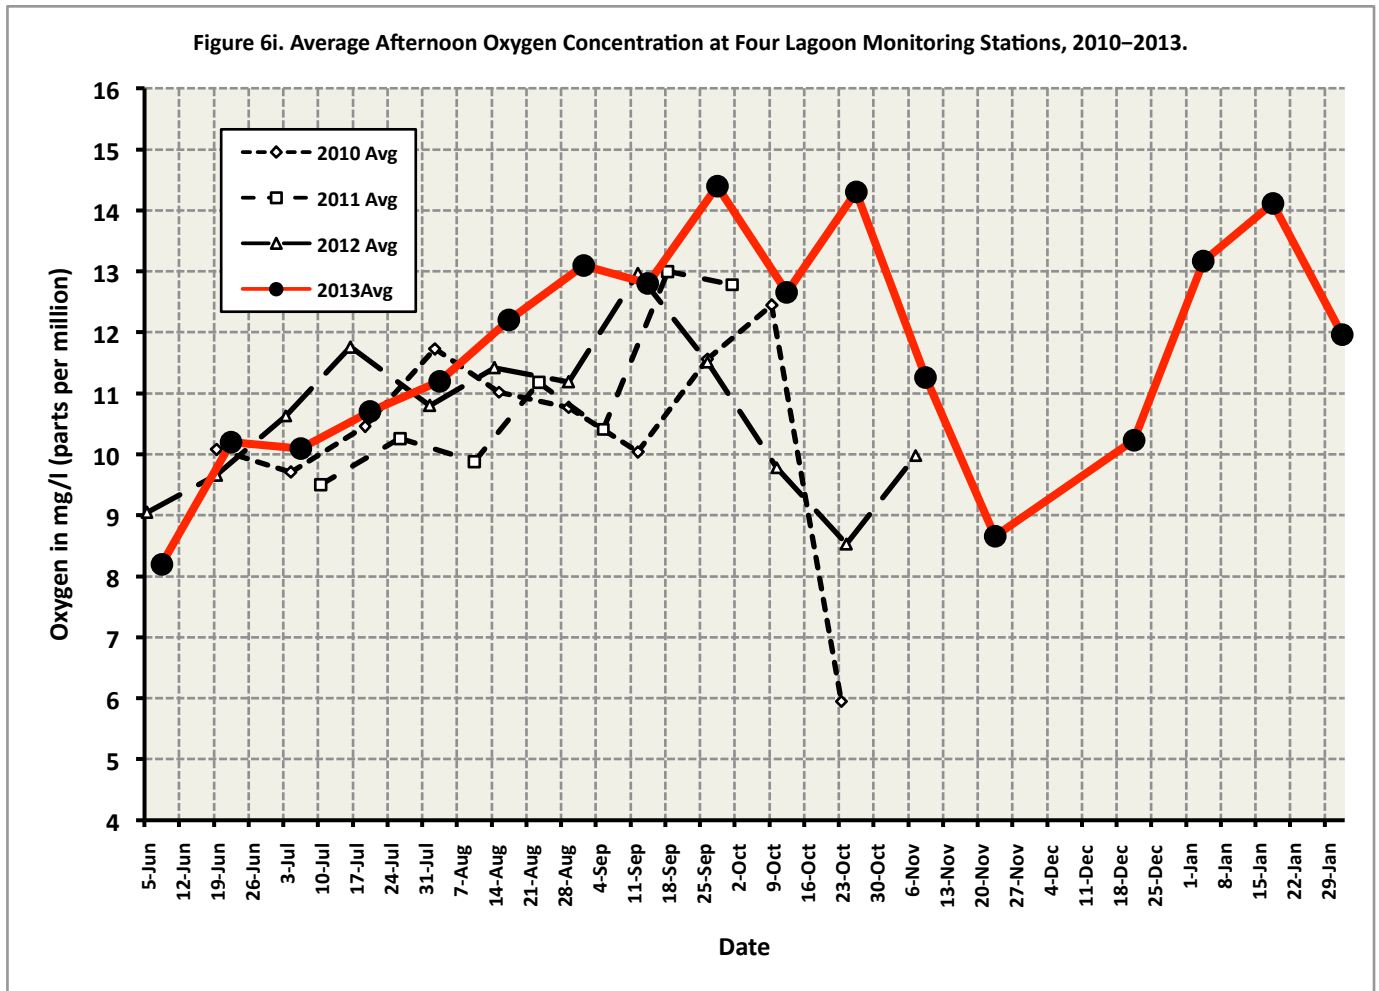
Figure 6i. Average Afternoon Oxygen Concentration at Four Lagoon Monitoring Stations, 2010–2013.

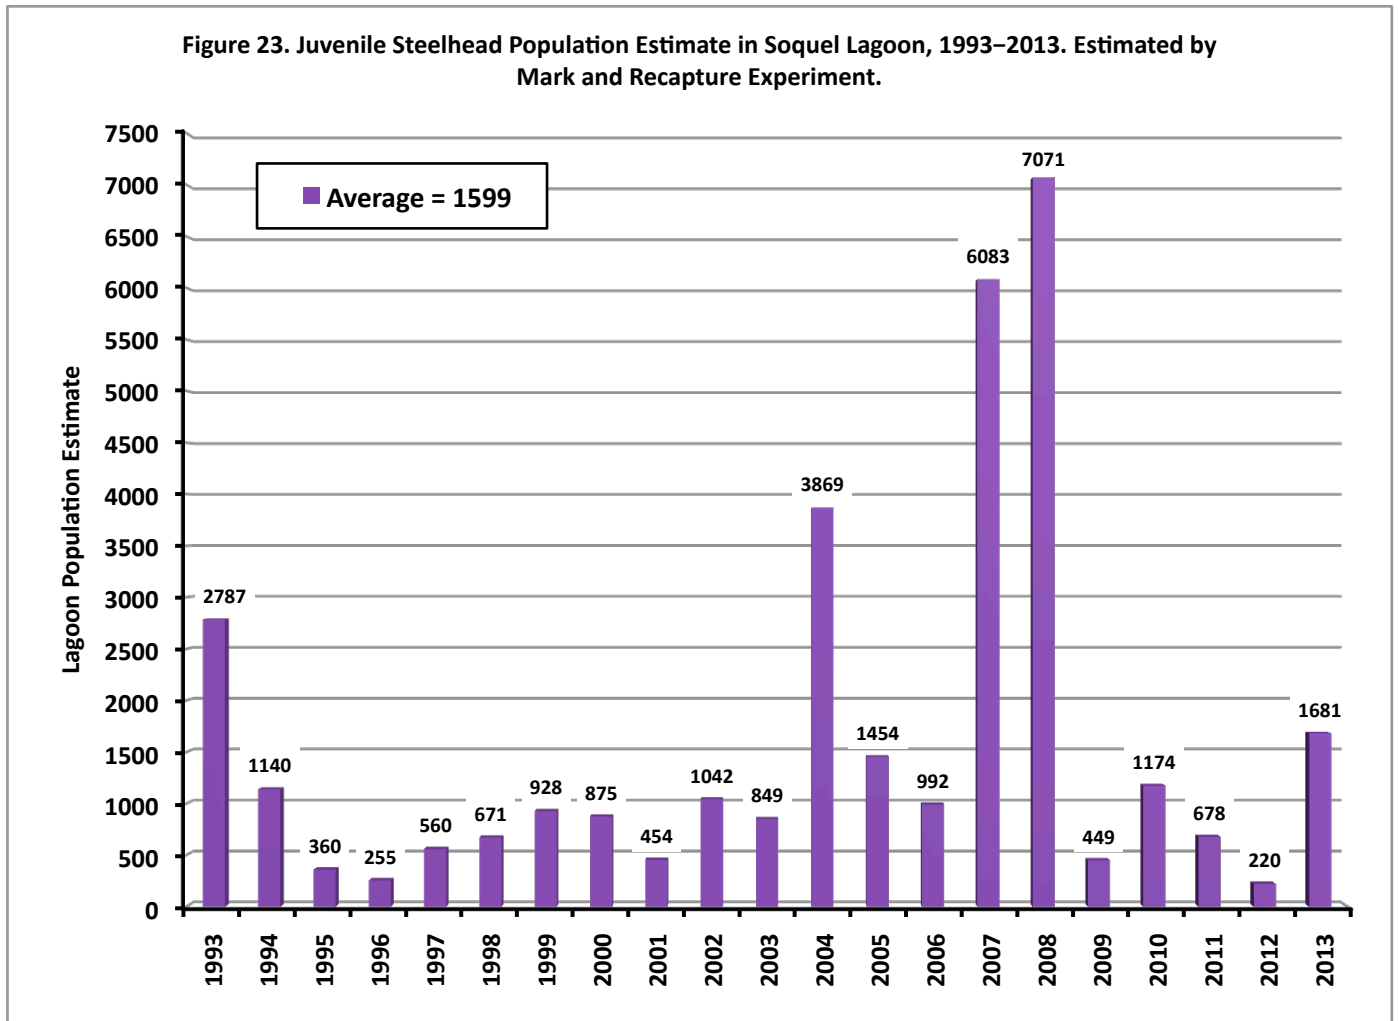
Figure 23. Juvenile Steelhead Population Estimate in Soquel Lagoon, 1993–2013. Estimated by Mark and Recapture Experiment.

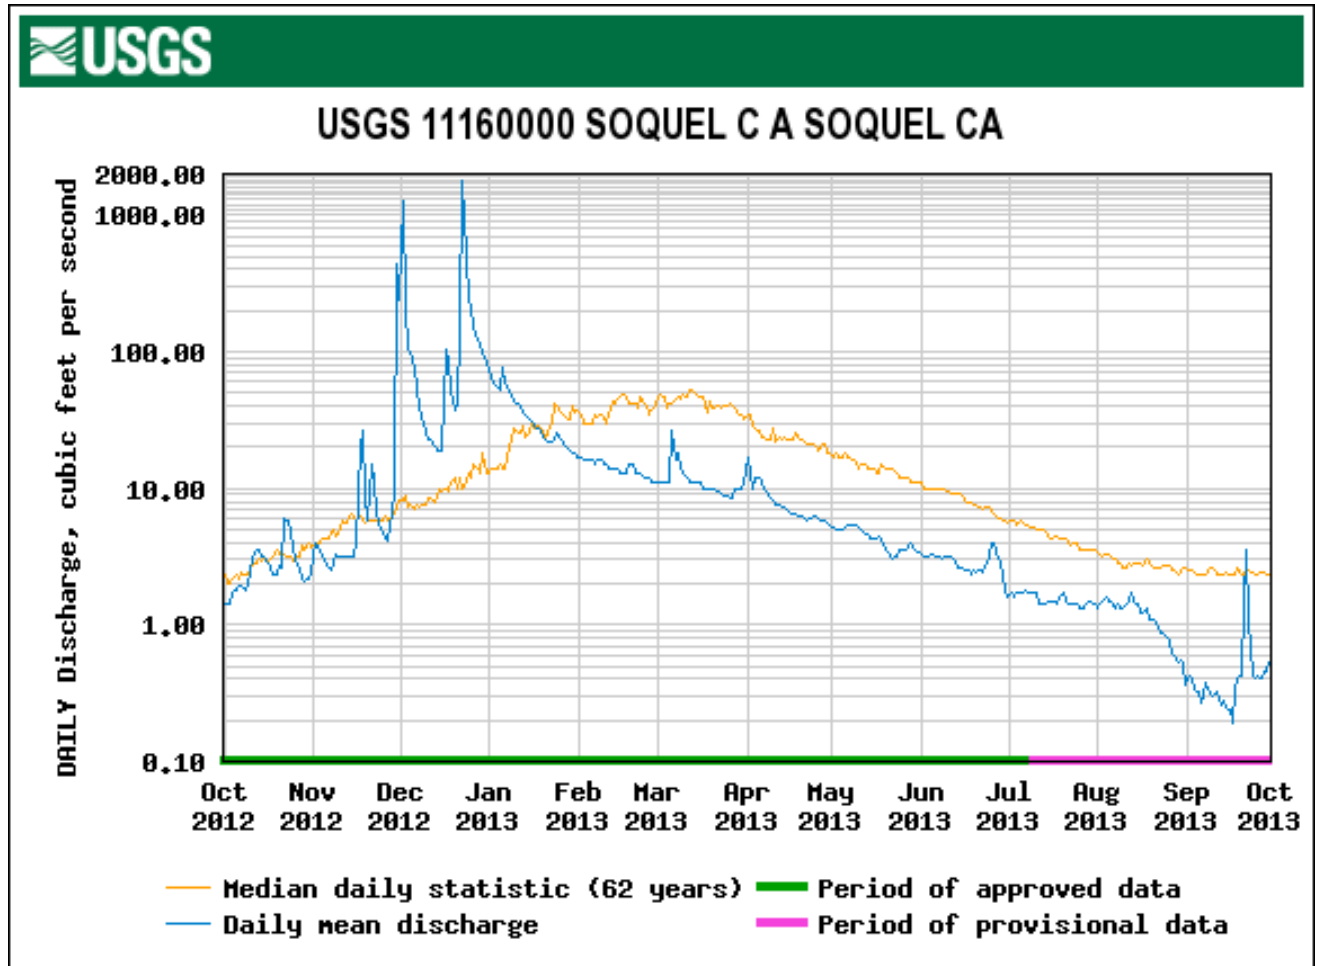
Figure 25. Soquel Creek Actual Streamflow Hydrograph for the USGS Gage in Soquel, CA, October 2012 – May 2013.

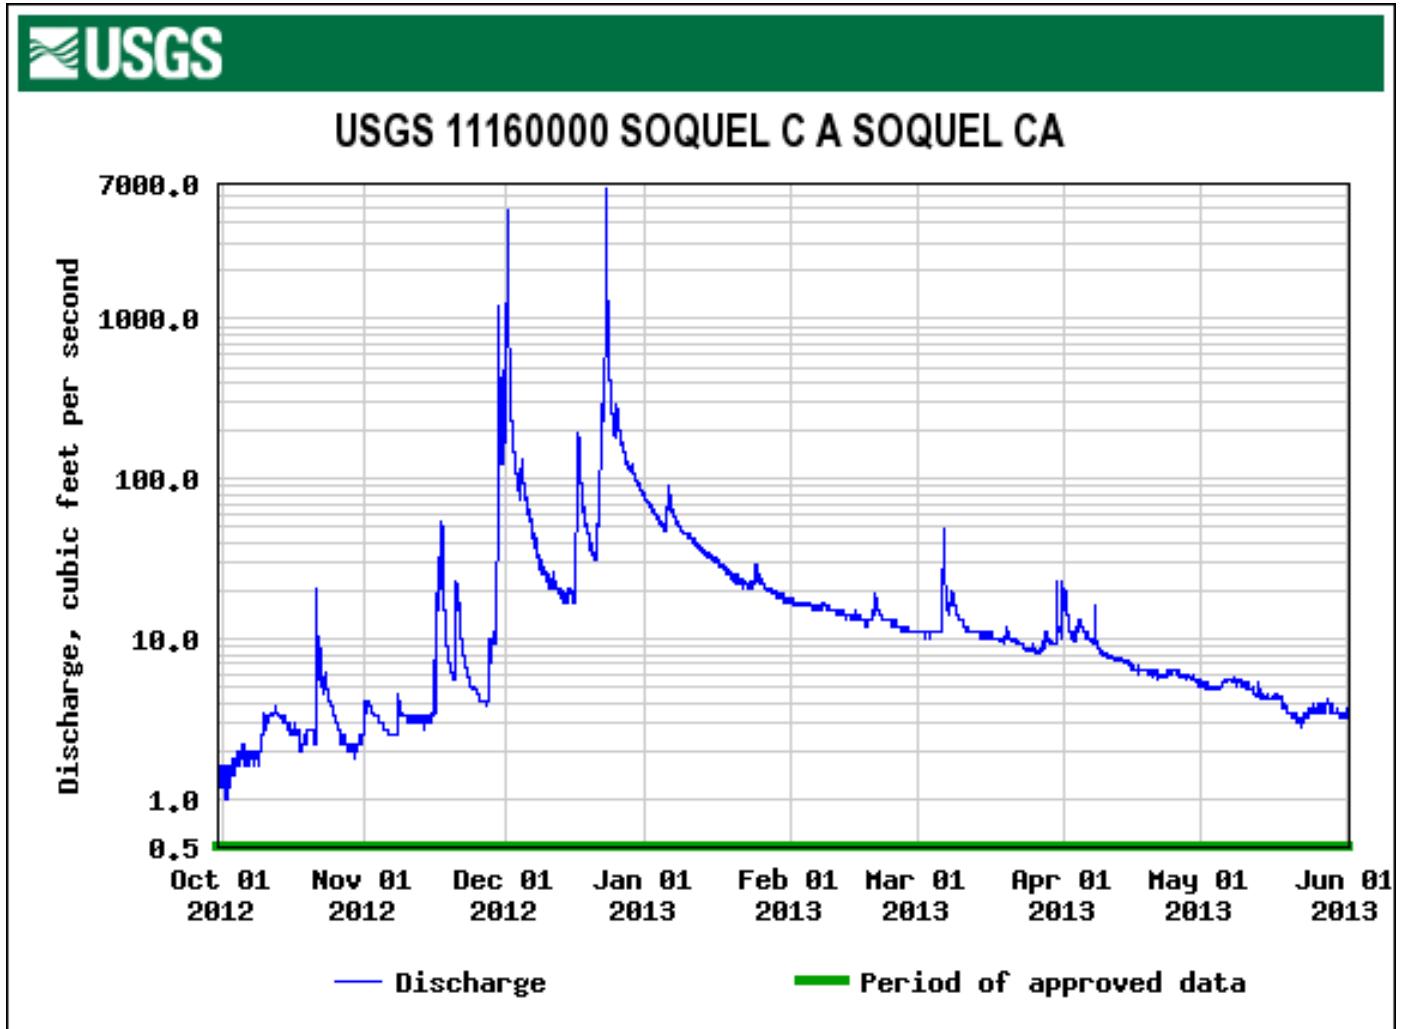
Figure 26. Soquel Creek Mean Daily Streamflow Hydrograph for the USGS Gage in Soquel, CA, 15 May 2013 – 11 February 2014.

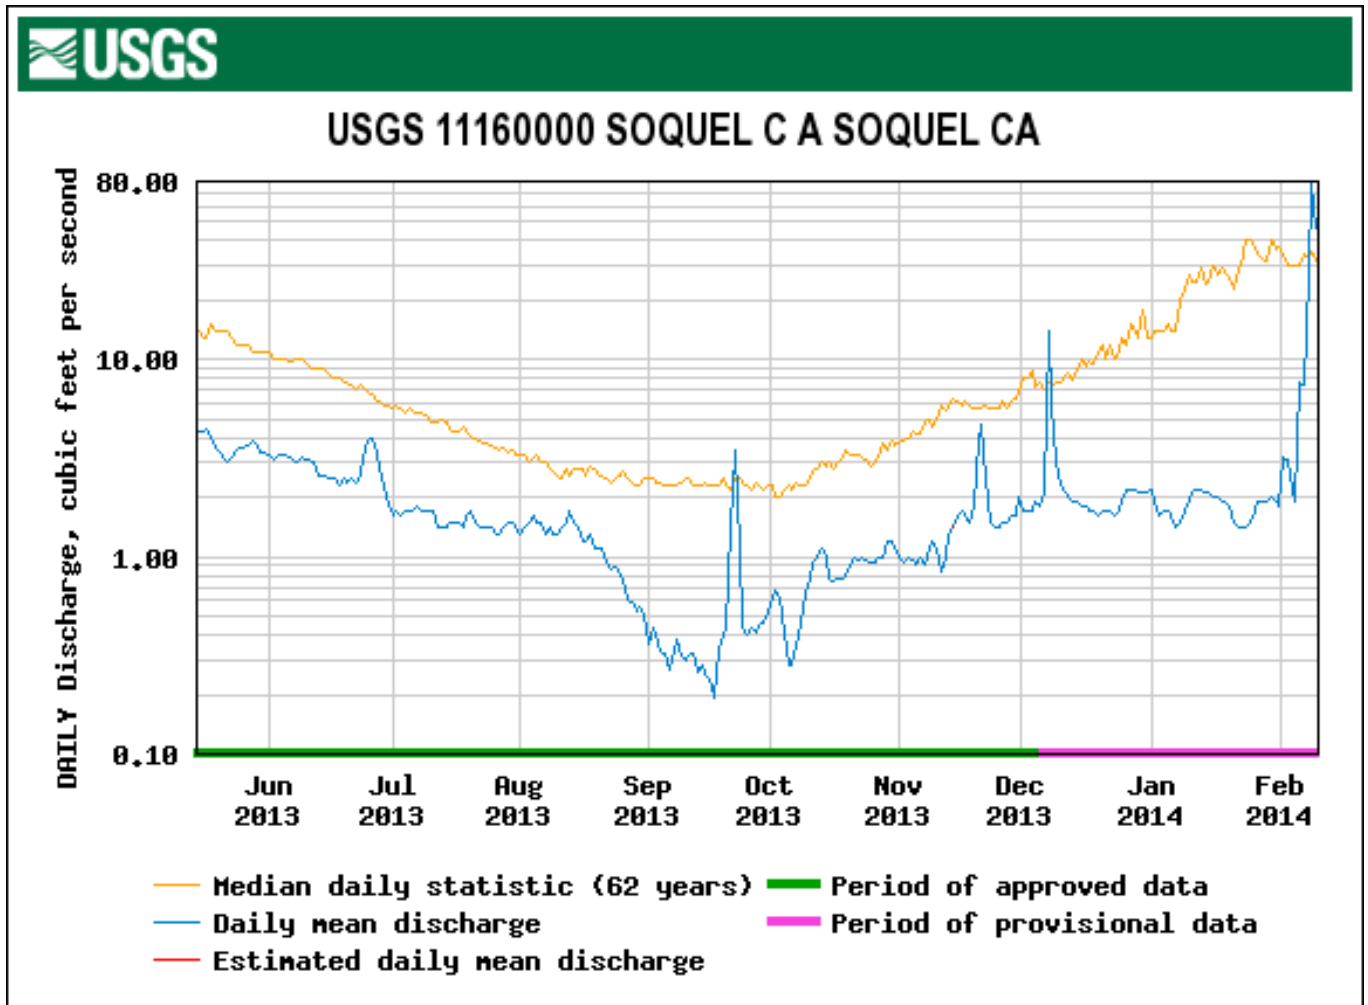
Figure 27. Soquel Creek Actual Streamflow Hydrograph for the USGS Gage in Soquel, CA, 15 May 2013 – 11 February 2014.
