Soquel Lagoon Monitoring Report- 2014

**CITY OF CAPITOLA
420 Capitola Avenue
Capitola, California 95010**

January 2015

Project # 106-24

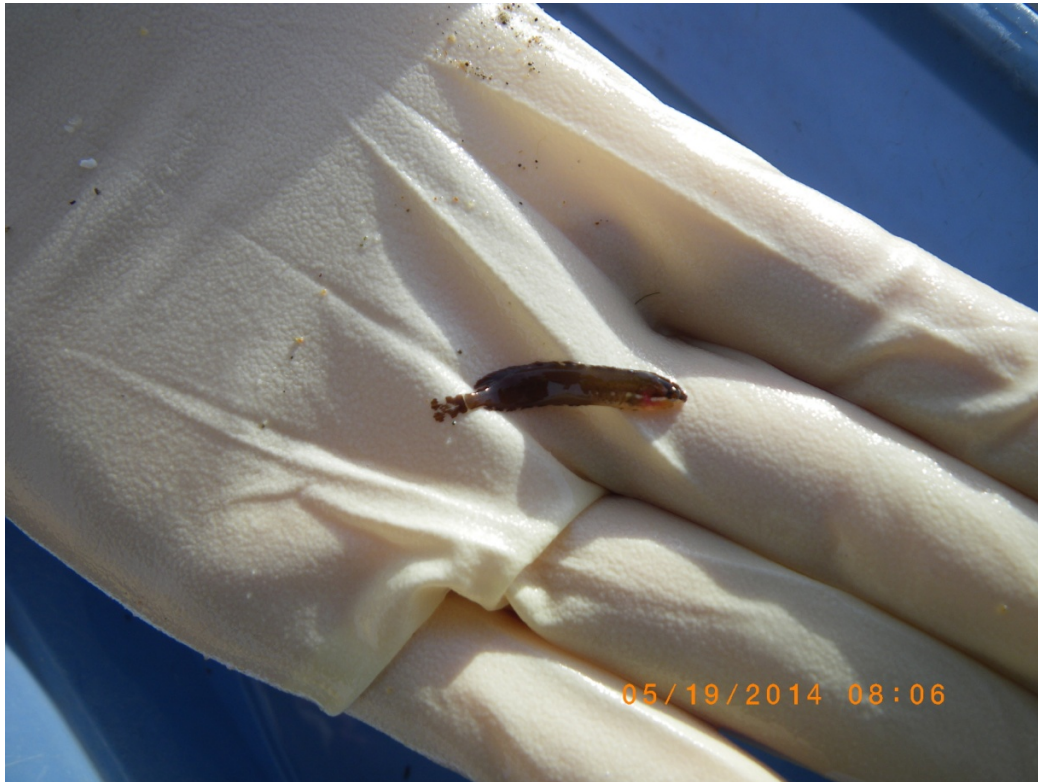
Kelpfish captured on 19 and 20 May 2014

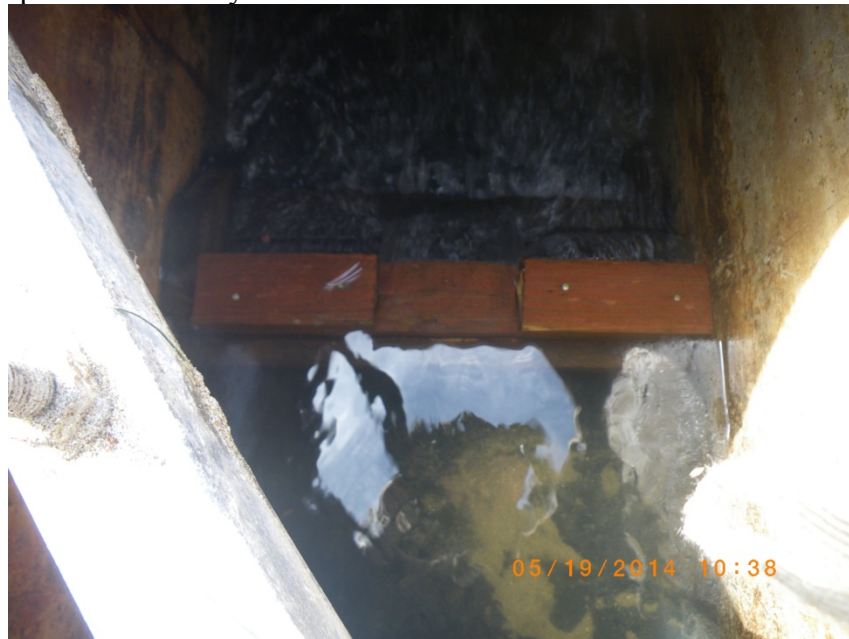
Reconstructed Weir Inside the Flume, 19 May 2014

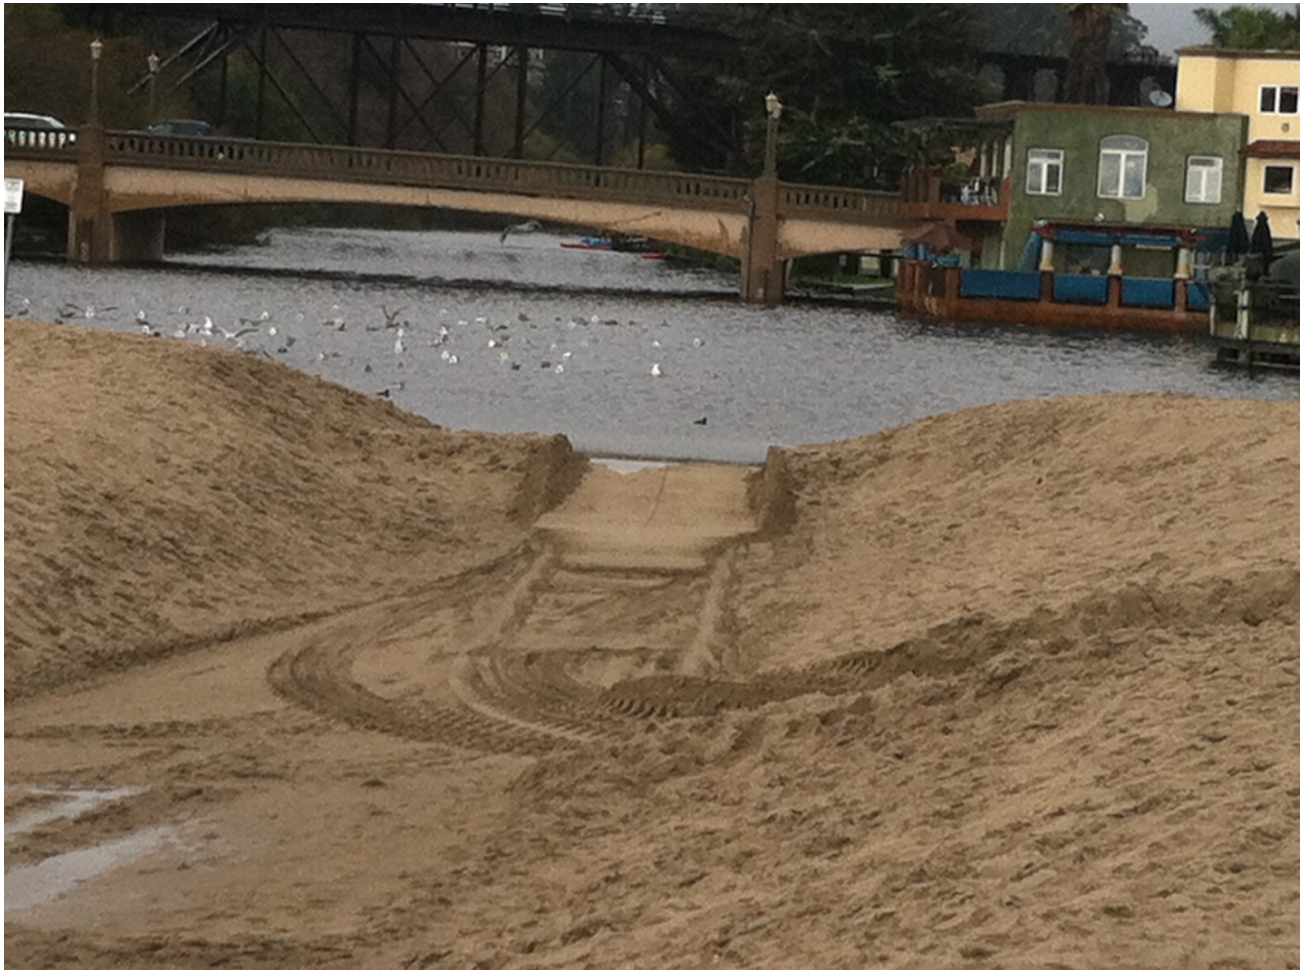
Inner Berm being overtopped at 1115 hr on 30 November 2014

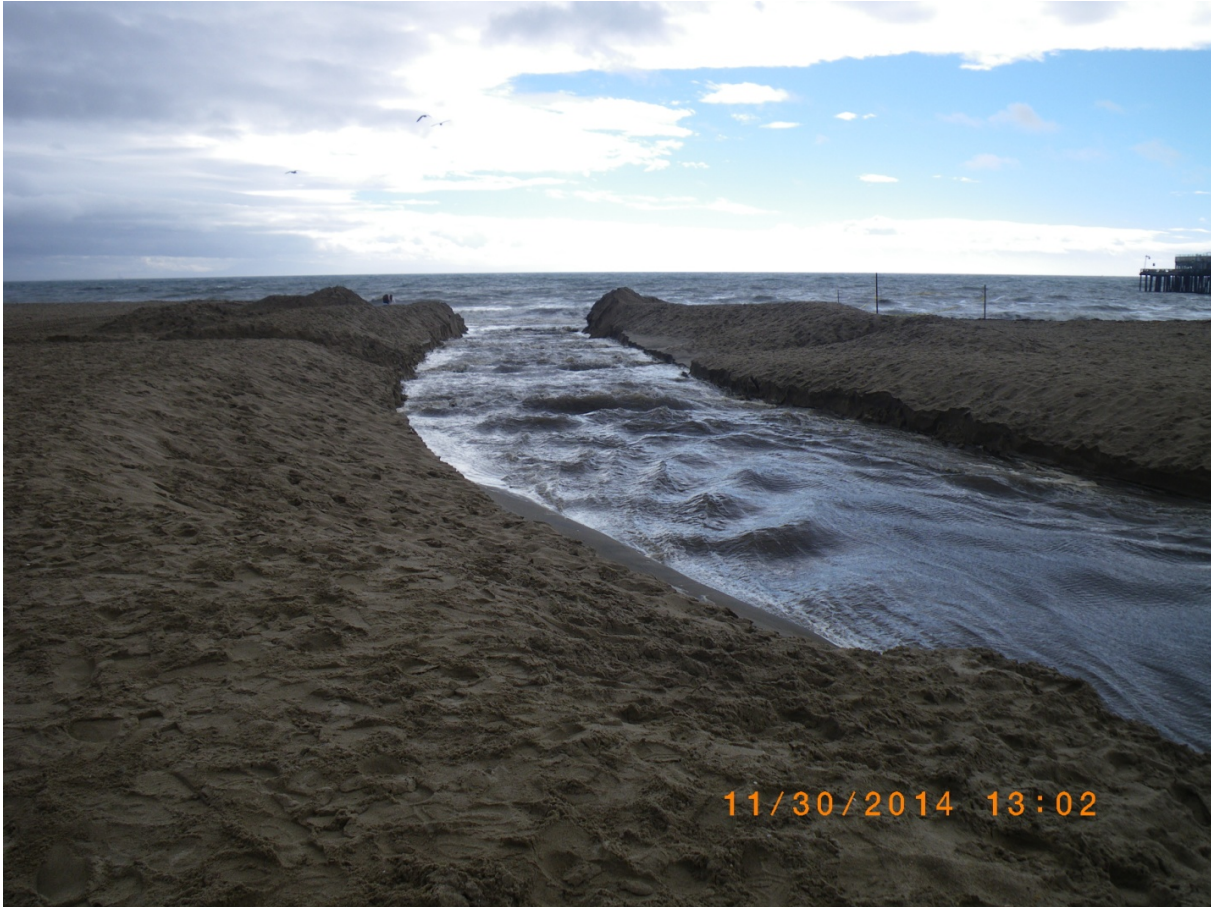
Outlet channel through beach after an emergency breach on 30 November 2014.
(Time printed on the photo was 1 hour later than the actual time of 1202 hr.)

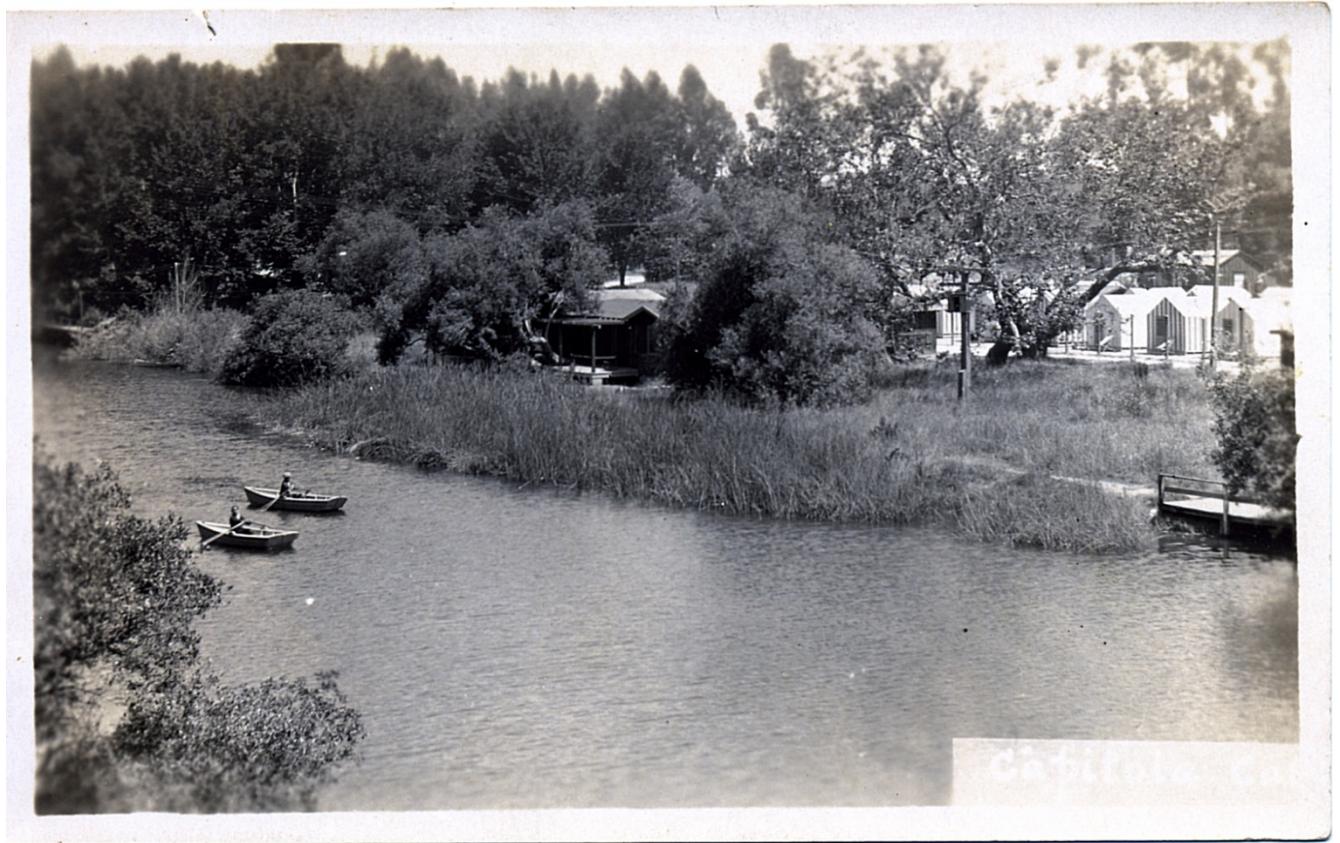
The historical lagoon had large tule beds prior to construction of the bulkheads following the 1955 flood. Tules are commonly used in managed wetlands to remove nutrients and other pollutants from wastewater effluent. Re-establishment of tule marsh in Soquel Lagoon would reduce nutrient pollution and may reduce bacterial counts. Tule re-establishment would also provide fish habitat in Soquel Lagoon.

Capitola's Soquel Lagoon with tule marsh.
(circa 1927; Provided by the Capitola Historical Museum.)

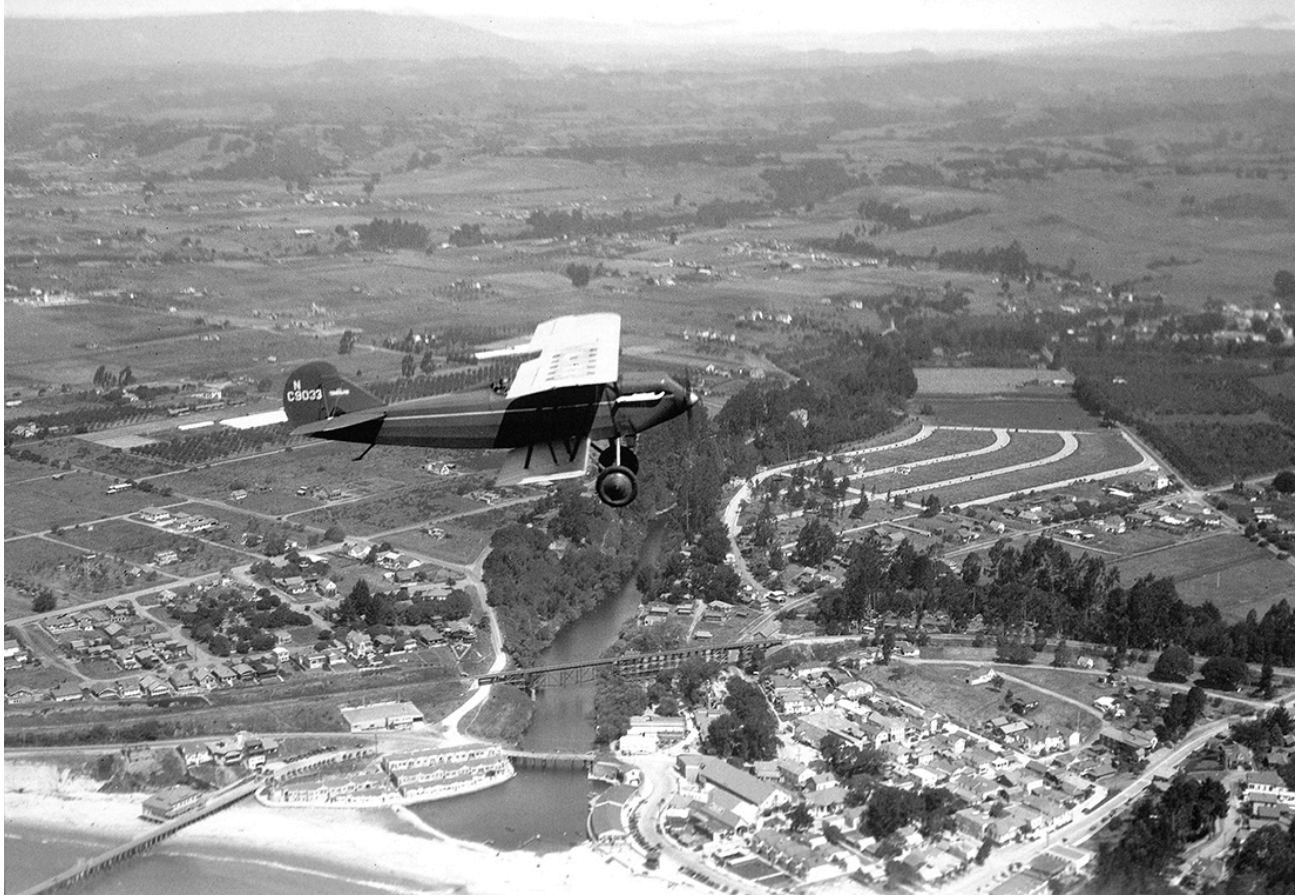
Soquel Lagoon Post-Venetian Court Construction- Older Stockton Avenue Bridge and prior to expanded development on eastern margin of the Lagoon, above and below the Railroad Trestle; circa 1931.
(Courtesy of the Capitola Historical Museum)

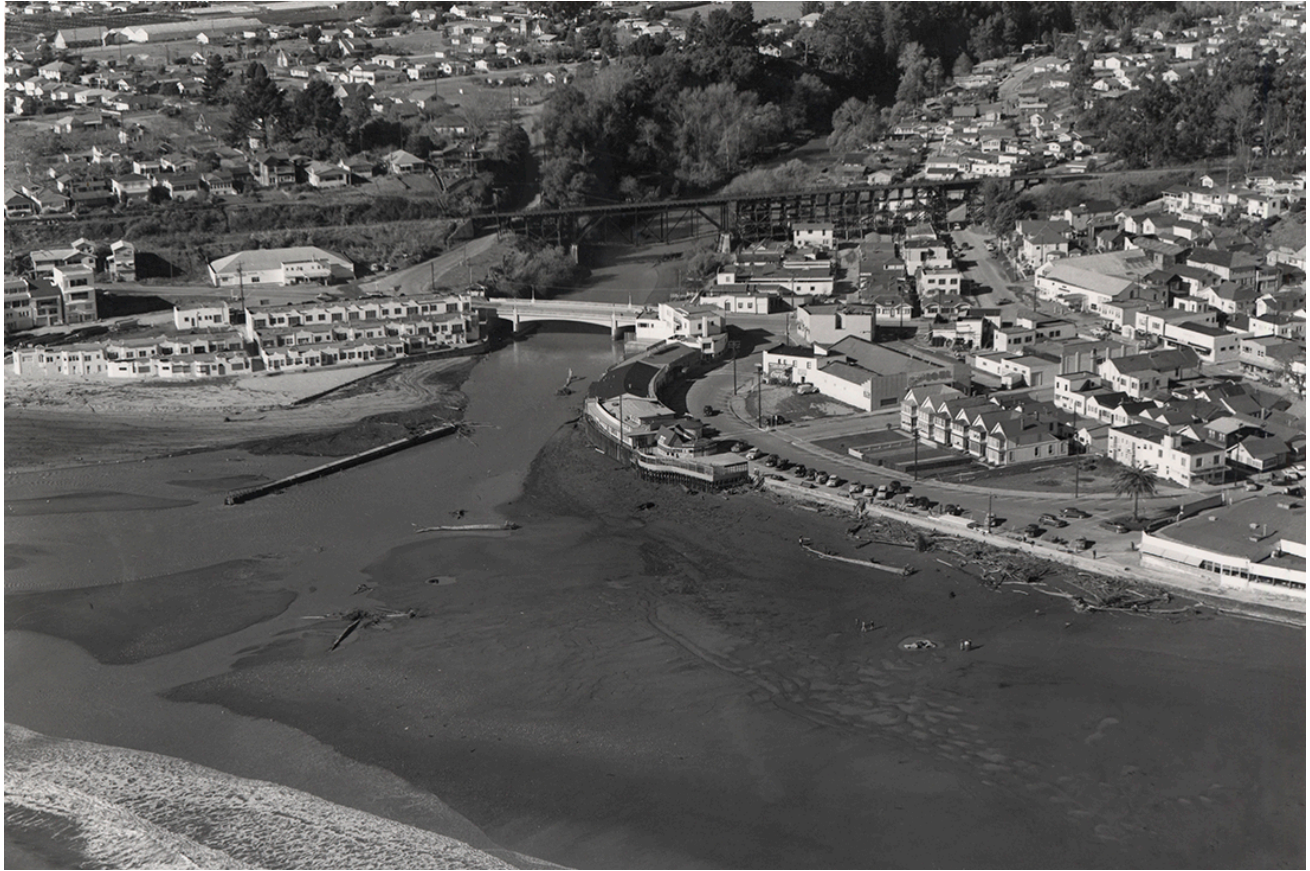
Post-World War II Soquel Creek Estuary at very low tide (present-day Stockton Bridge with flume exposed on the beach after the December 1955 flood). Riparian corridor re-established on west side above Stockton Bridge since 1931 photo; circa 1955-56 after the flood.
(Courtesy of the Capitola Historical Museum)

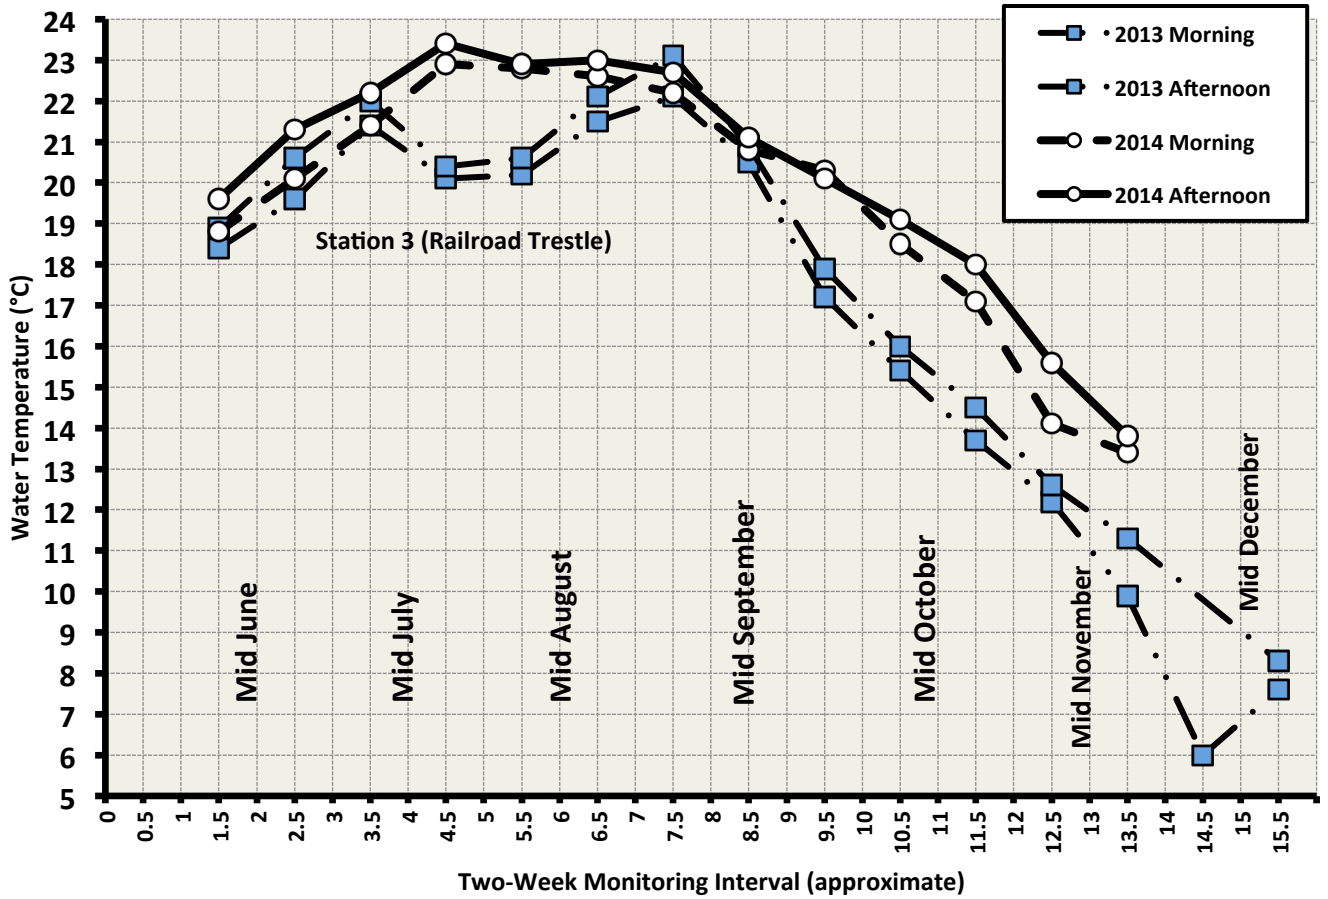
Figure 3c. 2013 and 2014 Soquel Lagoon Water Temperature at the Railroad Trestle (Station 3) Near the Bottom at Dawn and in the Afternoon after 1500 hr for June– Mid December.
