## **Soquel Lagoon Monitoring Report- 2016**

**Prepared by D.W. ALLEY & Associates, Aquatic Biology**

**CITY OF CAPITOLA  
420 Capitola Avenue  
Capitola, California 95010**

**January 2017**

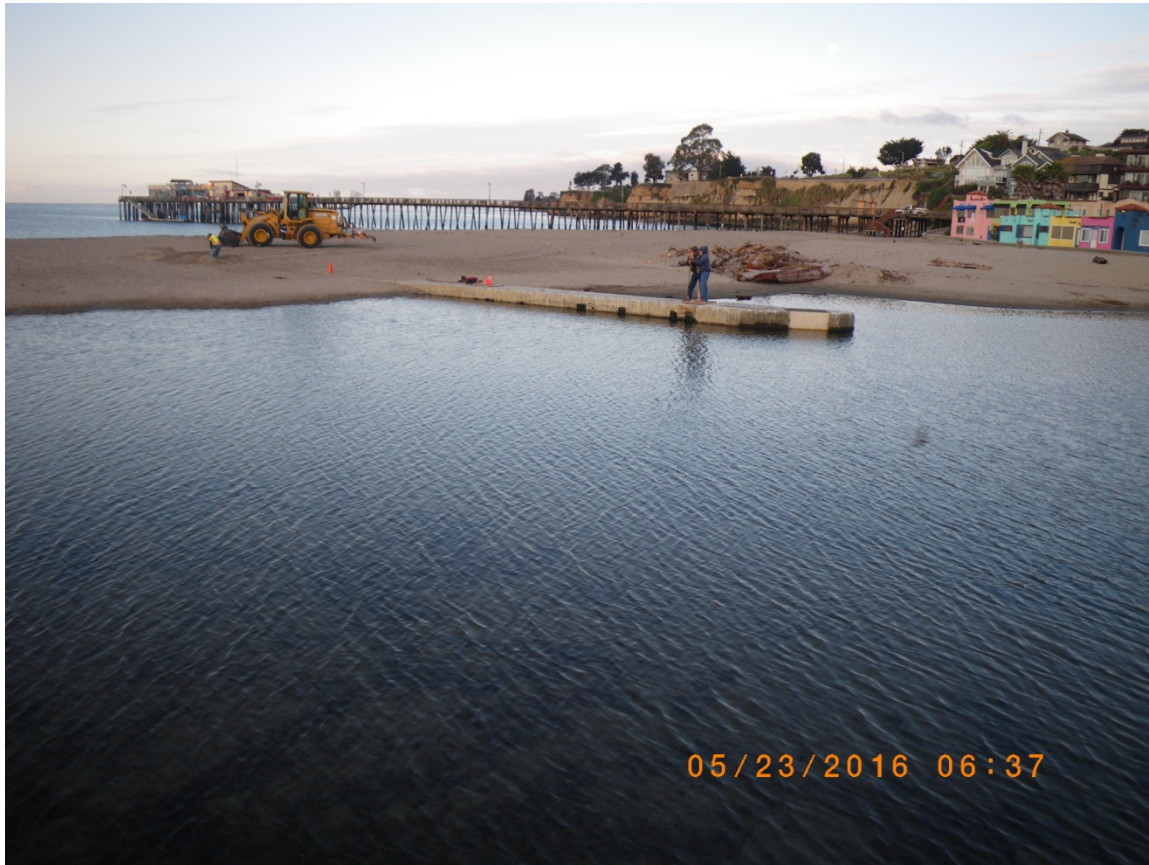
23 May 2016

Soquel Estuary and flume inlet before construction activities began.

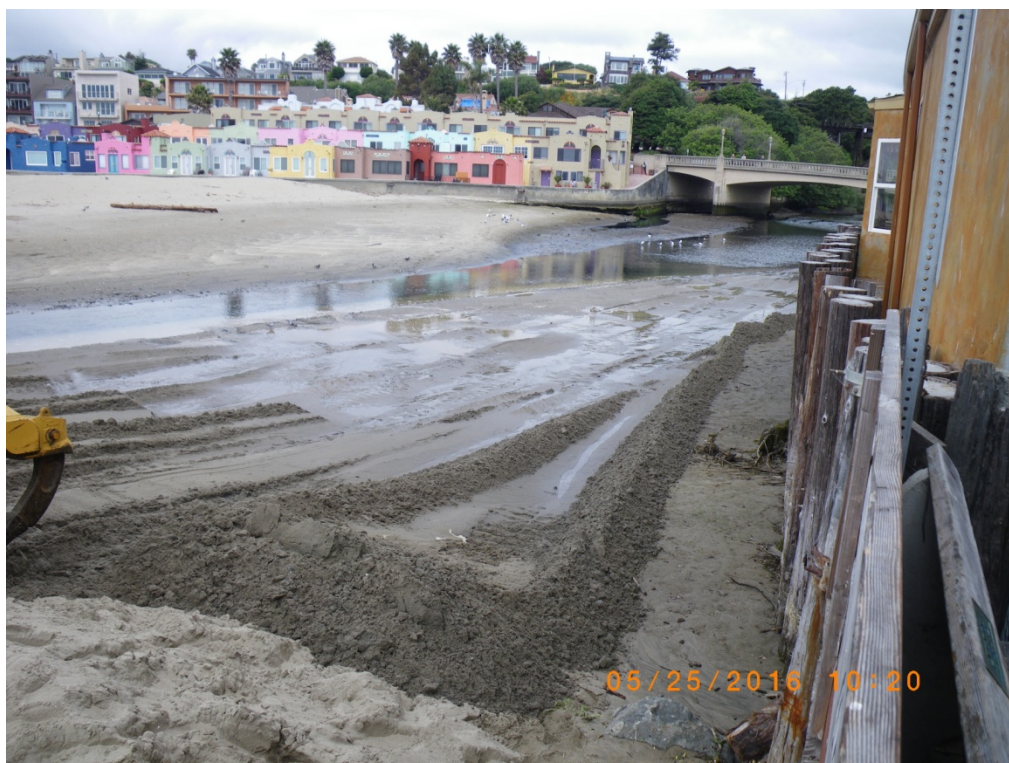
Lagoon deepened adjacent to restaurants (work done above estuary water surface)  
25 May 2016

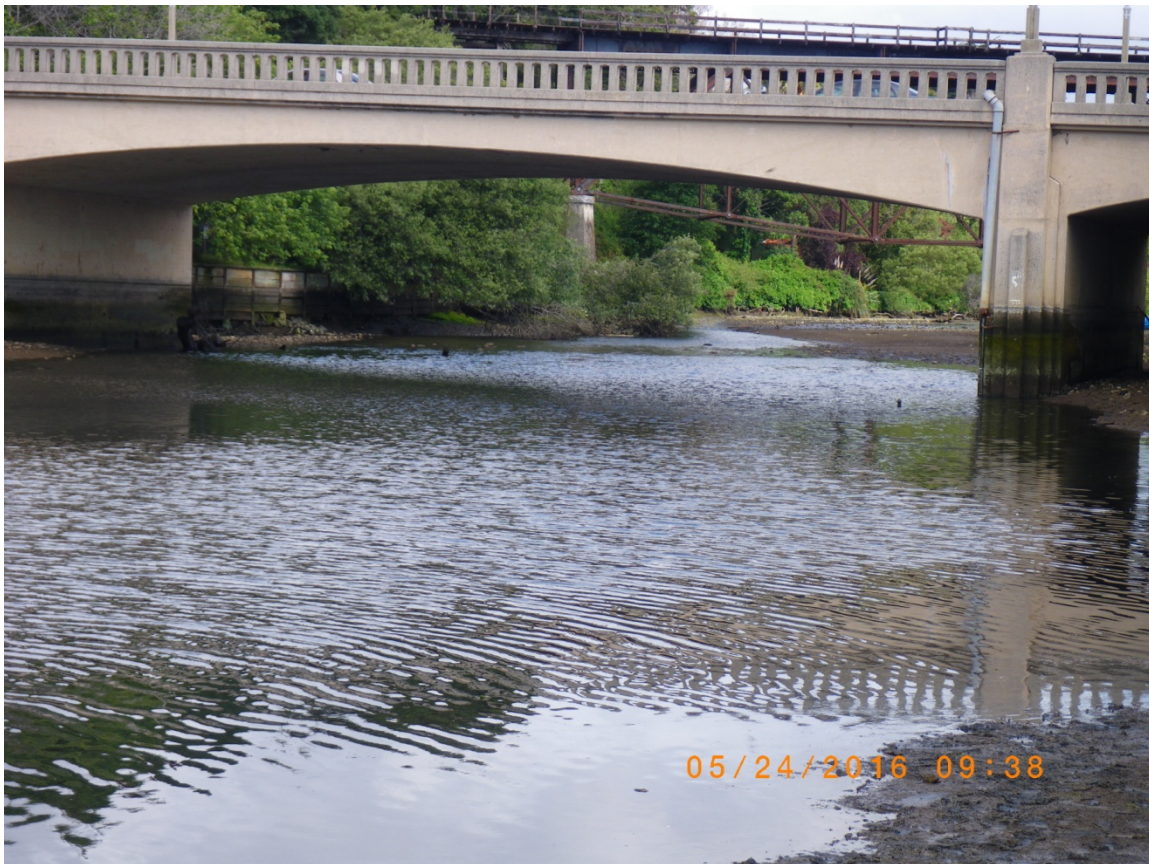
Slackwater pool between Stockton Bridge and railroad trestle (with overhanging willows) during artificial estuary fluctuation 24 May 2016

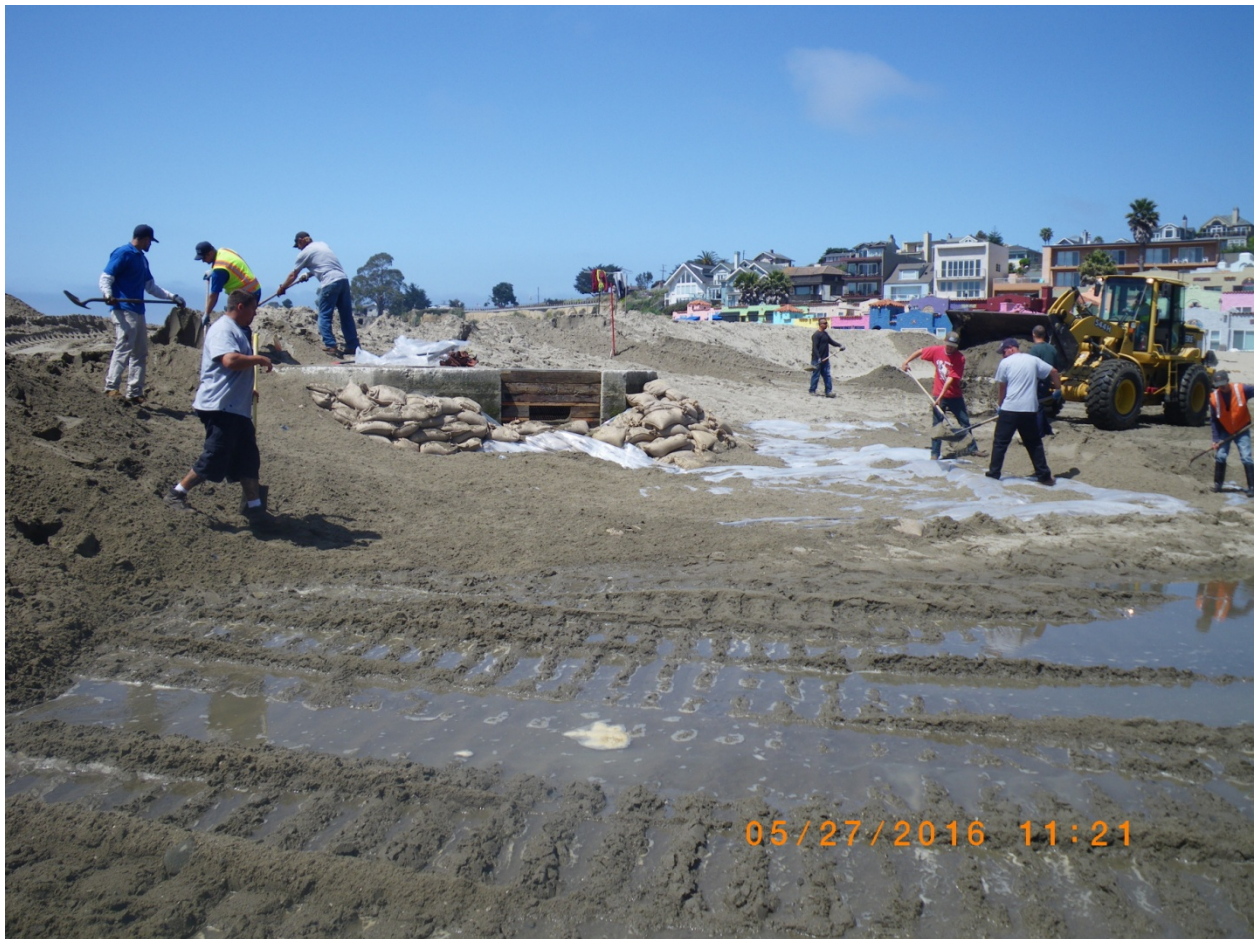
Preparation of the flume inlet.

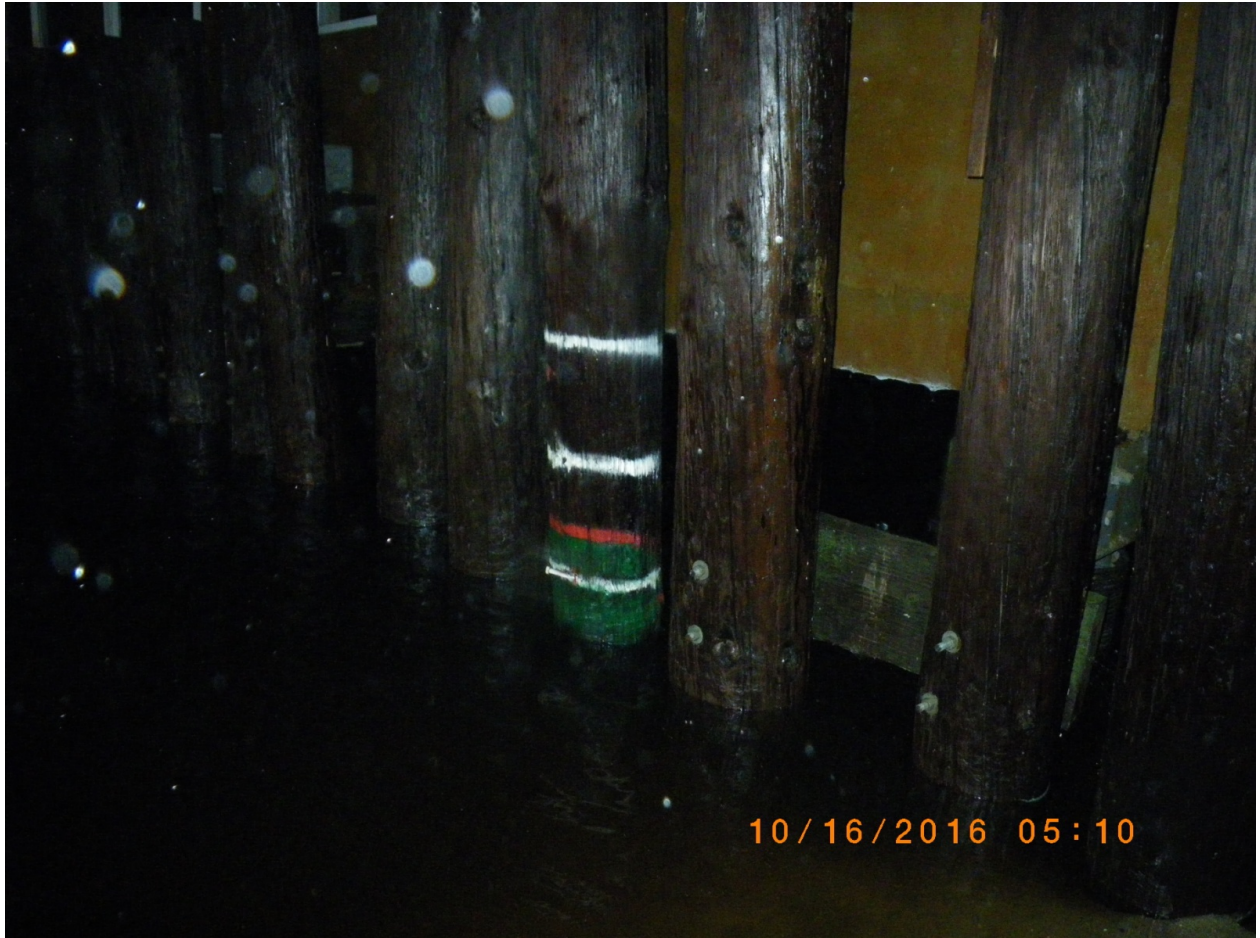
Lagoon water surface shortly after the facilitated breach (red line indicated point of flooding).  
16 October 2016

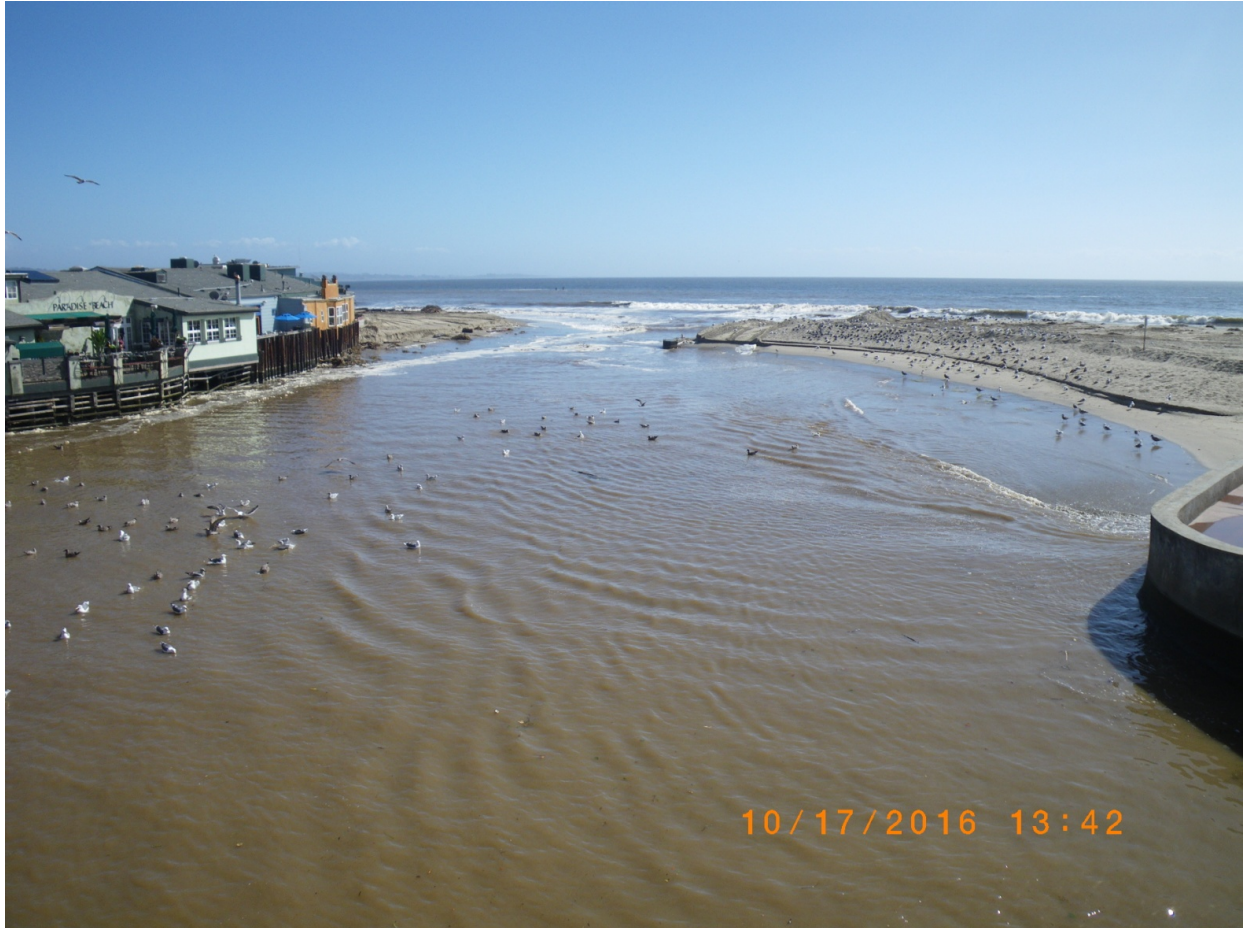
Open creekmouth the day after the facilitated breach.

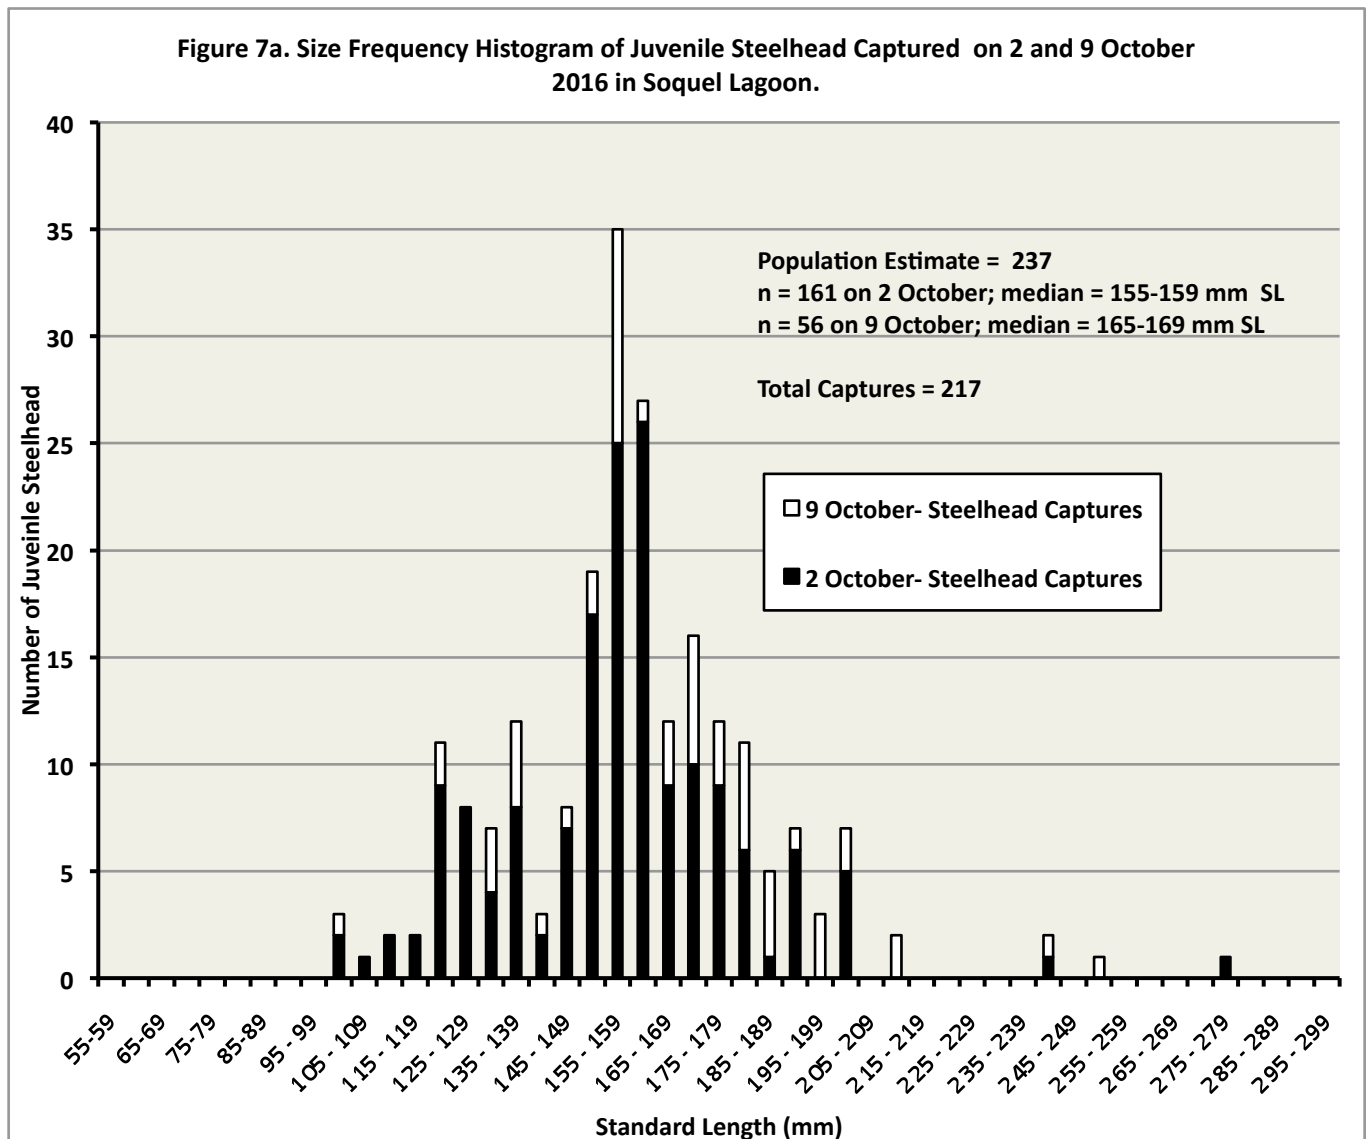
**Figure 7a.** Size Frequency Histogram of Juvenile Steelhead Captured on 2 and 9 October 2016 in Soquel Lagoon.
