Soquel Lagoon Monitoring Report- 2018

CITY OF CAPITOLA, 420 Capitola Avenue, Capitola, California 95010

January 2019

Project # 106-28

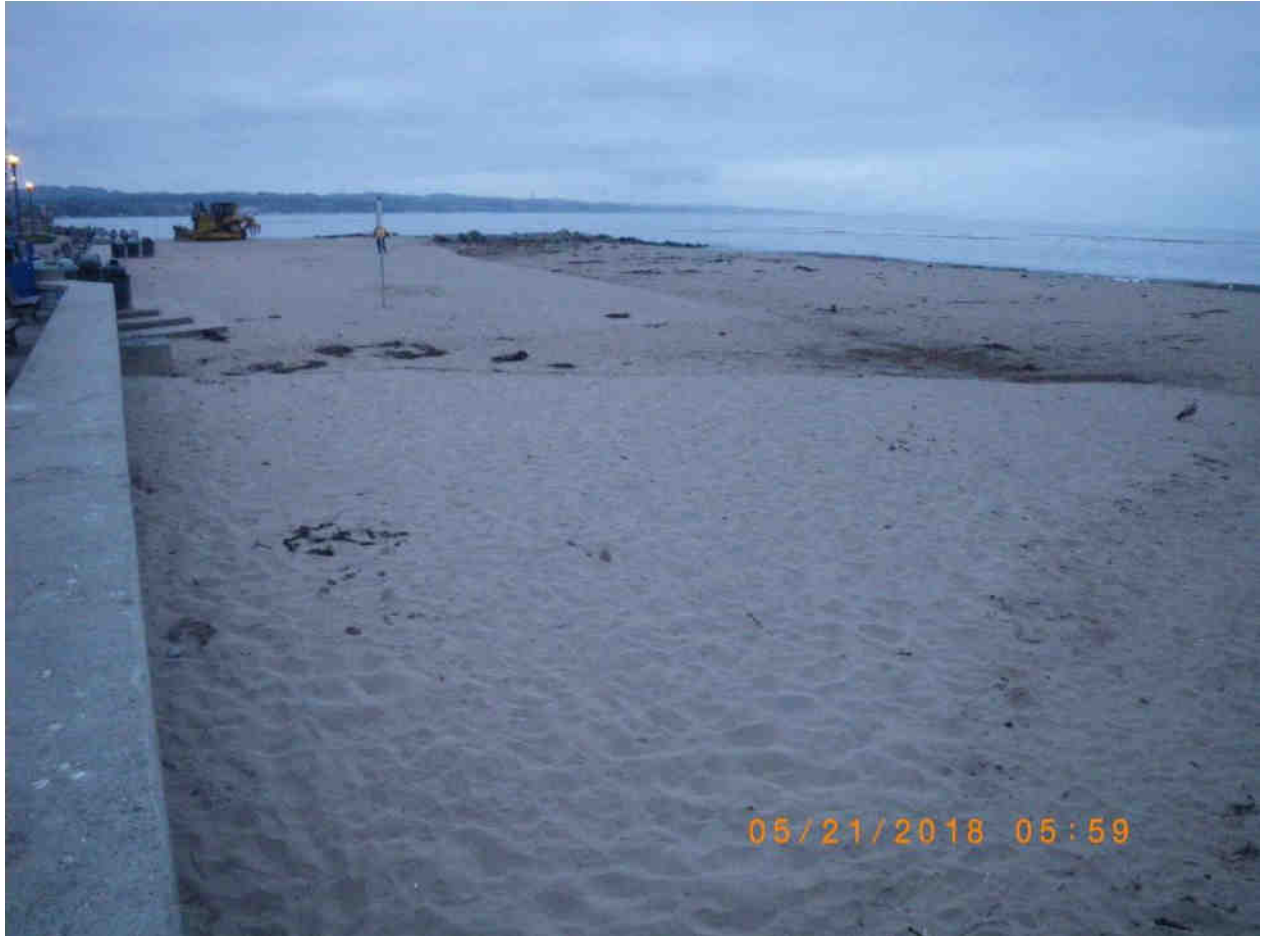
Naturally filled-in lateral channel adjacent seawall.
21 May 2018

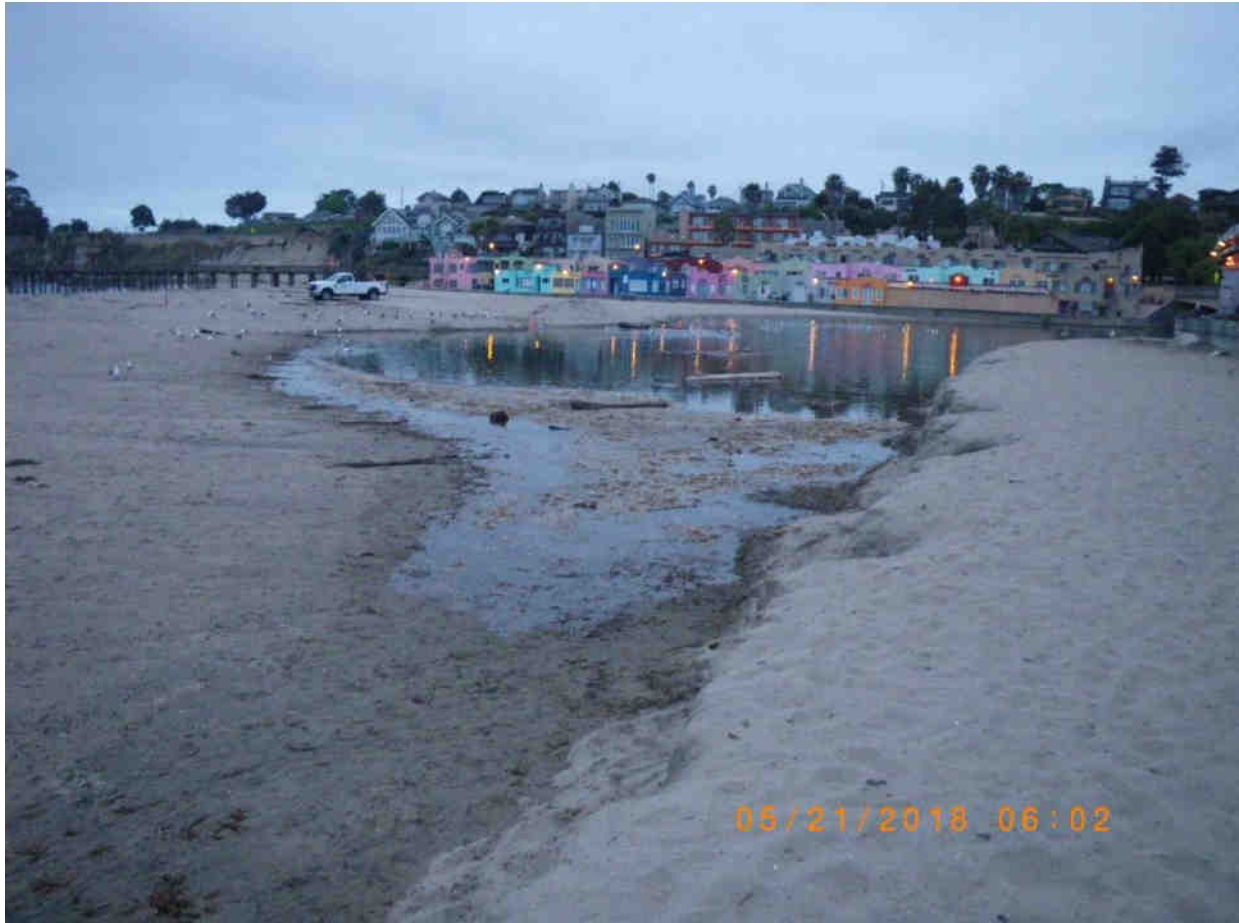
Soquel Lagoon prior to sandbar construction.
21 May 2018

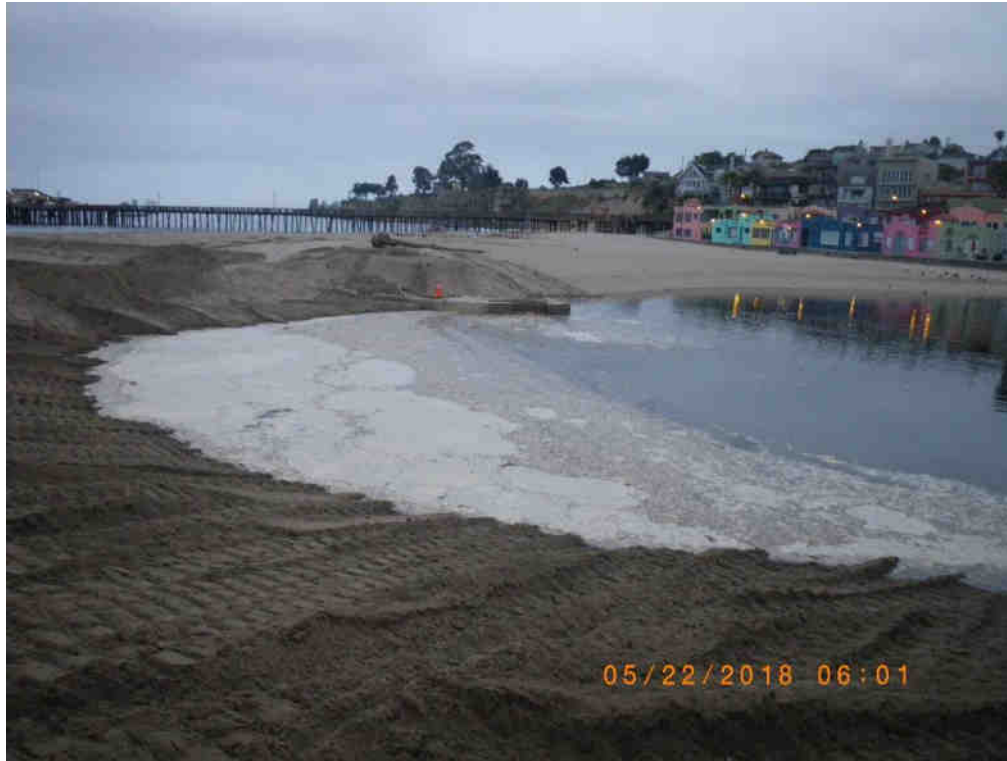
Sandbar around lagoon intact overnight. Lagoon partially full. Fish passage through underwater portal in flume inlet. 22 May 2018

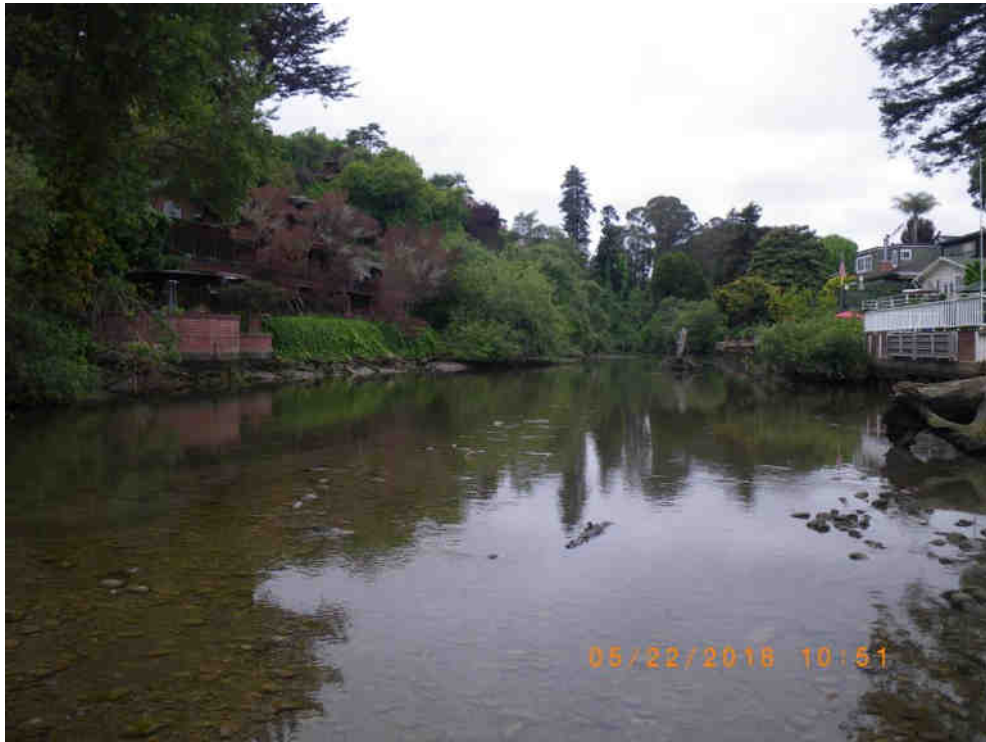
Estuary looking upstream from Noble Gulch past Shadowbrook Restaurant at estuary drawdown. 22 May 2018

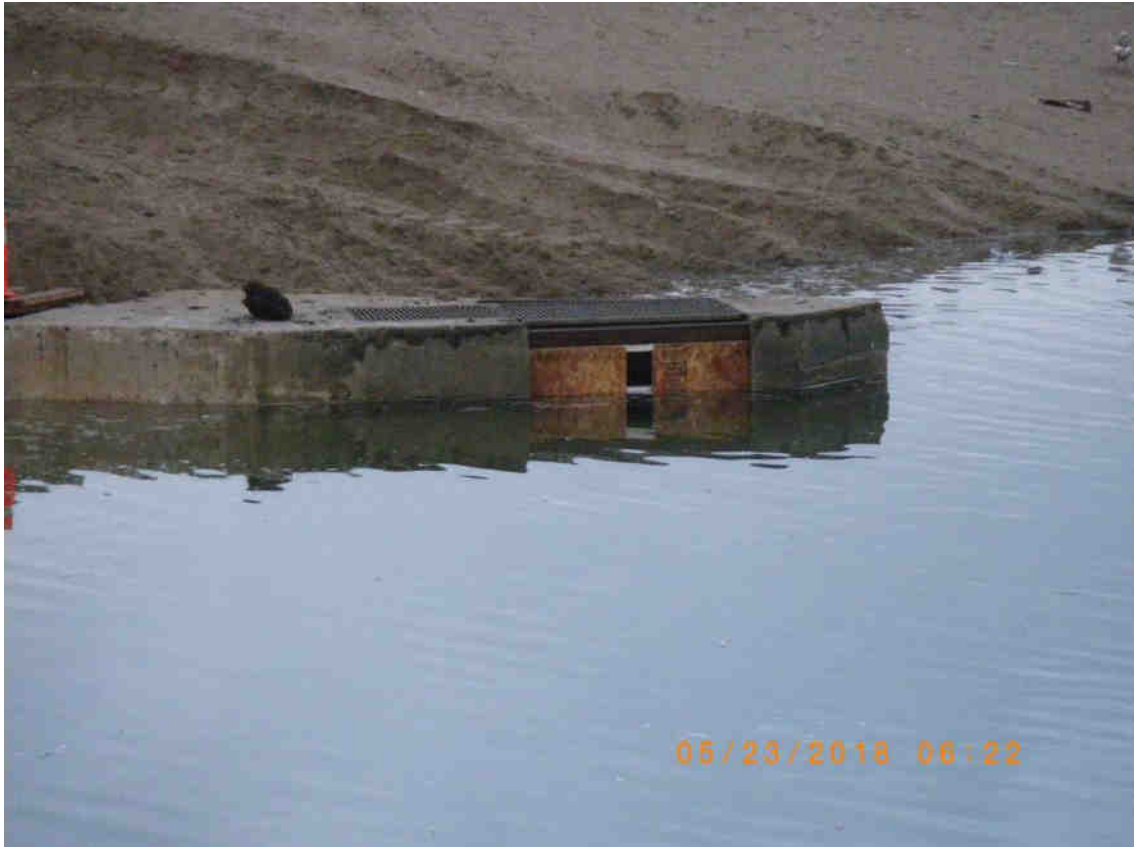
Sandbar intact overnight with lagoon partially full and no fish passage overnight.
23 May 2018

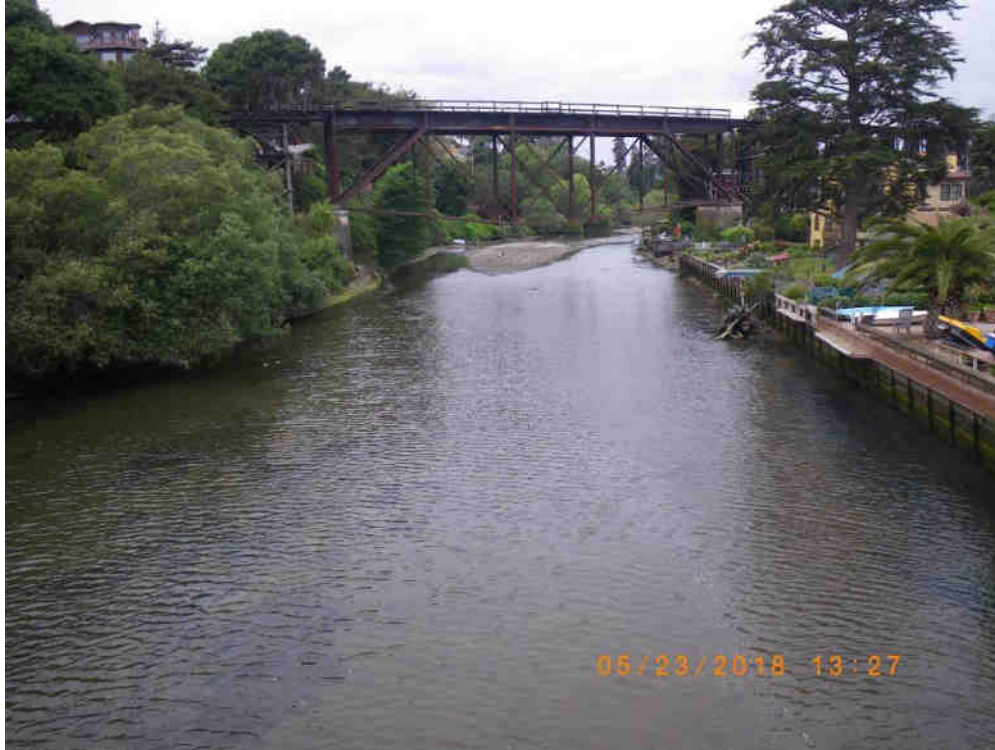
Lagoon looking upstream from Stockton Bridge with mid-channel bar visible upstream of the trestle, shortly after sandbar closure. 23 May 2018

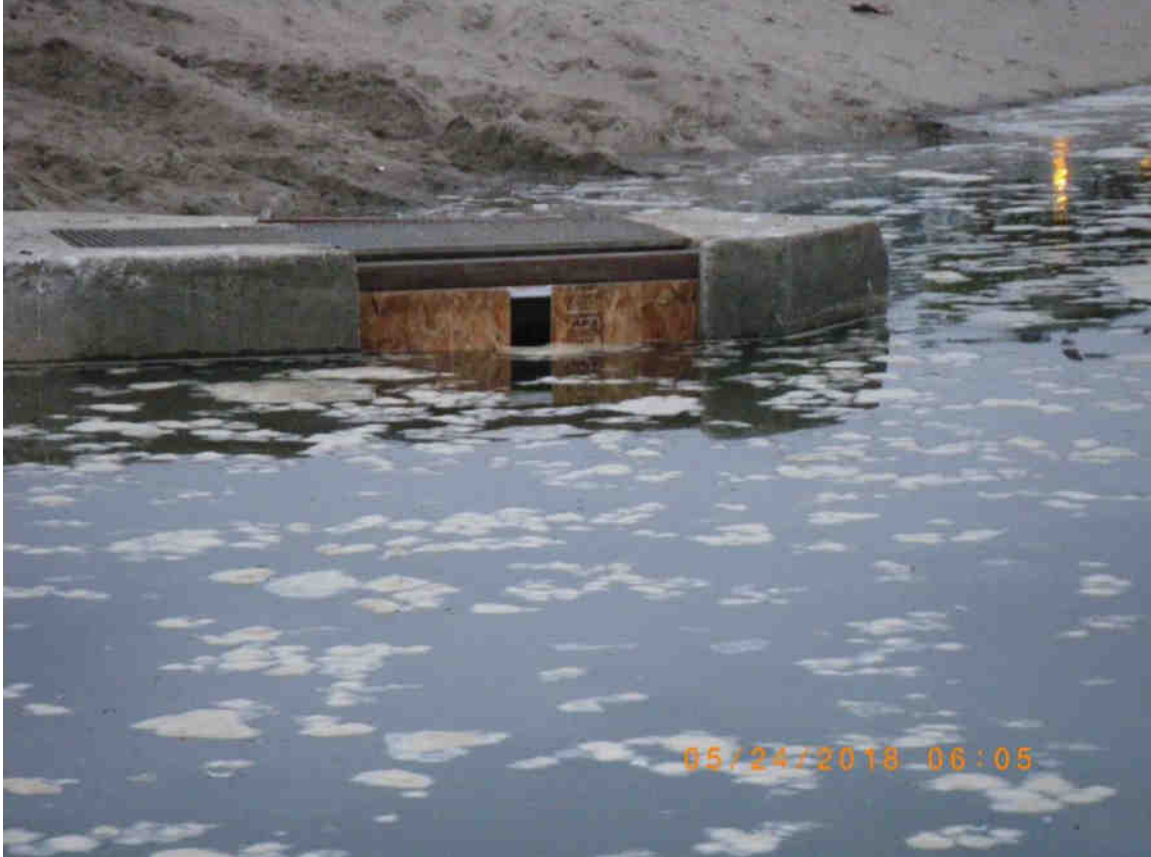
Lagoon partially filled overnight to provide steelhead smolt passage. 24 May 2018

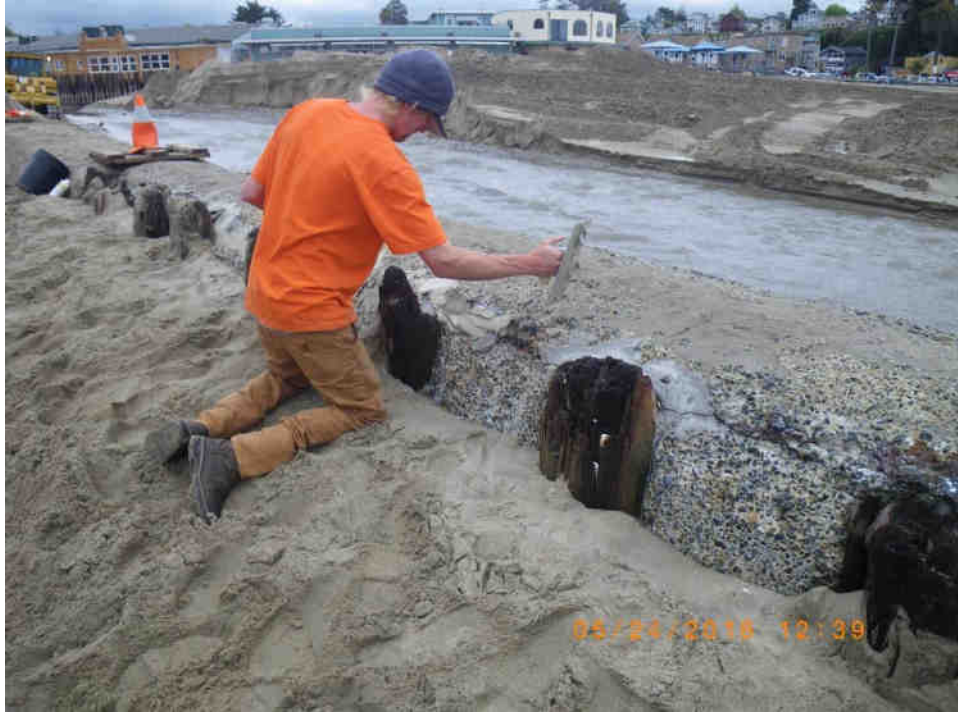
Public Works Maintenance Worker, Cooper Sanden, filling cracks in the flume. 24 May 2018

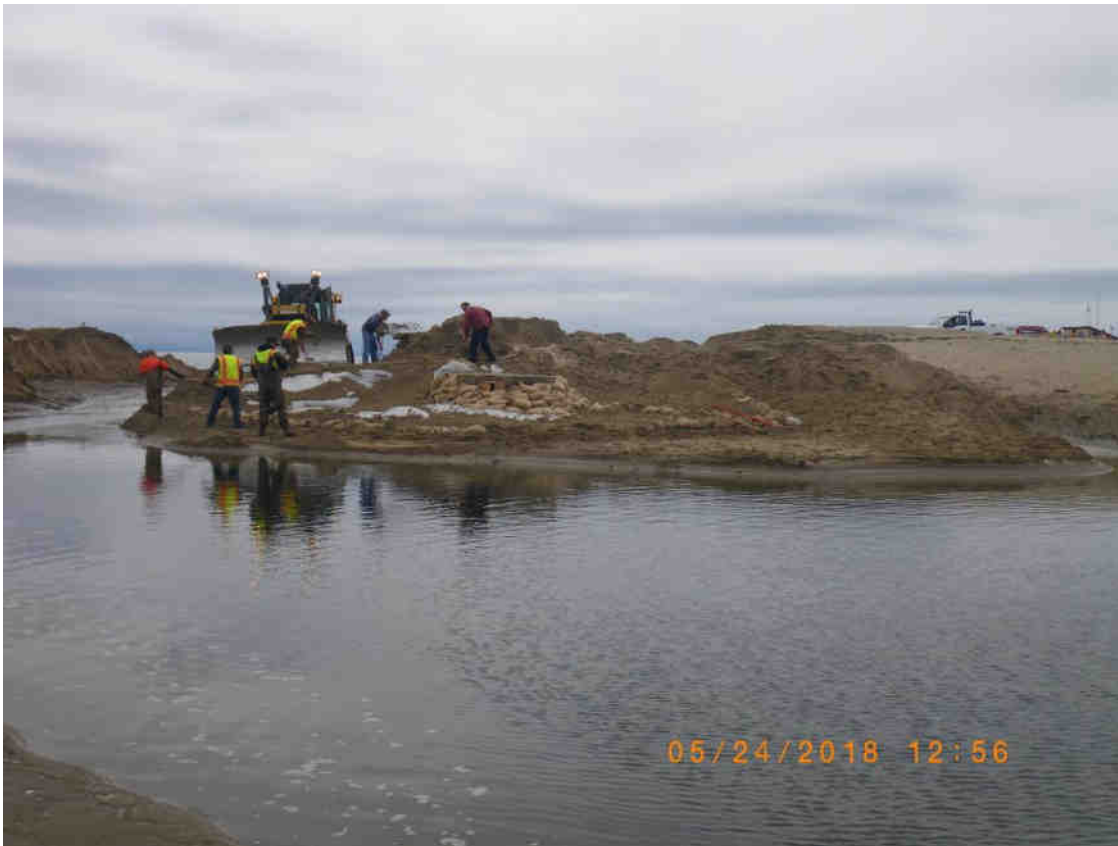
Flume inlet preparation prior to final sandbar closure for summer. 24 May 2018

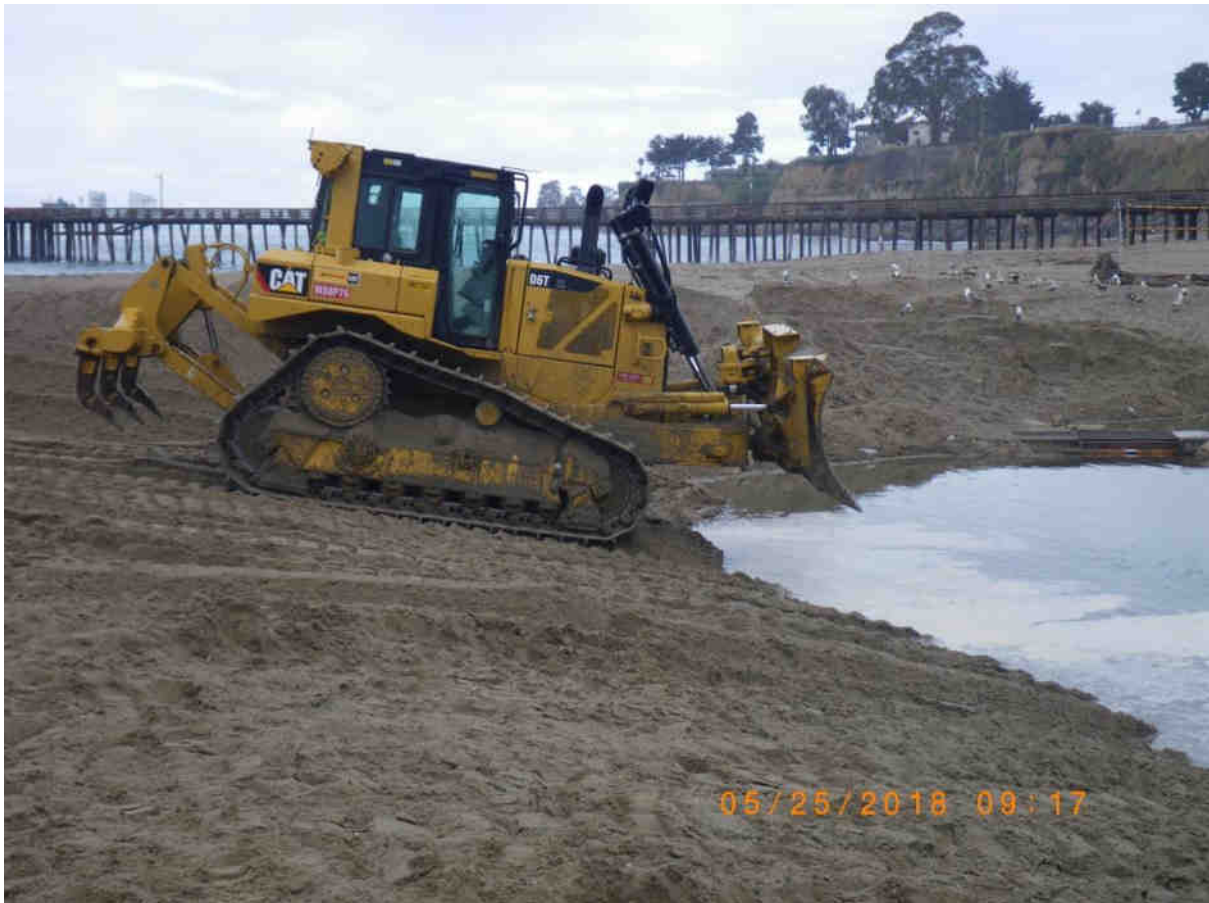
Public Works Heavy Equipment Operator, Matt Kotila, compacts lagoon margin with bull-dozer.
25 May 2018

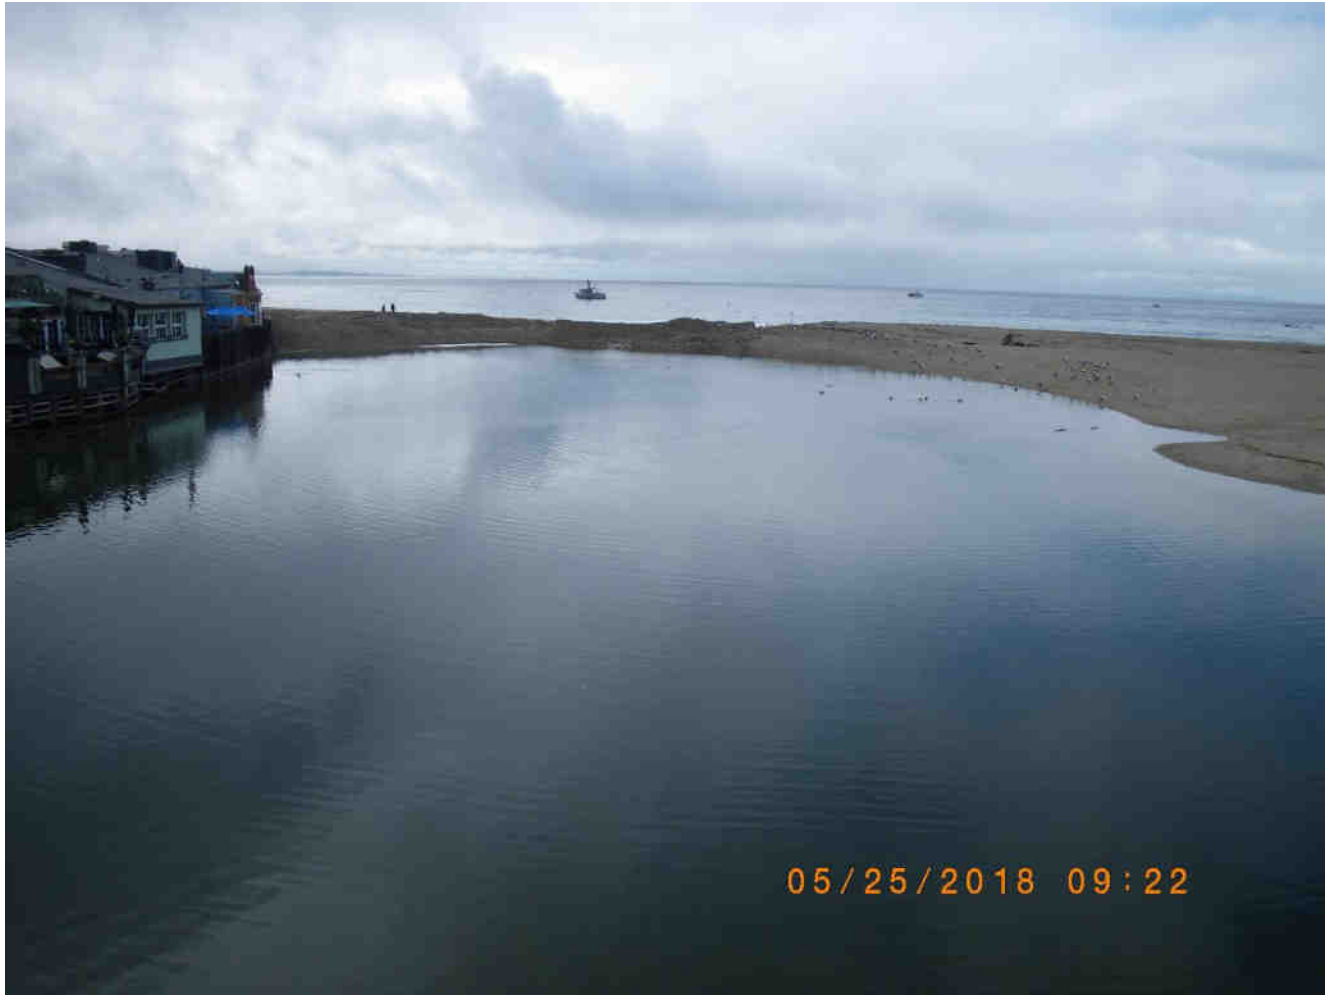
Lagoon periphery near the beach on 25 May 2018, after final seasonal sandbar closure the previous day.

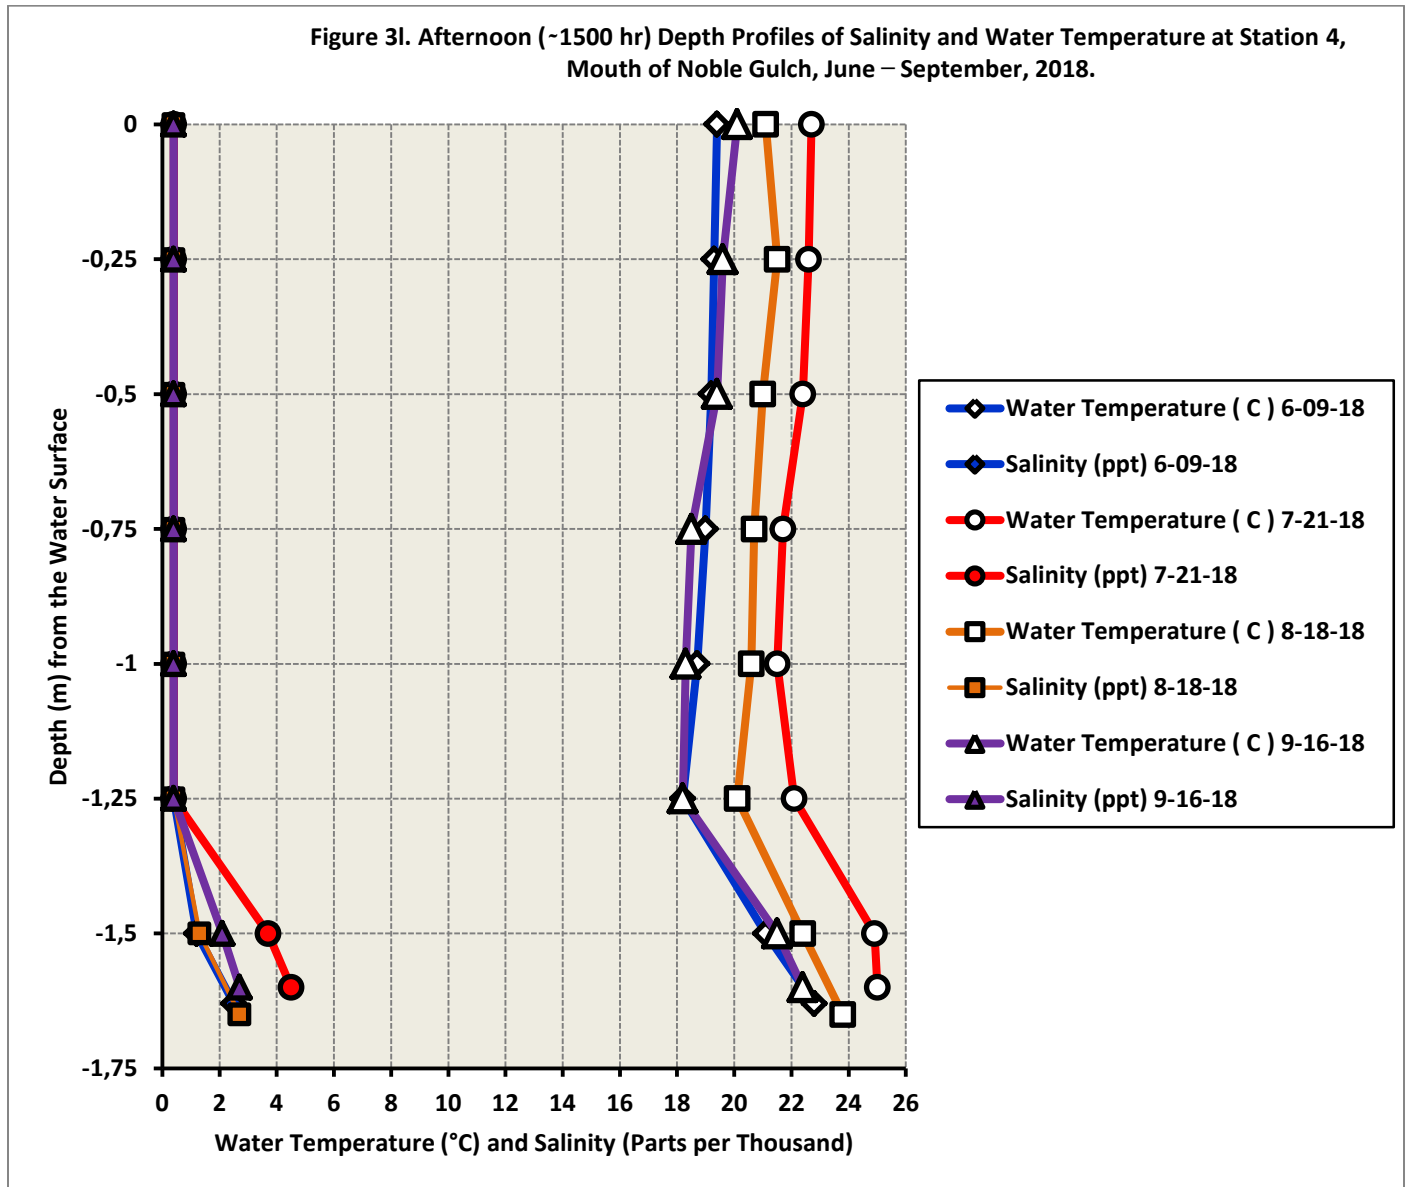
Figure 3I. Afternoon Depth Profiles of Salinity and Water Temperature at Station 4, Mouth of Noble Gulch, June – September, 2018.

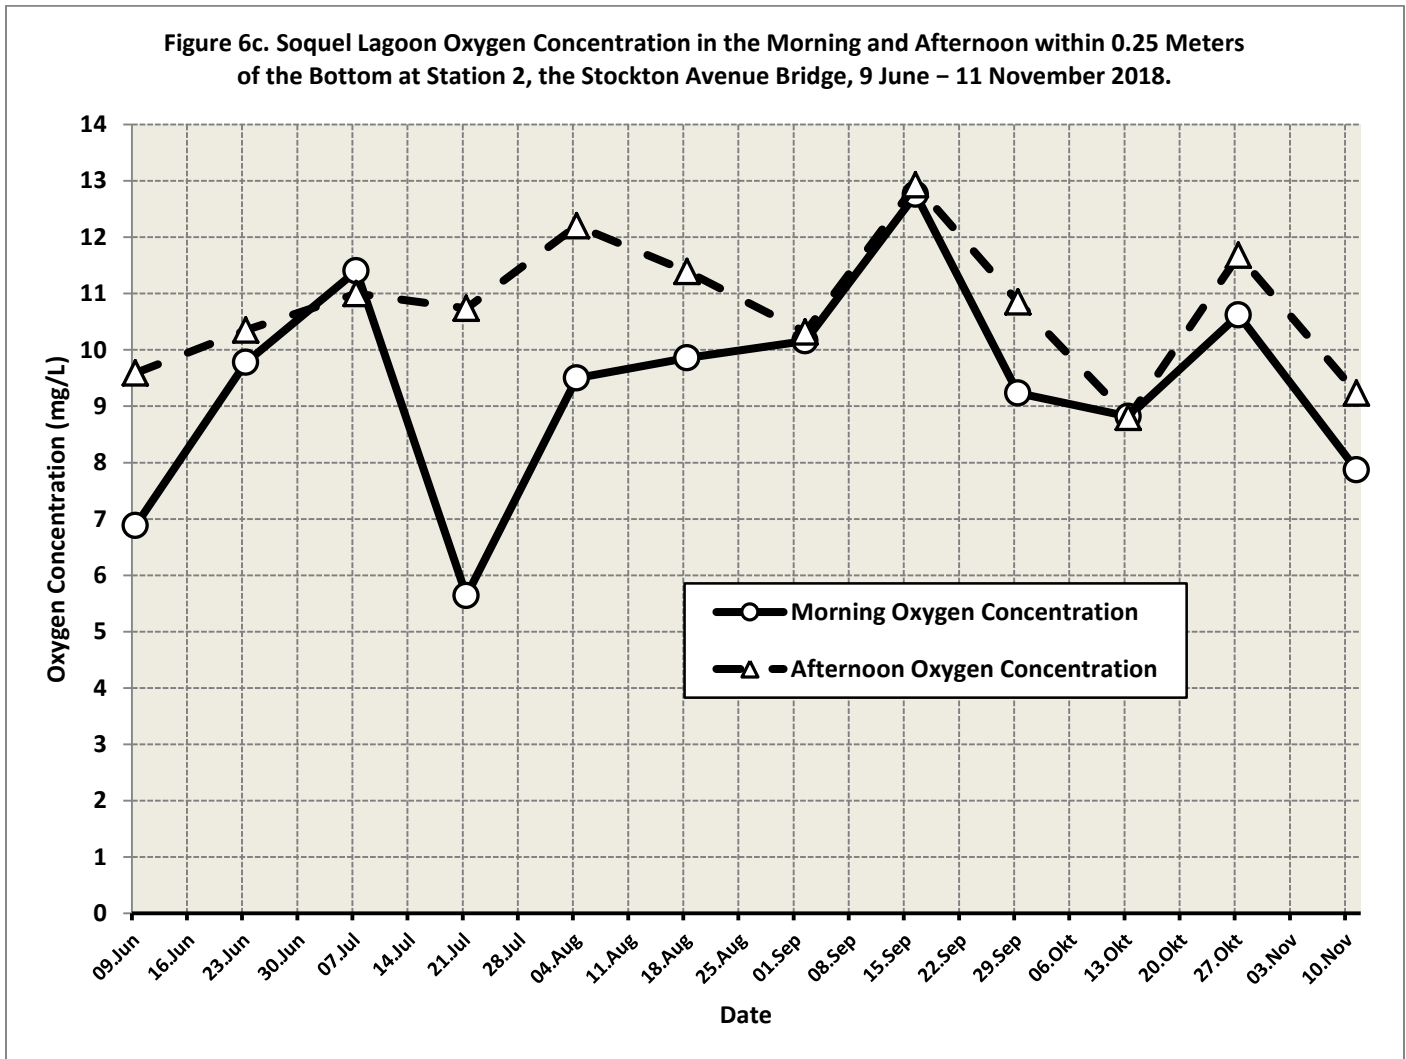
Figure 6c. Soquel Lagoon Oxygen Concentration in the Morning and Afternoon within 0.25 Meters of the Bottom at Station 2, the Stockton Avenue Bridge, 9 June – 11 November 2018.
