DRAFT Soquel Lagoon Monitoring Report- 2019

Prepared for the
CITY OF CAPITOLA, 420 Capitola Avenue, Capitola, California 95010
By
D.W. ALLEY & Associates, Aquatic Biology

December 2019

Project # 106-29

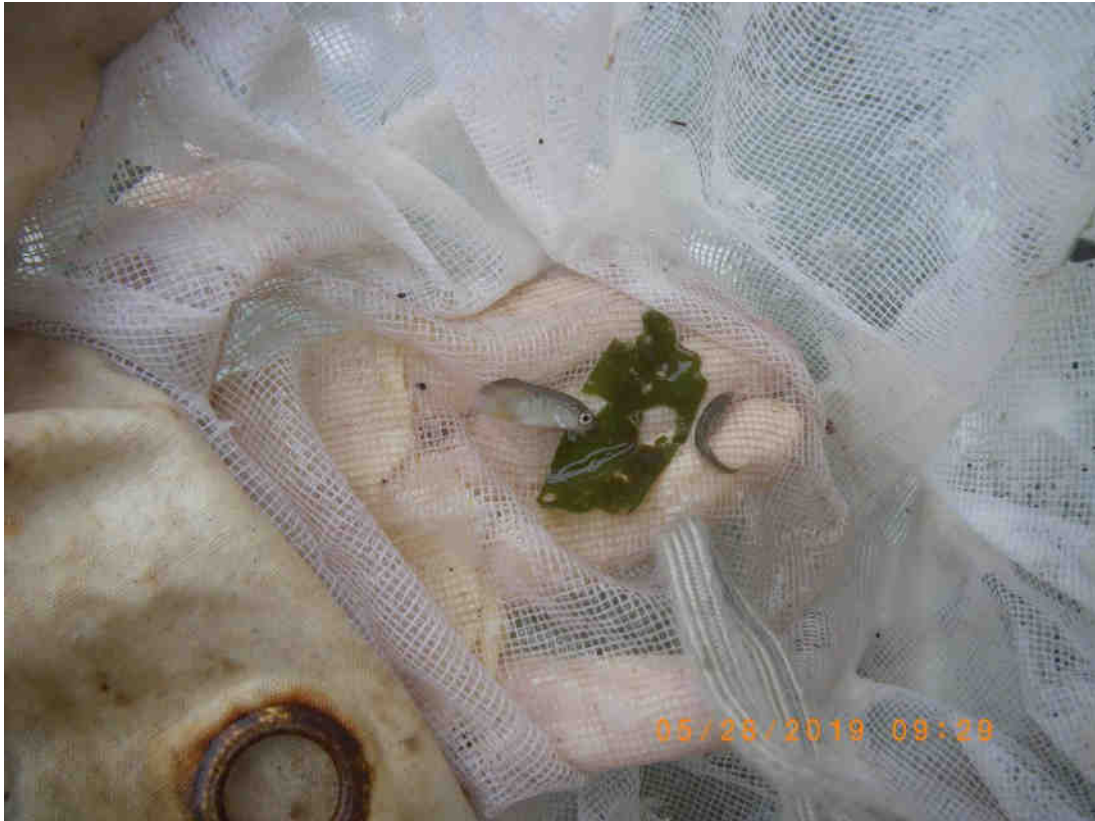
Small YOY steelhead captured and relocated from lateral channel. 28 May 2019

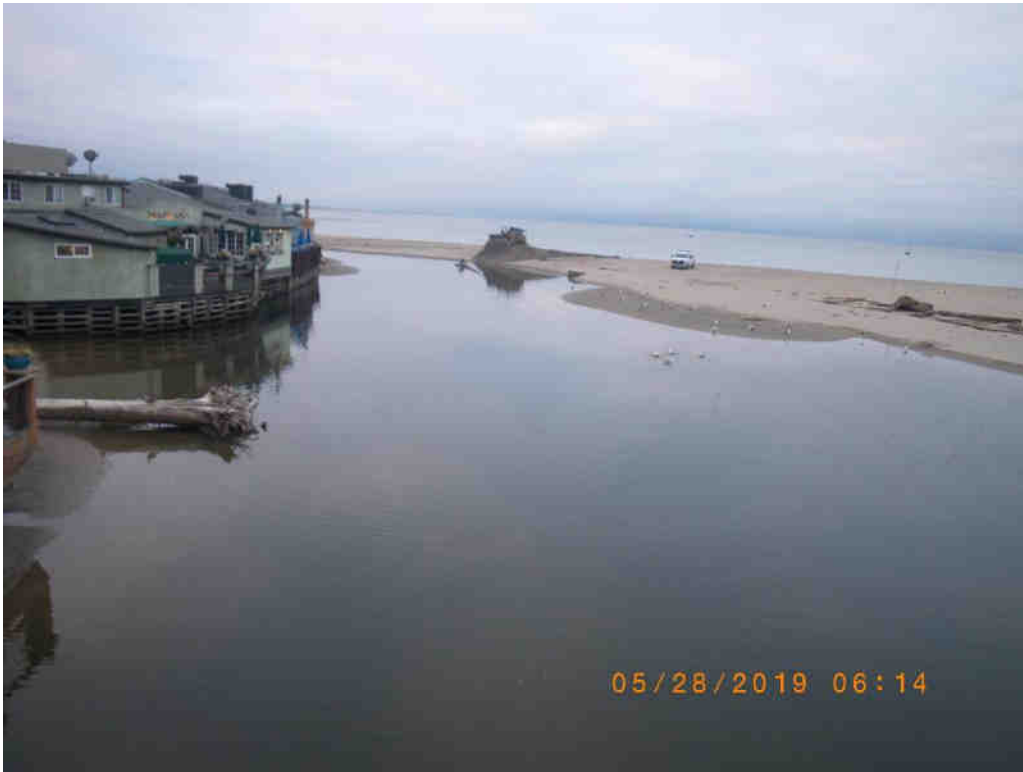
Soquel Estuary prior to sandbar construction.

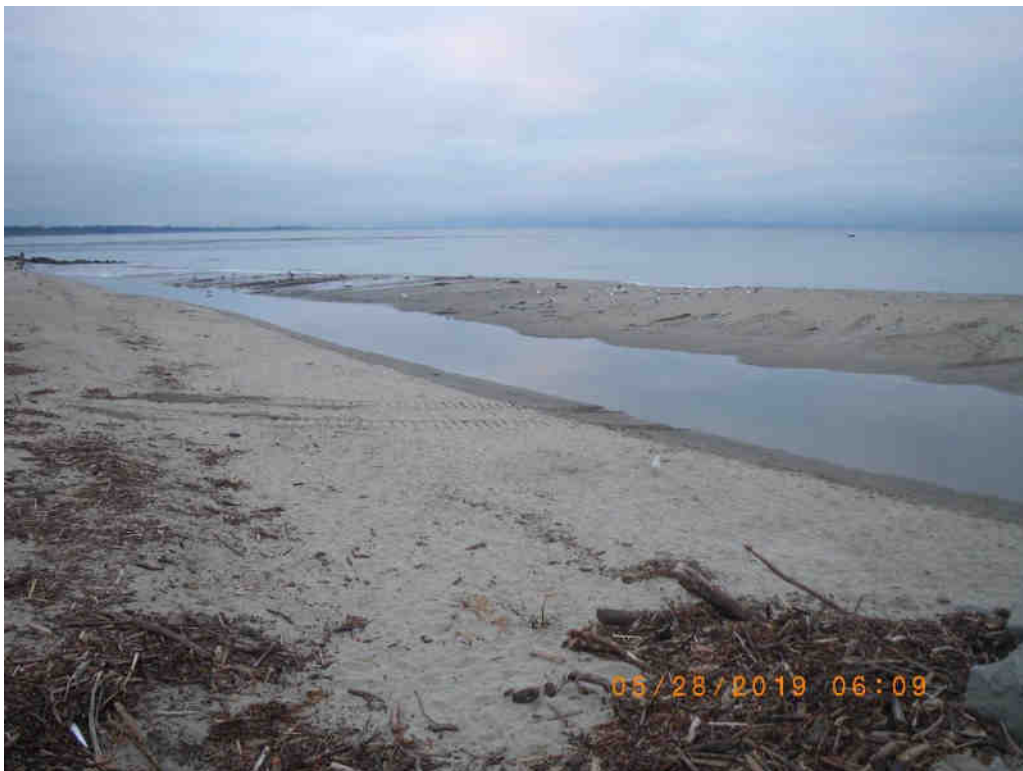
Lateral channel flowing diagonally across the beach to the end of the jetty. 28 May 2019

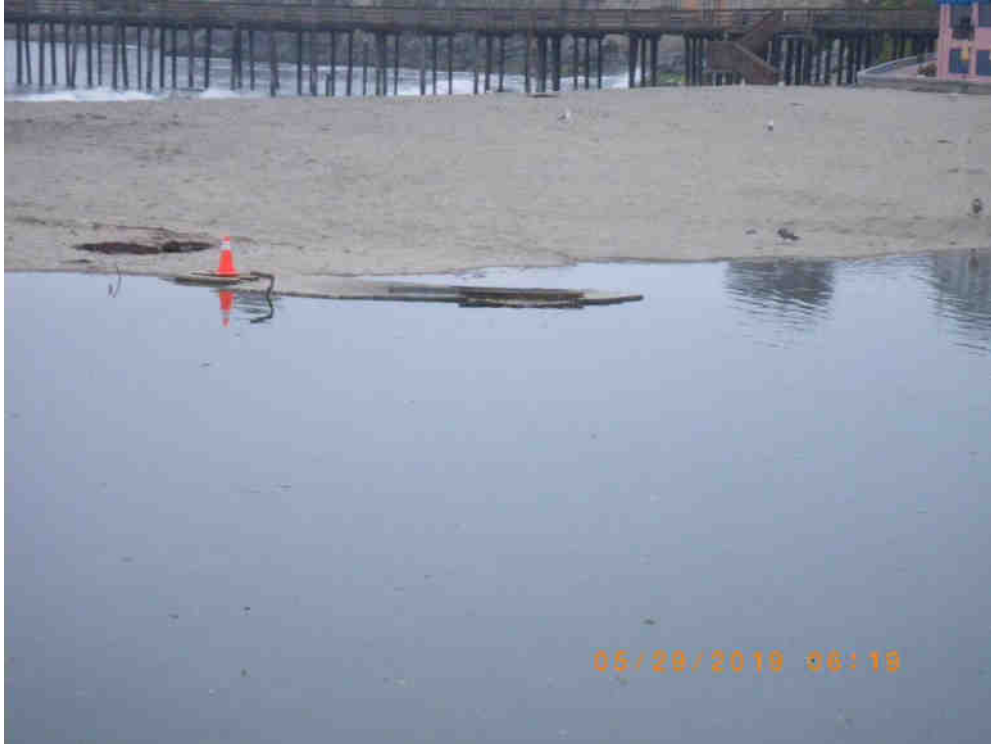
Lagoon filled overnight with steelhead adult and smolt passage through screened portal.
29 May 2019

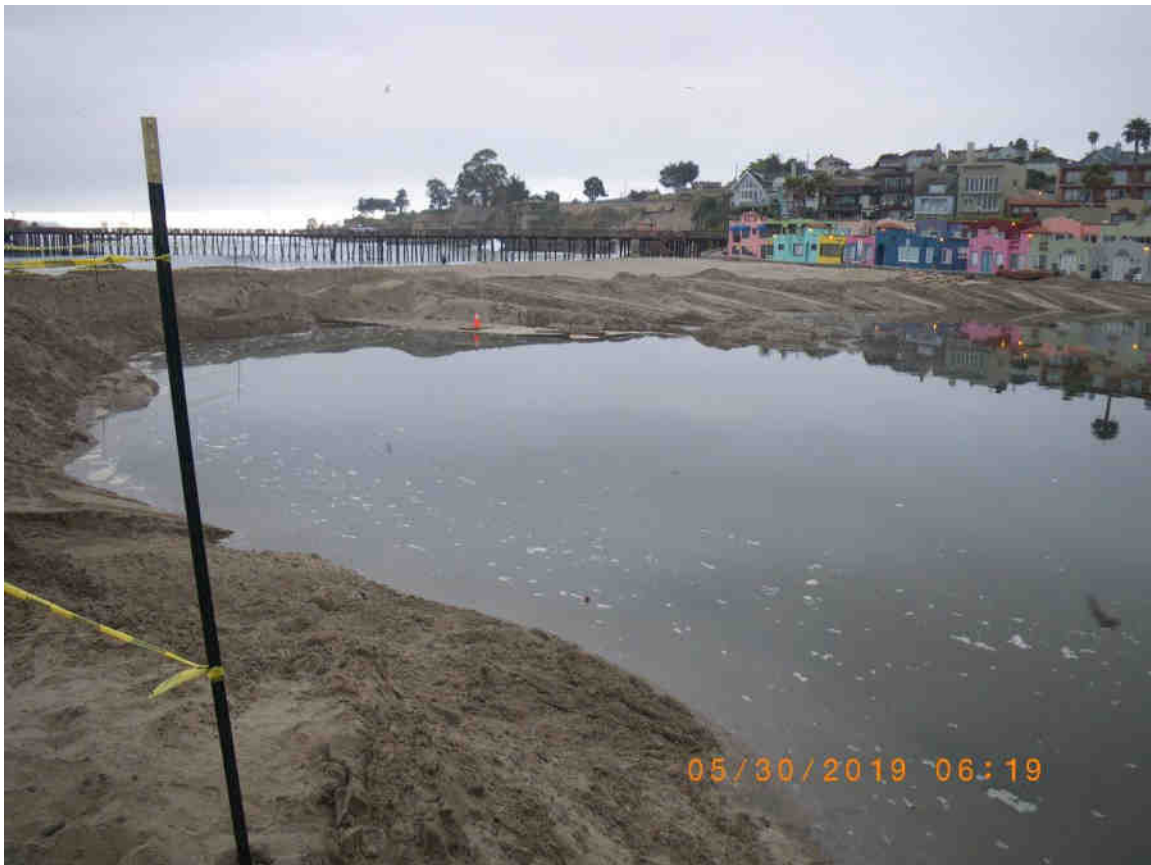
Lagoon filled overnight with steelhead adult and smolt passage through screened portal.
30 May 2019

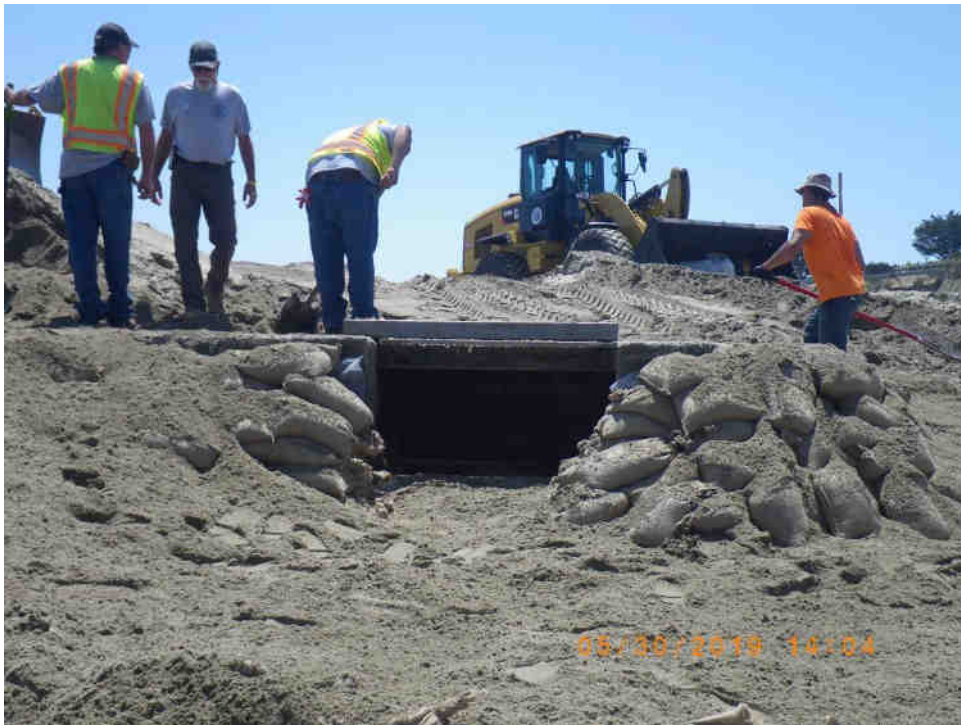
Sandbags placed around the flume inlet to prevent leakage of sand along the flume after sandbar closure. 30 May 2019

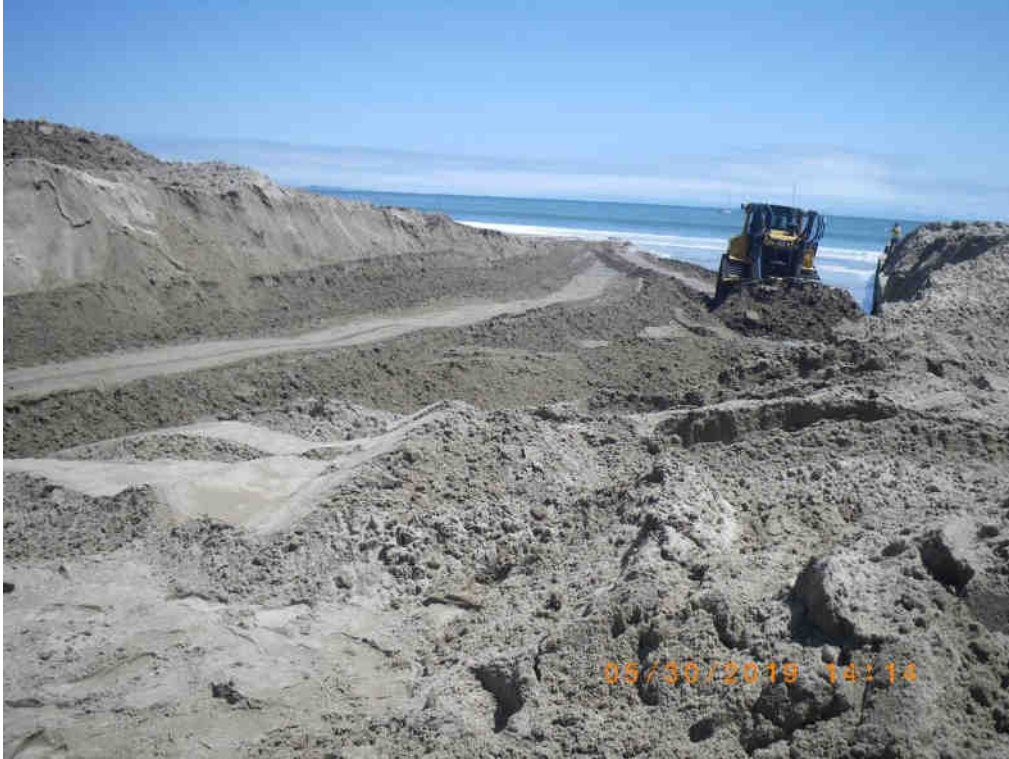
Kotila packing sand under the flume during sandbar closure. 30 May 2019

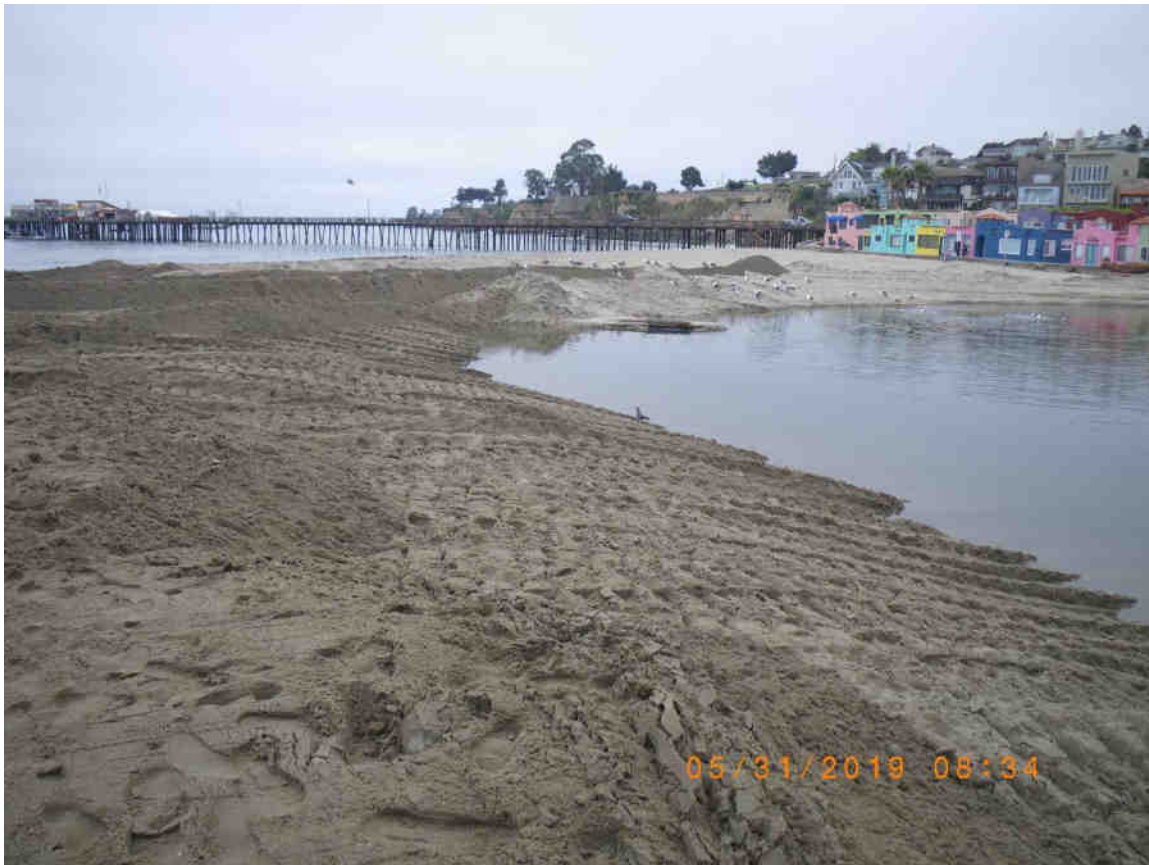
Lagoon full and periphery between the restaurants and the flume was complete.
31 May 2019

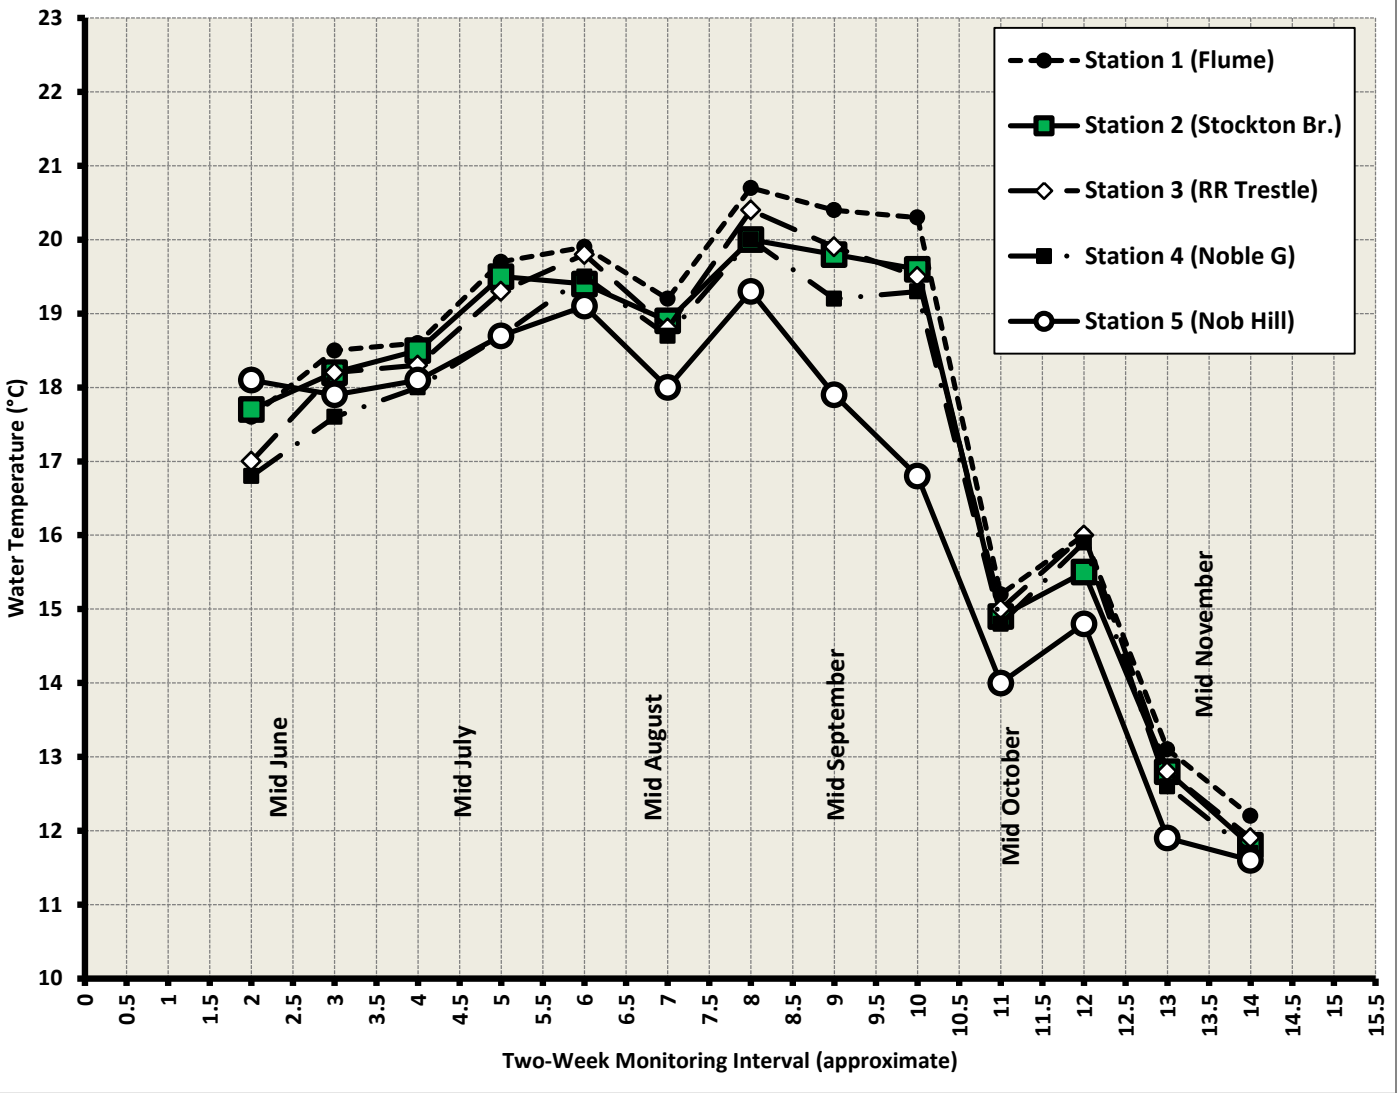
Figure 3h. Water Temperature in the Afternoon at Four Lagoon Stations Near the Bottom and Upstream from June to November 2019.

Water temperatures near the bottom at dawn generally increased through the dry season from June to mid-September, except for mid-August, with an approximate 3°C increase from June to mid-September at all stations (**Figure 3g**). The same increase was observed at the sites for afternoon water temperatures, with the dip on 18 August on a cooler, overcast day. (**Figure 3h**).
