Soquel Lagoon Monitoring Report- 2020

(Sampling for Tidewater Goby under USFWS Endangered Species Recovery Permit TE-793645-4)

CITY OF CAPITOLA, 420 Capitola Avenue, Capitola, California 95010

February 2021

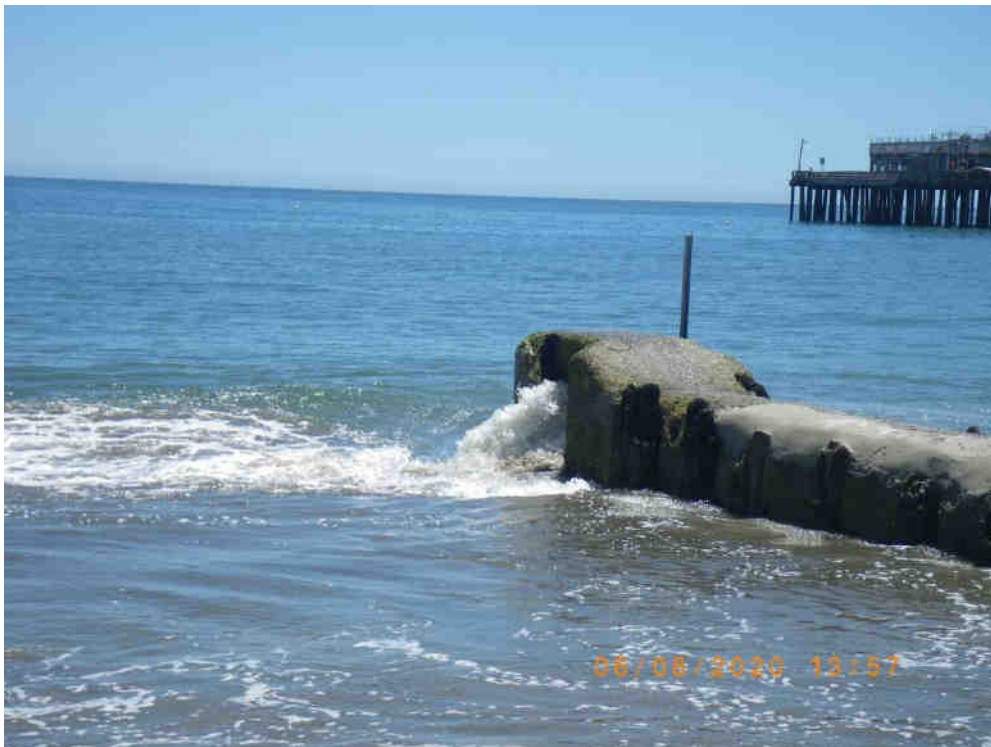
Flume cleared of sand with its first flush of streamflow from the lagoon that had overtopped the flume before clearance. 8 June 2020

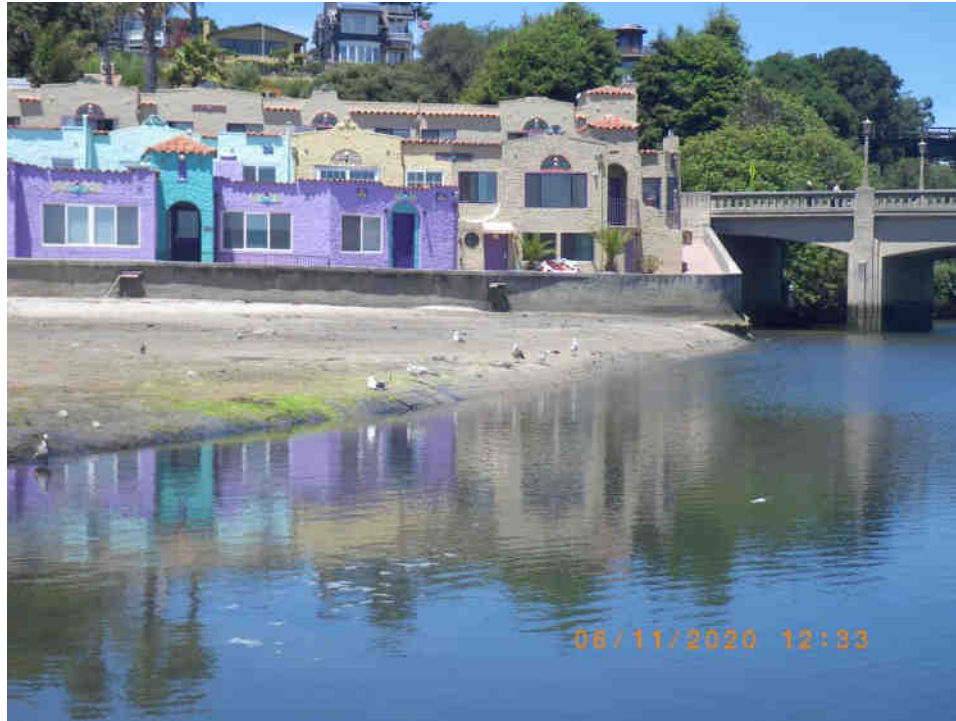
Lagoon filling after sandbar closure, showing steep drop-off created by good spring stormflow scour to deepen the lagoon. 11 June 2020

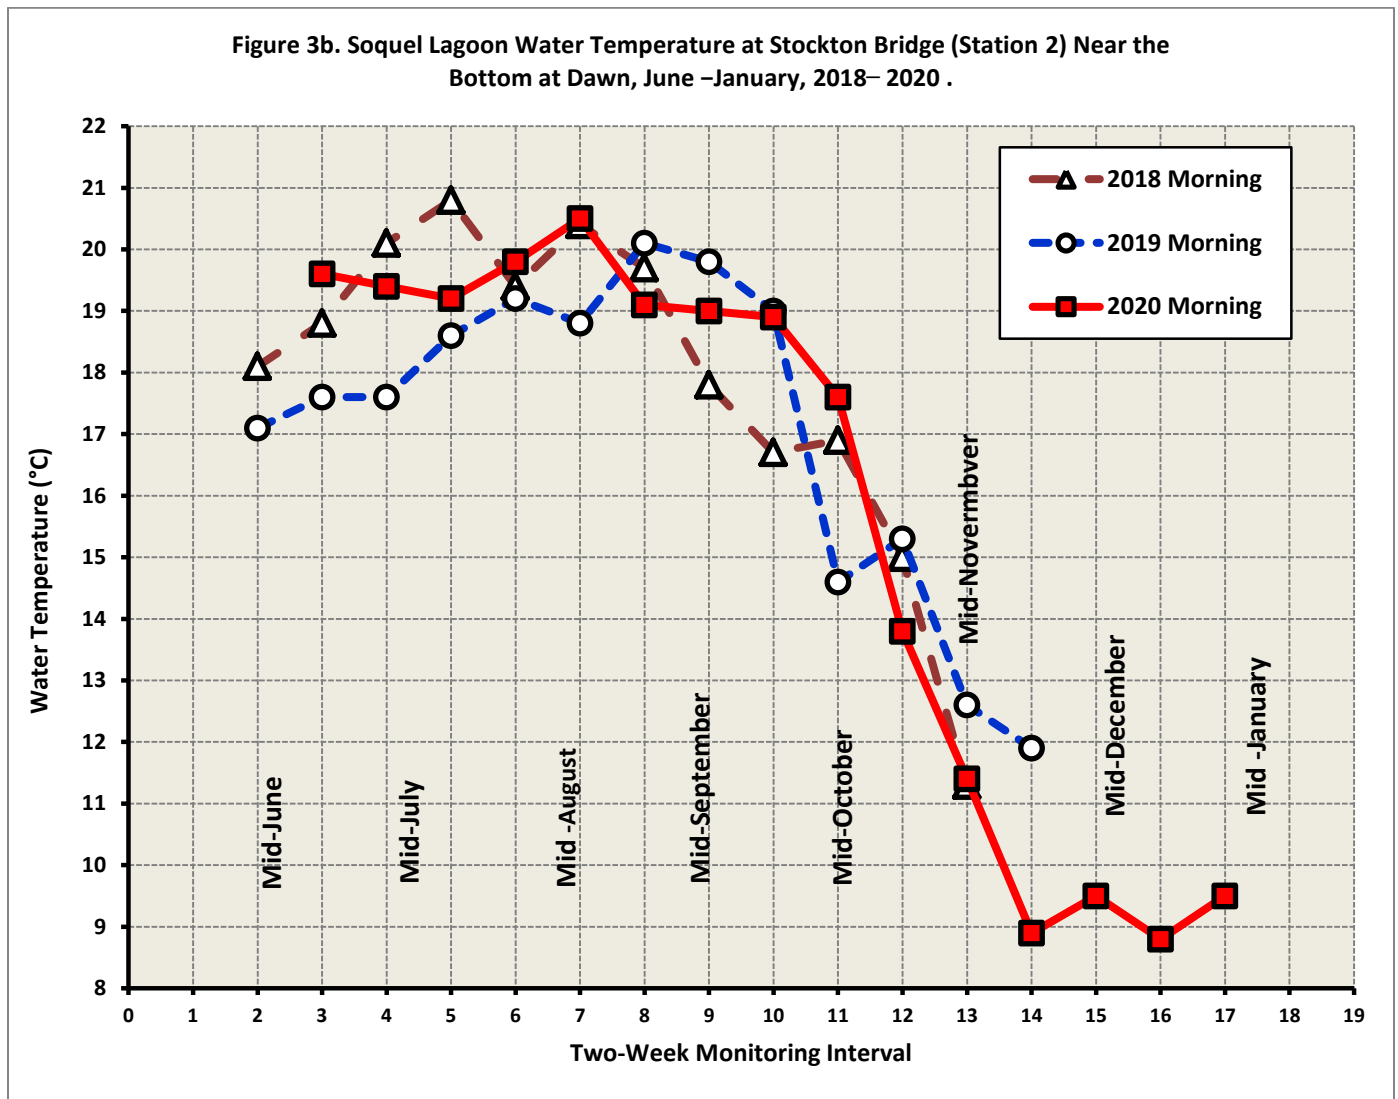
Figure 3b. Soquel Lagoon Water Temperature at Stockton Avenue Bridge Near the Bottom at Dawn for June – January, 2018–2020.

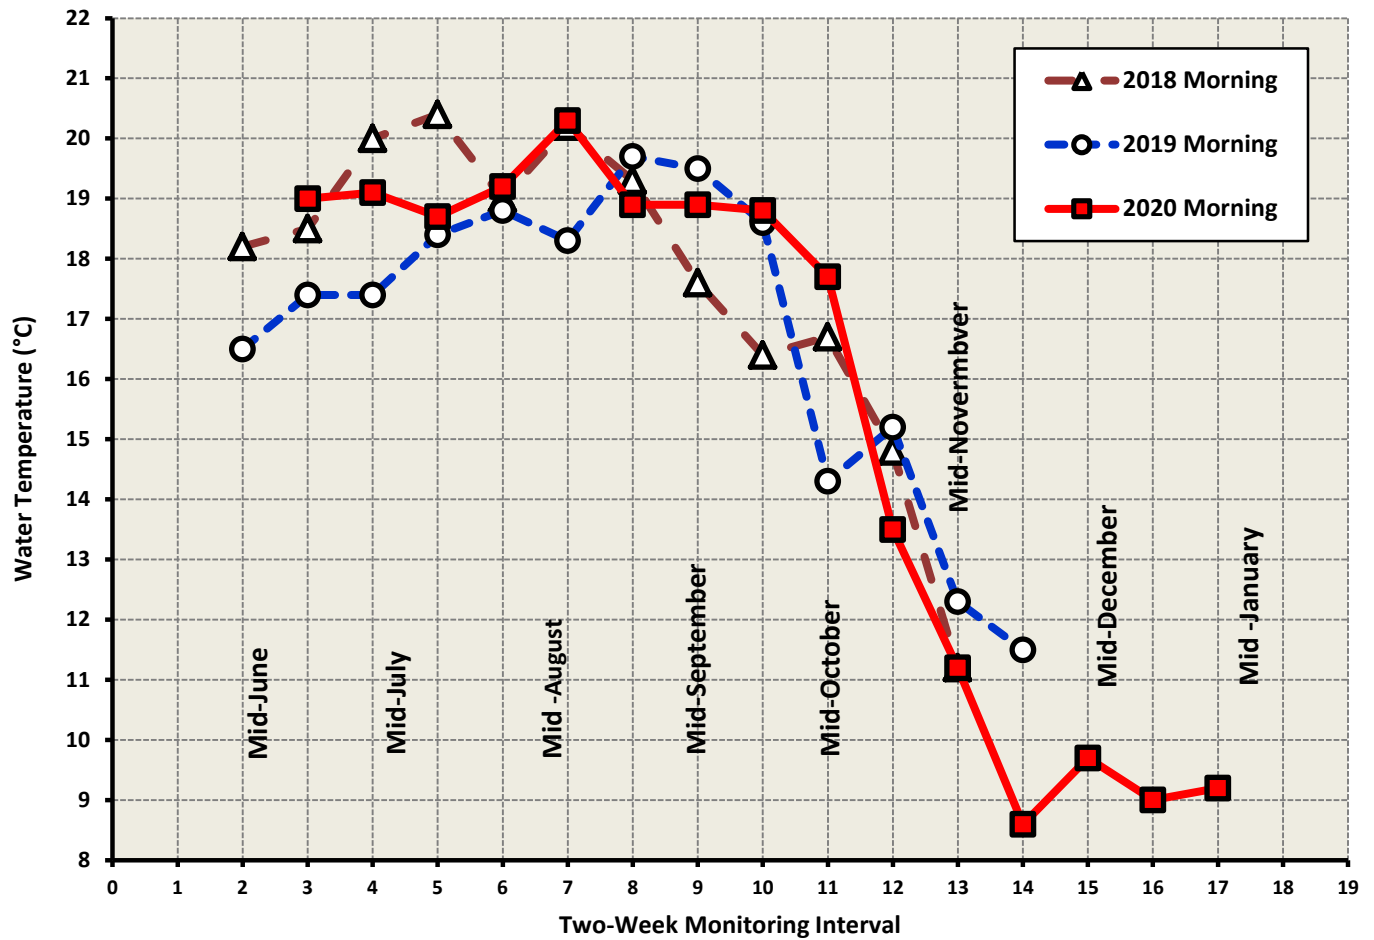
Figure 3c. Soquel Lagoon Water Temperature at the Railroad Trestle (Station 3) Near the Bottom at Dawn for June– January, 2018–2020..

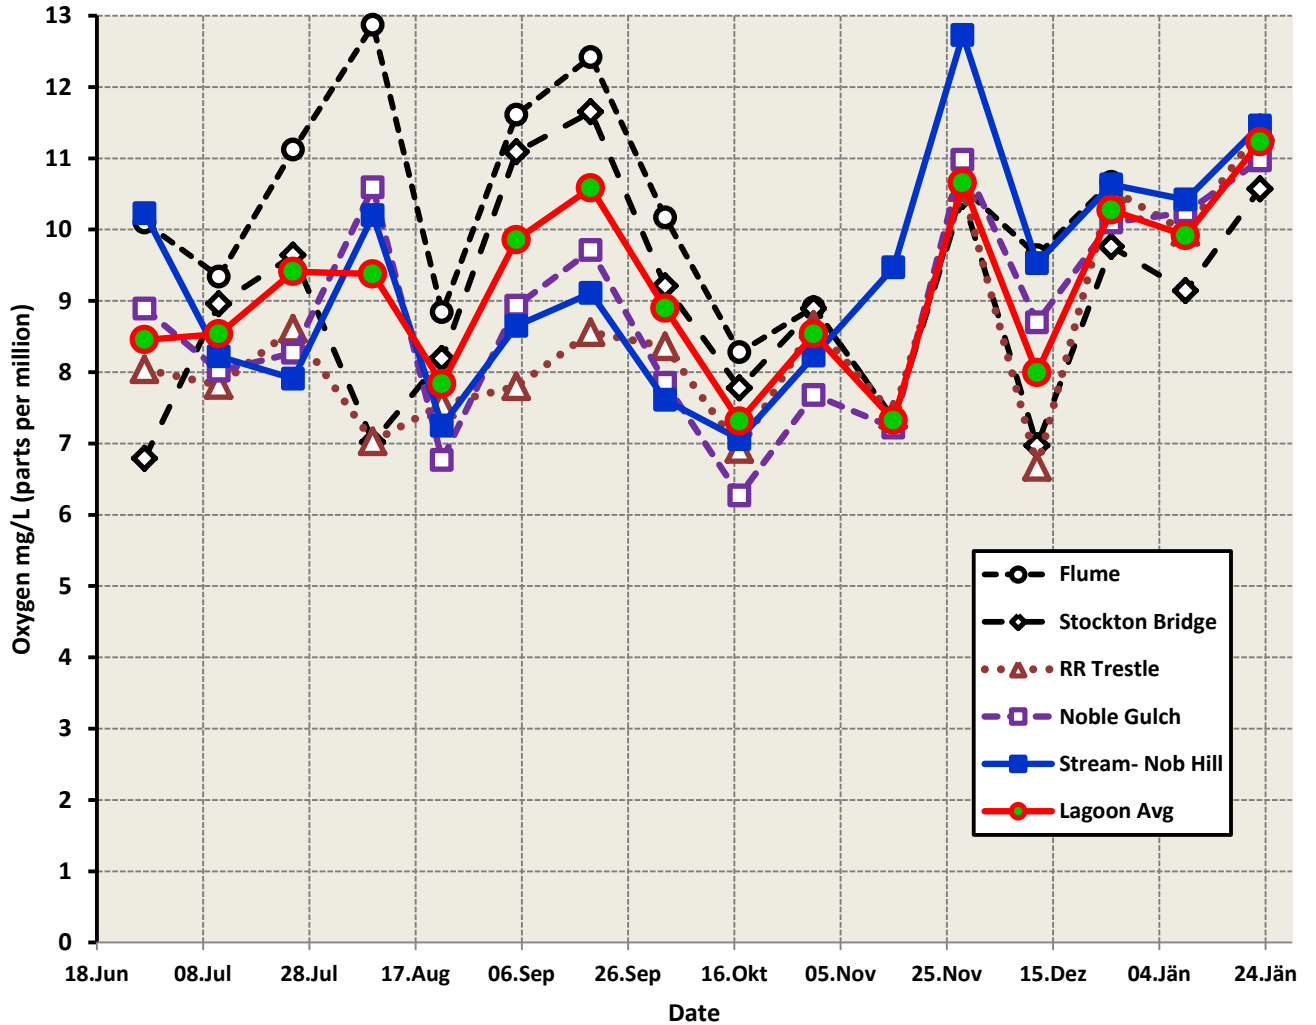
Figure 6a. Soquel Lagoon/Stream Oxygen Concentration at Dawn Within 0.25m of the Bottom at Five Monitoring Stations, 16 June – 23 January 2021.

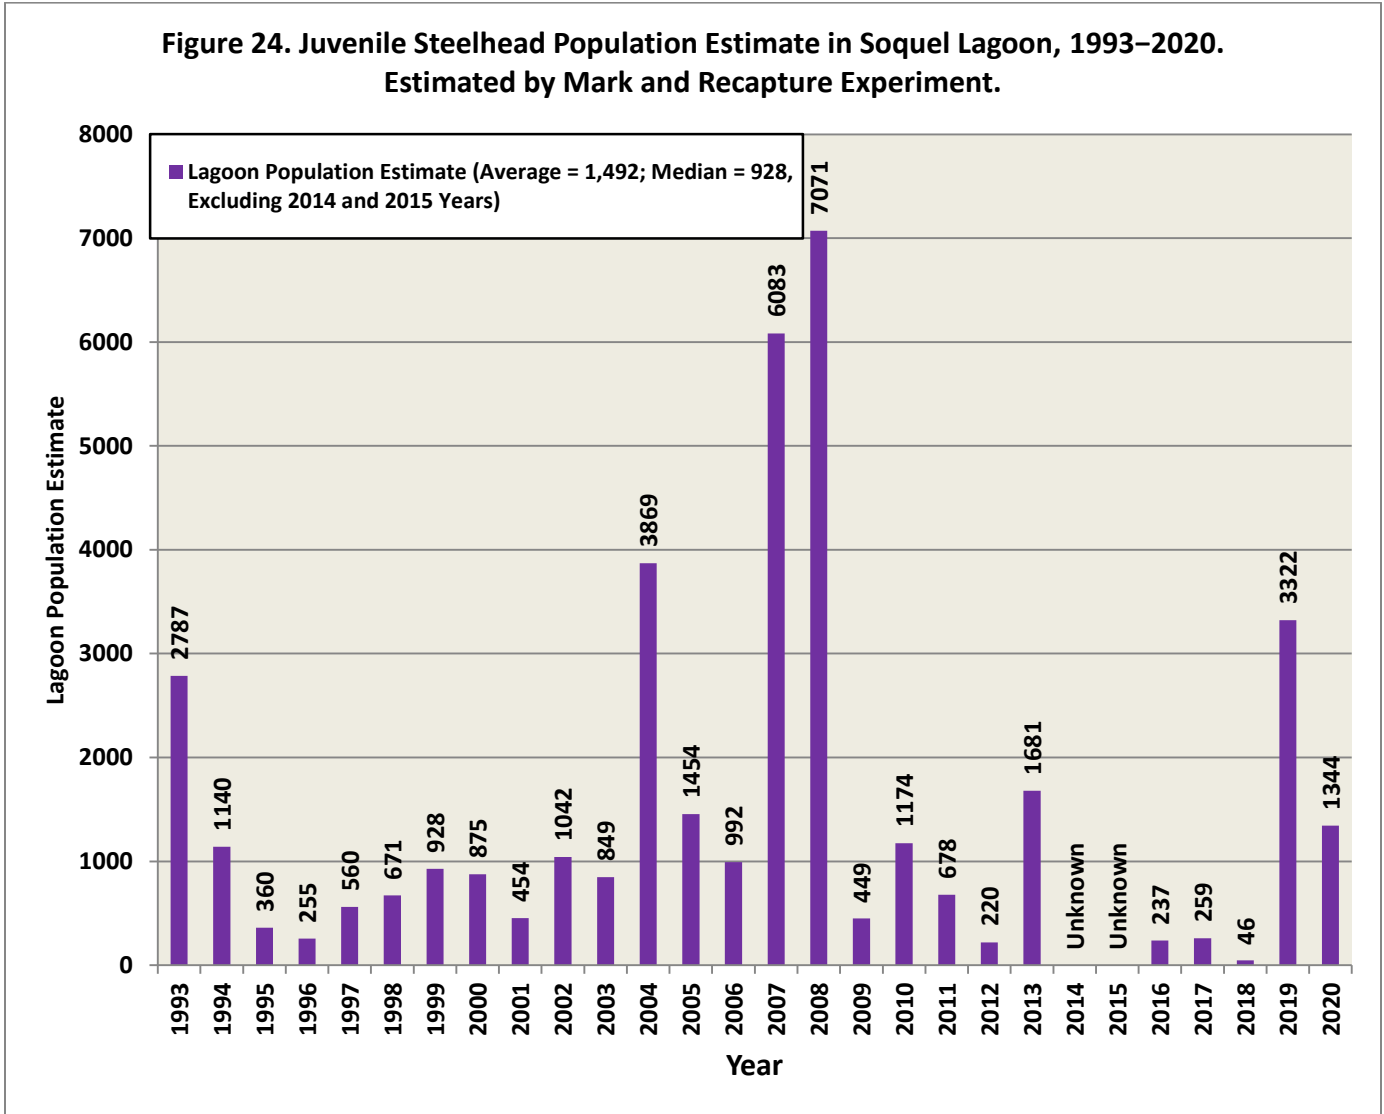
Figure 24. Steelhead Population Estimate in Soquel Lagoon, 1993–2020.
