Soquel Lagoon Monitoring Report- 2022

(Sampling for Tidewater Goby under USFWS Endangered Species Recovery Permit TE-793645-4)

Prepared for the
CITY OF CAPITOLA, 420 Capitola Avenue, Capitola, California 95010
D.W. ALLEY & Associates, Aquatic Biology

December 2022

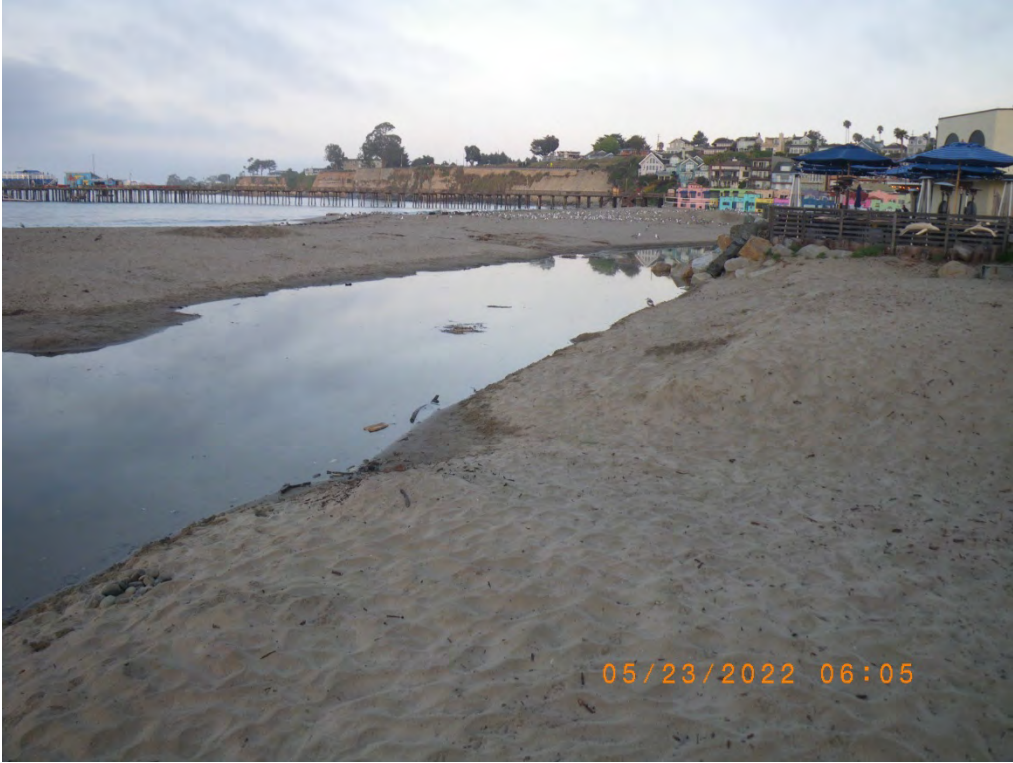
**Lateral channel ponded diagonally across the beach, looking upstream toward the flume.
23 May 2022**

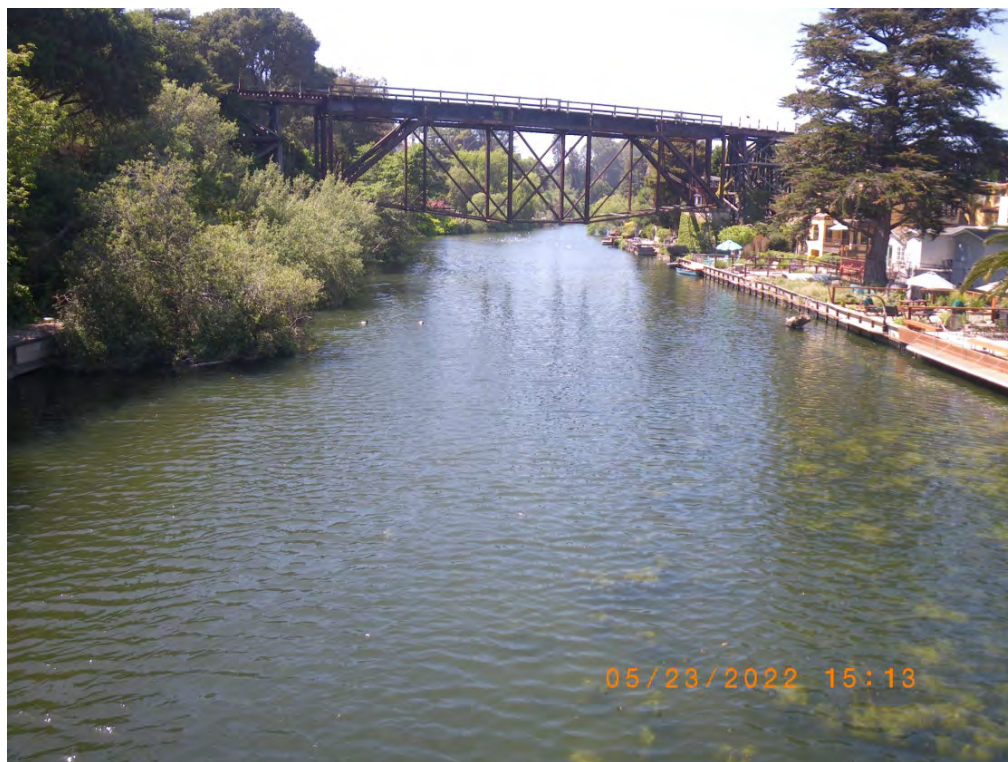
Lagoon spanning entire width of channel at the end of the day (pondweed visible on the right). 23 May 2022

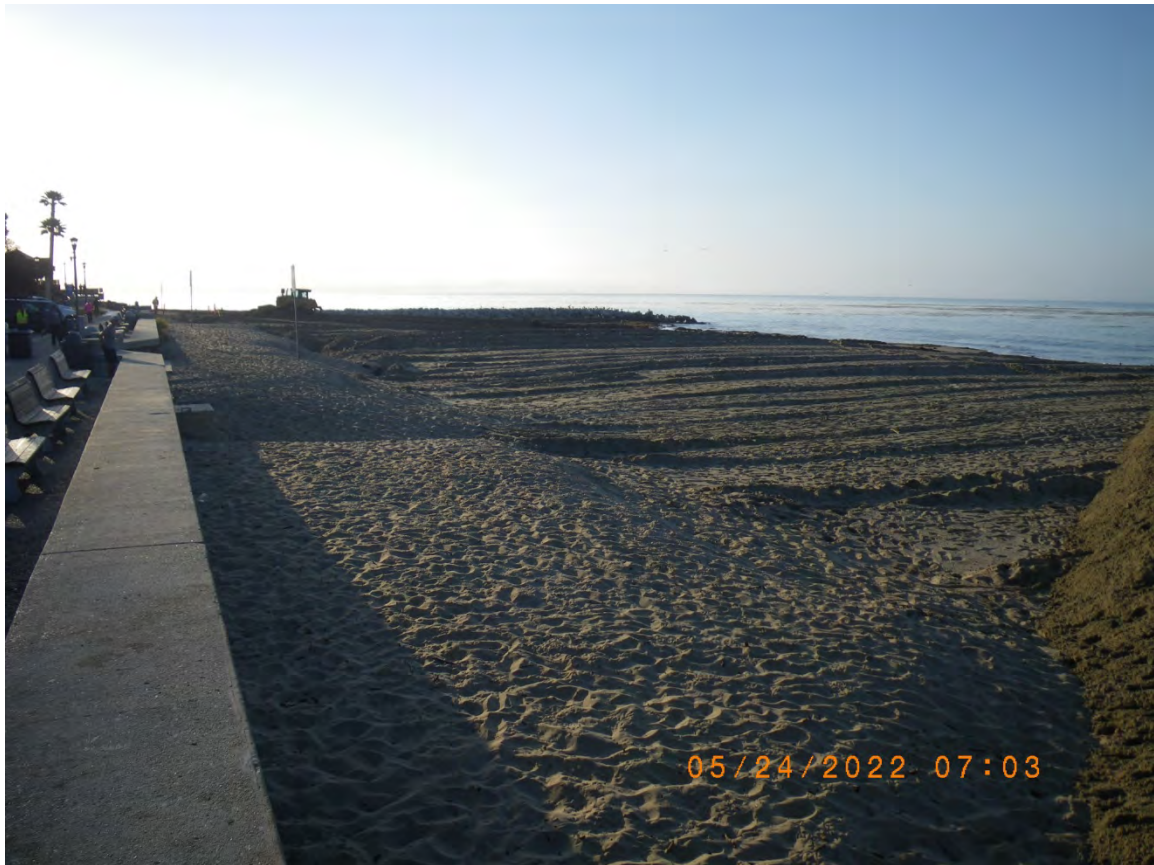
Lateral channel conversion to beach completed the previous day. Kotila filling in area near the jetty with sand that was lost by tidal action overnight. 24 May 2022

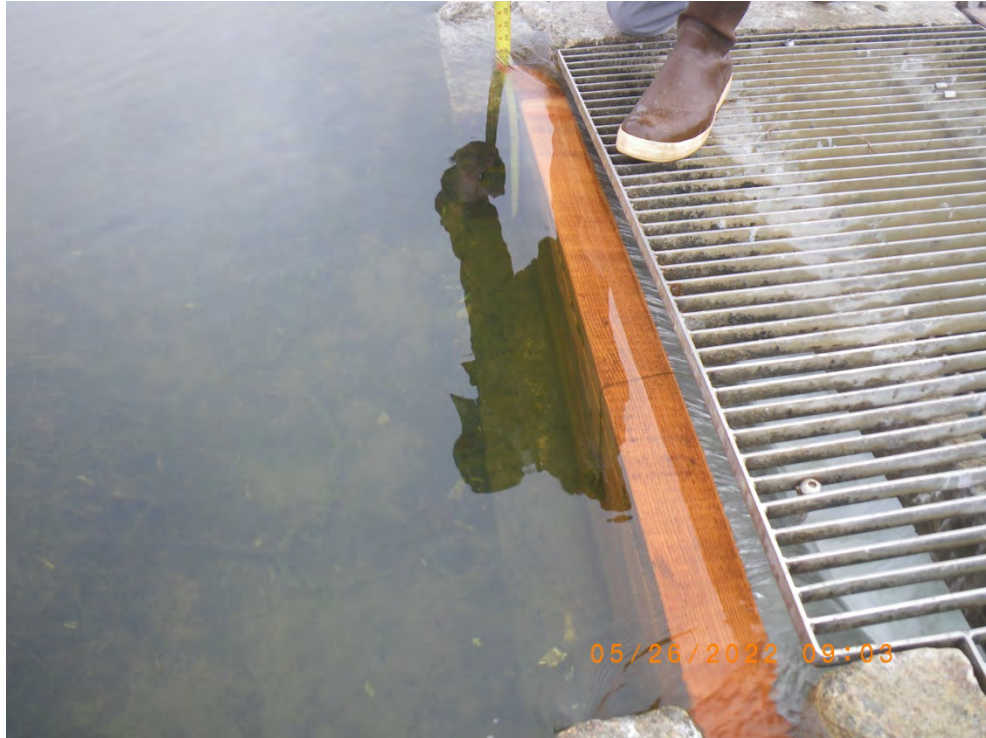
**Lagoon filled overnight with added flashboards, providing smolt steelhead passage the previous night.
26 May 2022**

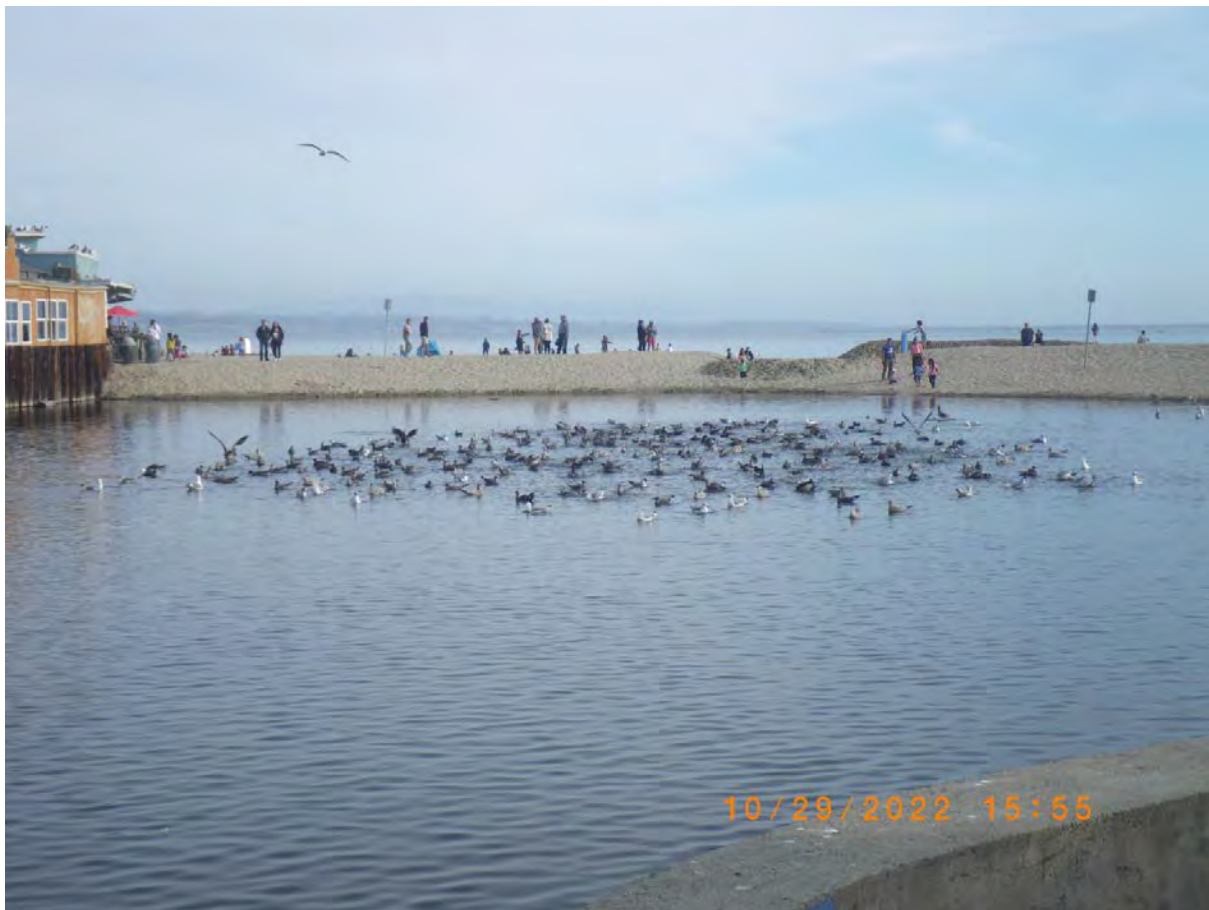
Gulls bathing in Reach 1 (mostly Hermann’s Gulls). Notch prepared in sandbar preliminary to stormflows. 29 October 2022

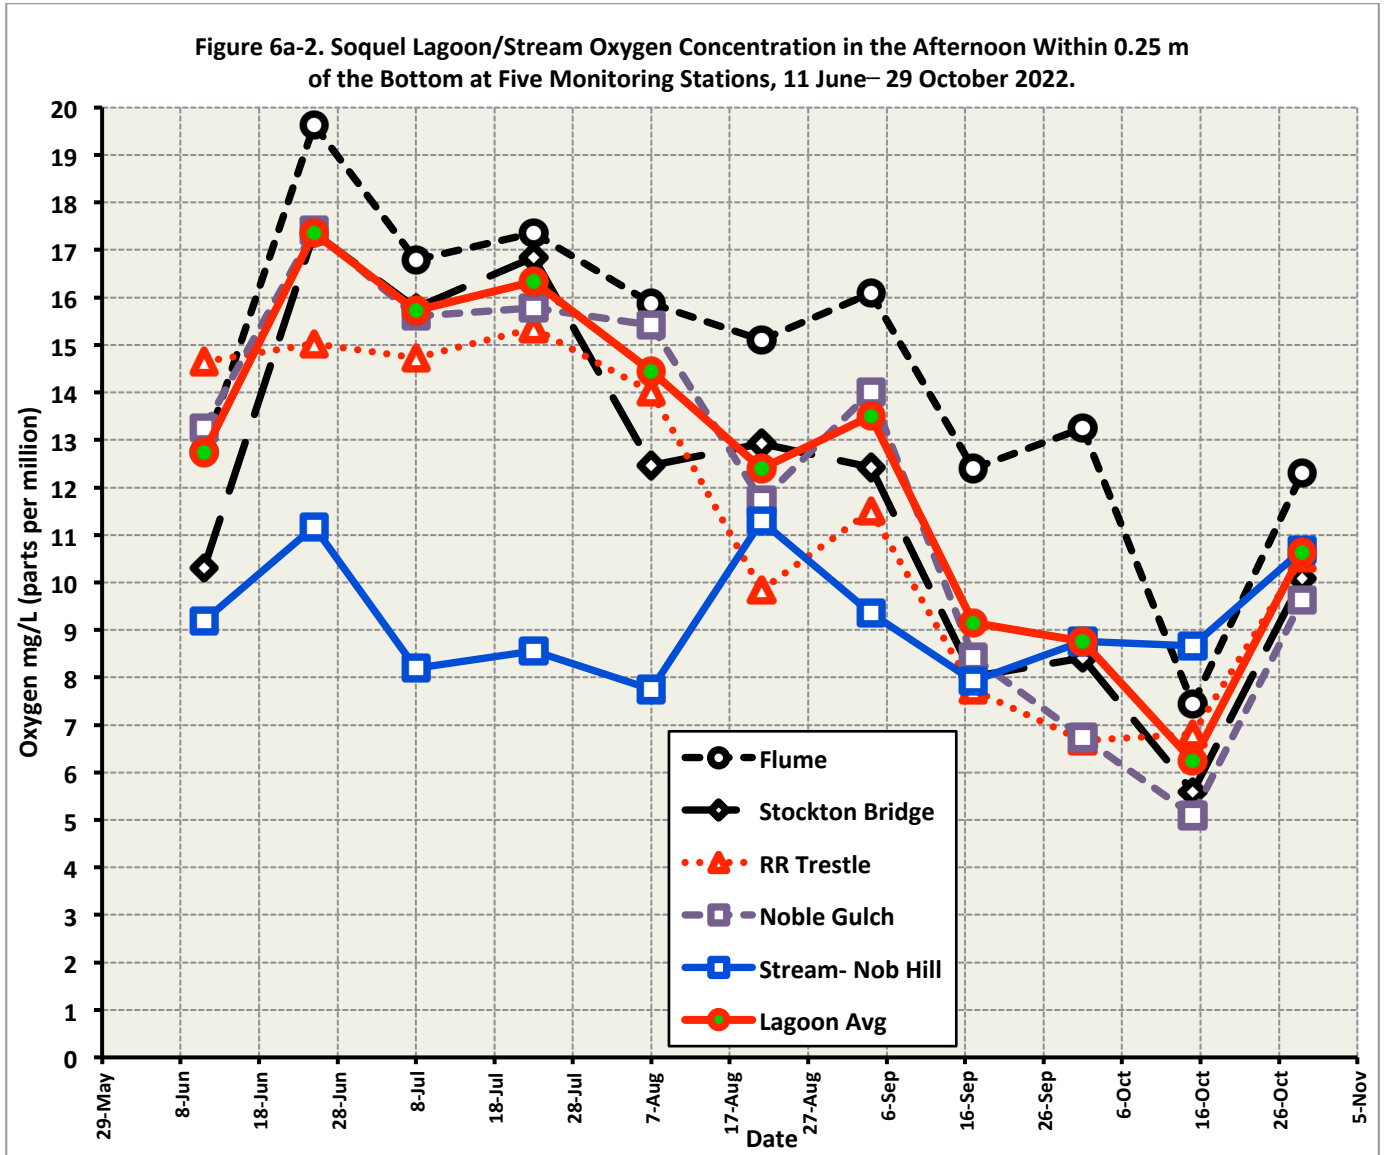
Figure 6a-2. Soquel Lagoon/Stream Oxygen Concentration in the Afternoon Within 0.25m of the Bottom at Five Monitoring Stations, 11 June – 29 October 2022.
