CAPITOLA CITY COUNCIL SPECIAL MEETING

SUBJECT: Consider a Budget Amendment To Fund Emergency Tree Removal at City Hall,
420 Capitola Avenue

A Limited Risk Assessment of 13 Trees City Hall and Beach & Village Parking Lots

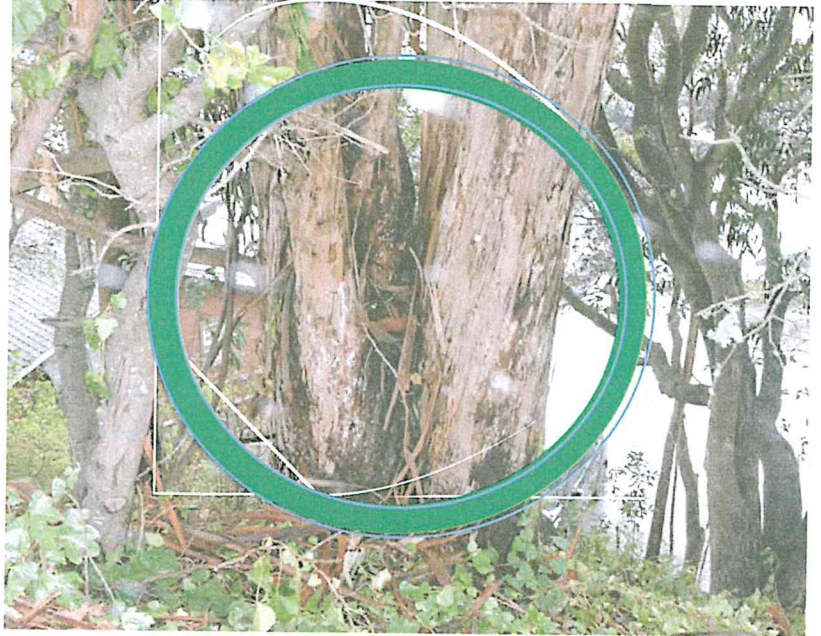
Assigned Risk Rating = 10, High Risk Category 2

- Probability of Failure, Moderately High = 3
- Target Area, High = 4
- Size of the Defective Part, Branches or Stems greater than 20 diameter inches = 3
