ADDENDUM NO. 1

TO: All Plan holders and Prospective Bidders
FROM: City of Capitola Public Works
DATE: March 27, 2020
RE: **ADDENDUM NO. 1**
BROMMER STREET COMPLETE STREET IMPROVEMENT PROJECT

GEOTECHNICAL INVESTIGATION DESIGN PHASE

FOR
BROMMER COMPLETE STREET IMPROVEMENT
CAPITOLA, CALIFORNIA

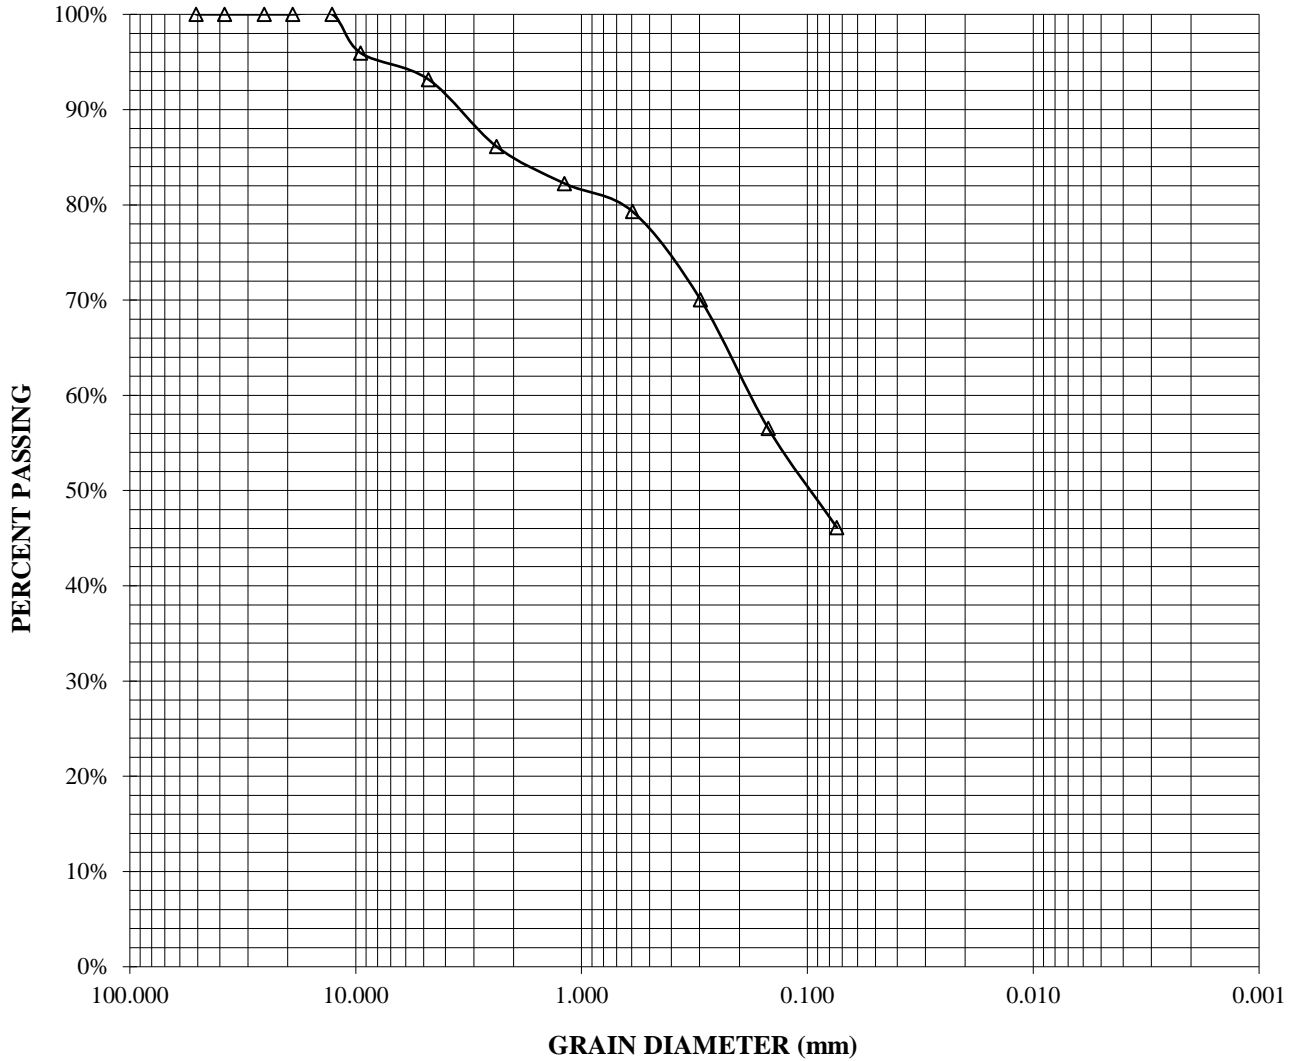
BORING:	C3	PERCENT	PERCENT
DEPTH (ft):	1.5	PASSING No. 4	PASSING No. 200
SOIL TYPE (USCS):	SC	93.2%	46.1%

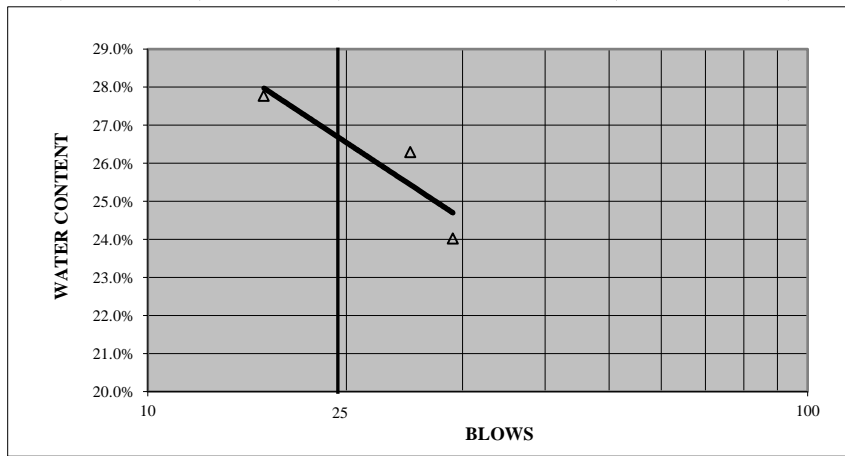
FIGURE
B-2

Tare No.:	E	W	V		
Wet Wt. + Tare:	18.32	18.28	18.90		
Dry Wt. + Tare:	17.74	17.69	18.21		
Tare Wt.:	13.86	13.69	13.60		
Wet Wt.:	4.46	4.59	5.30		
Dry Wt.:	3.88	4.00	4.61		
Wt. of Water:	0.58	0.59	0.69		
Water Content (%):	14.9%	14.8%	15.0%		
				LIQUID LIMIT:	26.5
				PLASTIC LIMIT:	14.9
				PLASTICITY INDEX:	11.6

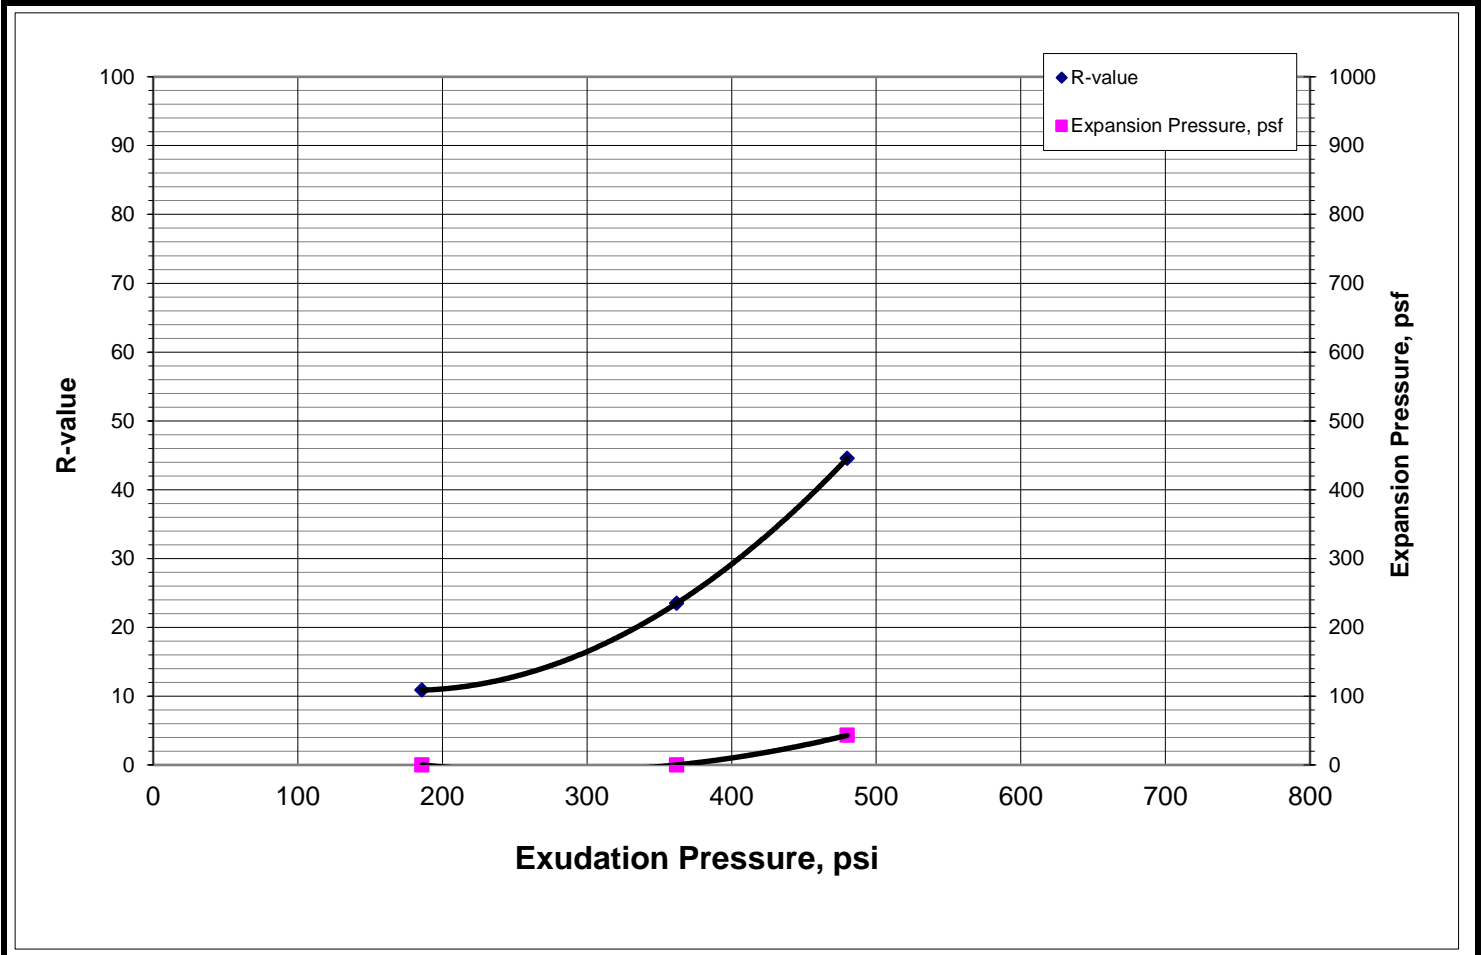
Figure B-6

Job No.:	673-027	Date:	01/08/19	Initial Moisture,	7.9
Client:	Butano Geotechnical	Tested	PJ	R-value	16
Project:	18-232-SC	Reduced	RU	Expansion Pressure	0 psf
Sample	C1,C2,C3,C4_Composite	Checked	DC		
Soil Type:	Dark Brown Clayey SAND w/ Gravel

Specimen Number	A	B	C	D	Remarks:
Exudation Pressure, psi	362	186	480		
Prepared Weight, grams	1200	1200	1200		
Final Water Added, grams/cc	45	61	34		
Weight of Soil & Mold, grams	3234	3189	3175		
Weight of Mold, grams	2116	2098	2090		
Height After Compaction, in.	2.58	2.50	2.43		
Moisture Content, %	11.9	13.3	10.9		
Dry Density, pcf	117.4	116.7	122.0		
Expansion Pressure, psf	0	0	43		
Stabilometer @ 1000					
Stabilometer @ 2000	113	135	69		
Turns Displacement	3.62	3.80	3.80		
R-value	23	11	45
